MODEL BD-100-1A10 (CL-300)

ATA 28-11

**REWORK – WING TANK – ADDITION OF SEALANT TO FACILITATE
WATER DRAINAGE FROM WING FUEL TANKS AND
PREVENT ERRATIC FUEL INDICATIONS**

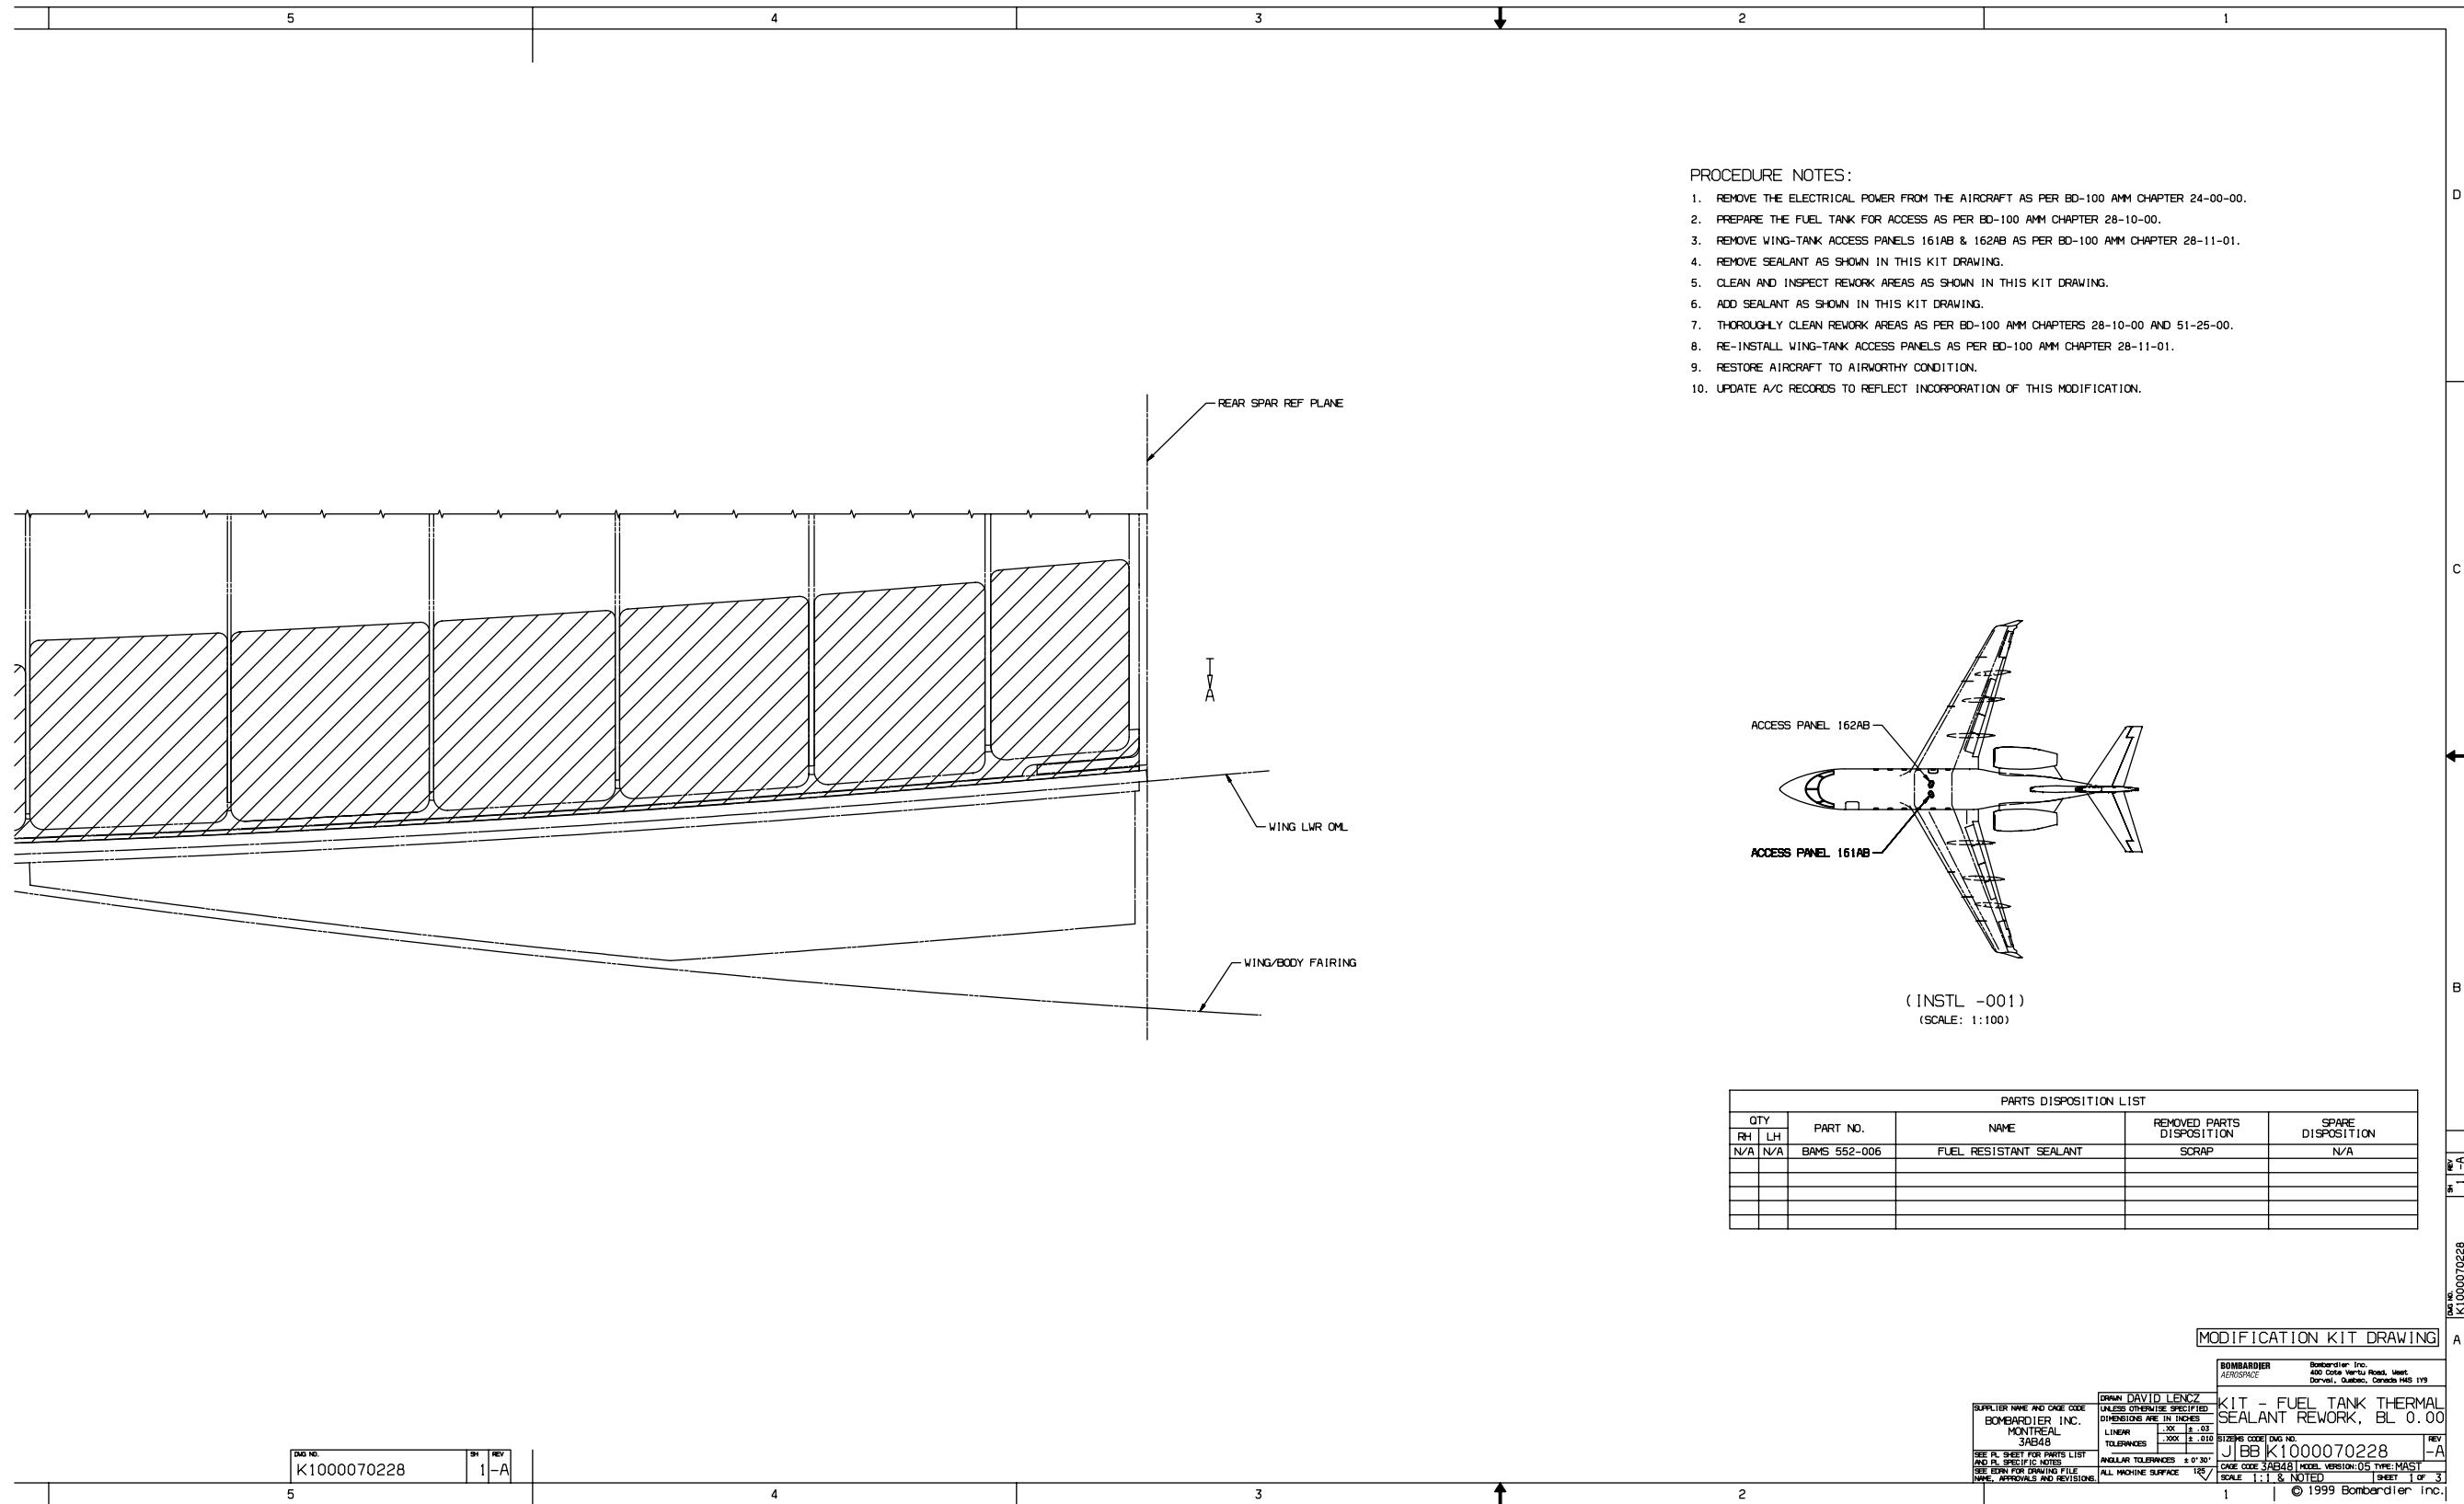
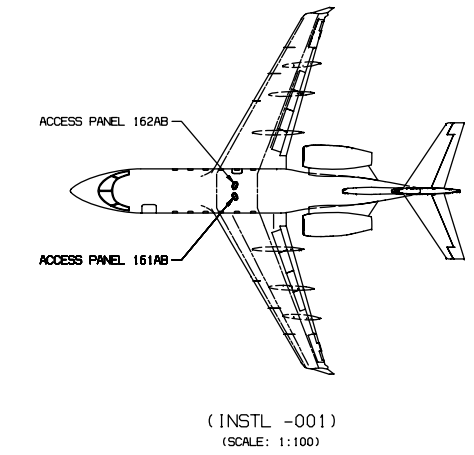
K1000070228 – Kit – Fuel Tank Thermal Sealant Rework BL 0.00
(Sheet 1 of 3, Rev. A)

Many fuel indication issues have occurred as a result of fuel probe/compensator No. 8 being contaminated with water. Water may collect at the bottom of the tank, between the forward stringers, due to sealant that is applied to provide thermal insulation in the event of a wheels-up landing. The sealant is applied up against the stringers and may prevent water from draining towards the water drain valves.

The accomplishment of this Service Bulletin will remove sealant to provide a drain path for any trapped water. Sealant is also added to reduce areas where a drain path is not possible and where water may accumulate without reaching the drain valve.

- (1) Using a non-metallic tool, remove the sealant to provide water drainage paths in all areas identified as flag note 14. Refer to Kit Drawing K1000070228; view A-A, sections E-E and R-R.
NOTE: The use of paint remover to soften sealant is not permitted.
- (2) Using a non-metallic tool, remove sealant in areas identified as flag note 18 as necessary to create a water drainage path. Refer to Kit Drawing K1000070228; flag note 14, 18 and view A-A.
- (3) Prepare areas indicated by flag note 13 of Kit Drawing K1000070228, view A-A, sections L-L, N-N, and P-P for thermal insulation sealant application as follows:
 - (a) Using a Scotch-brite, sand the exposed surface of the cured sealant.
 - (b) Vacuum and clean the area to be sealed. Refer to TASK 51-25-00-110-801.

- (4) Verify the thickness of the sealant in the area indicated by flag note 16. The sealant should be at 0.75 to 0.85 inch (19.05 to 21.59 mm) from the top of the stringer. Refer to Kit Drawing K1000070228; section P-P.
 - (a) If the sealant thickness is greater than 0.85 inch (21.59 mm), remove excess sealant using non-metallic tools or Scotch-brite and prepare surface as per Paragraph 2.B.(3). Refer to Kit Drawing K1000070228.
 - (b) If the sealant thickness is less than 0.75 inch (19.05 mm), prepare surface as per Paragraph 2.B.(3). Refer to Kit Drawing K1000070228.
- (5) Inspect the reworked areas for damage to structure or finish before the application of new sealant. If any damage is present, contact Bombardier Aerospace Customer Support Engineering for disposition.
- (6) Inspect the reworked area sealant for damage and good adhesion to structure.

NOTE: No gaps or void between sealant is permitted.
- (7) If any sealant is missing or damaged over fasteners, skin splices or splice edges, repair area as per AMM requirements. A minimum thickness of 0.06 in (1.56 mm) over fasteners and a minimum thickness of 0.10 in (2.54 mm) at the base of the fasteners and around washers is required. Refer to TASK 51-23-00-390-810.

NOTE: Minimum sealant thickness over fasteners is required to meet EMC/Lightning requirements.
- (8) Install thermal insulation sealant, Part No. PR-1429 B-1/2 or PR-1429 B-2 (BAMS 552-006) as per TASK 51-23-00-390-807, in the areas indicated by flag note 13 and 16 as required to provide a smooth and evenly sloped water drainage path. Refer to Kit Drawing K1000070228; view A-A, sections L-L, N-N, and P-P.
