Service Bulletin No. 100-32-25

Revision No. 01 Dated Jun 30/2015

MODEL BD-100-1A10 (CL-300)

## SPECIAL CHECK/MODIFICATION - NOSEWHEEL-STEERING CONTROL SYSTEM - REPLACEMENT OF THE STEERING MANIFOLD

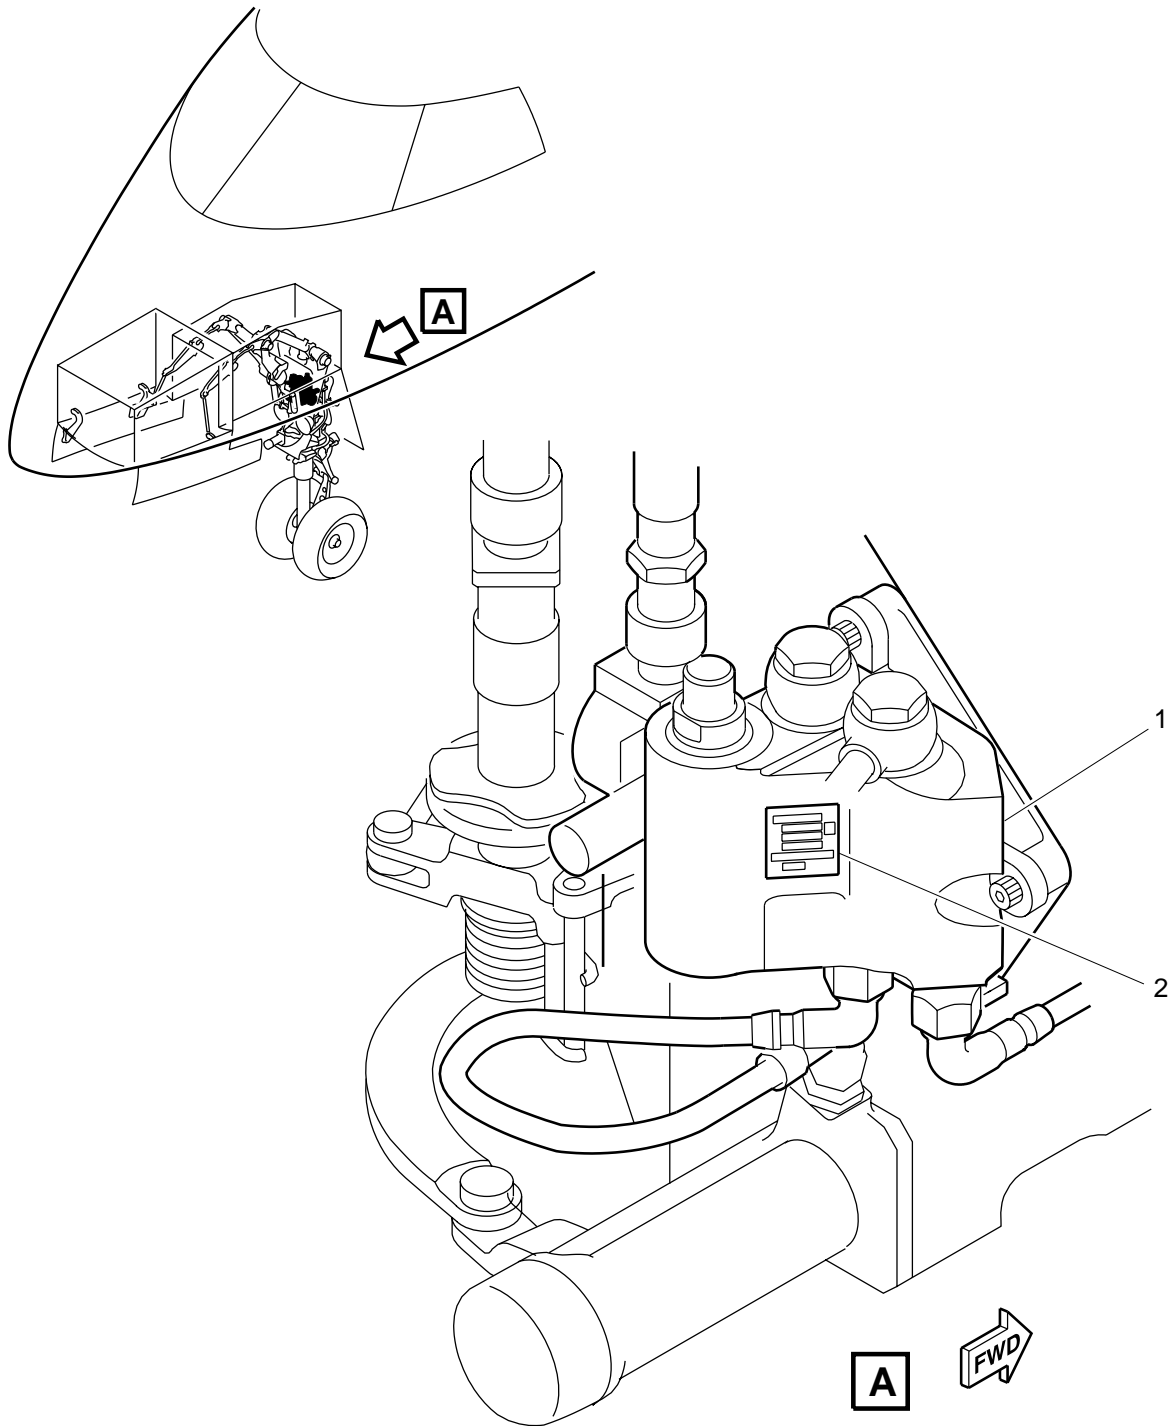
Steering Manifold – Special Check  
Figure 1

- (1) Verify the Part No. of the steering manifold (1) on the identification plate (2). Refer to Figure 1.
- (2) For aircraft with a steering manifold Part No. 40750-103, continue to Paragraph 2.D.
- (3) For aircraft with a steering manifold, Part No 40750-101, continue with PART B of this Service Bulletin.
