MODEL BD-100-1A10 (CL-300)

Alert Service Bulletin No. A100-30-03

Revision No. 01 Dated Dec 21/2005

SPECIAL CHECK – WINDSHIELD AND SIDE WINDOW ANTI-ICE – TORQUING OF ELECTRICAL CONNECTIONS AT TERMINAL BLOCKS TB3 AND TB4; GROUND STUDS GS2269, GS2270, GS2273 AND GS2274; WINDSHIELD TERMINALS G, H, L1 AND L2; AND SIDE WINDOW TERMINALS P AND G

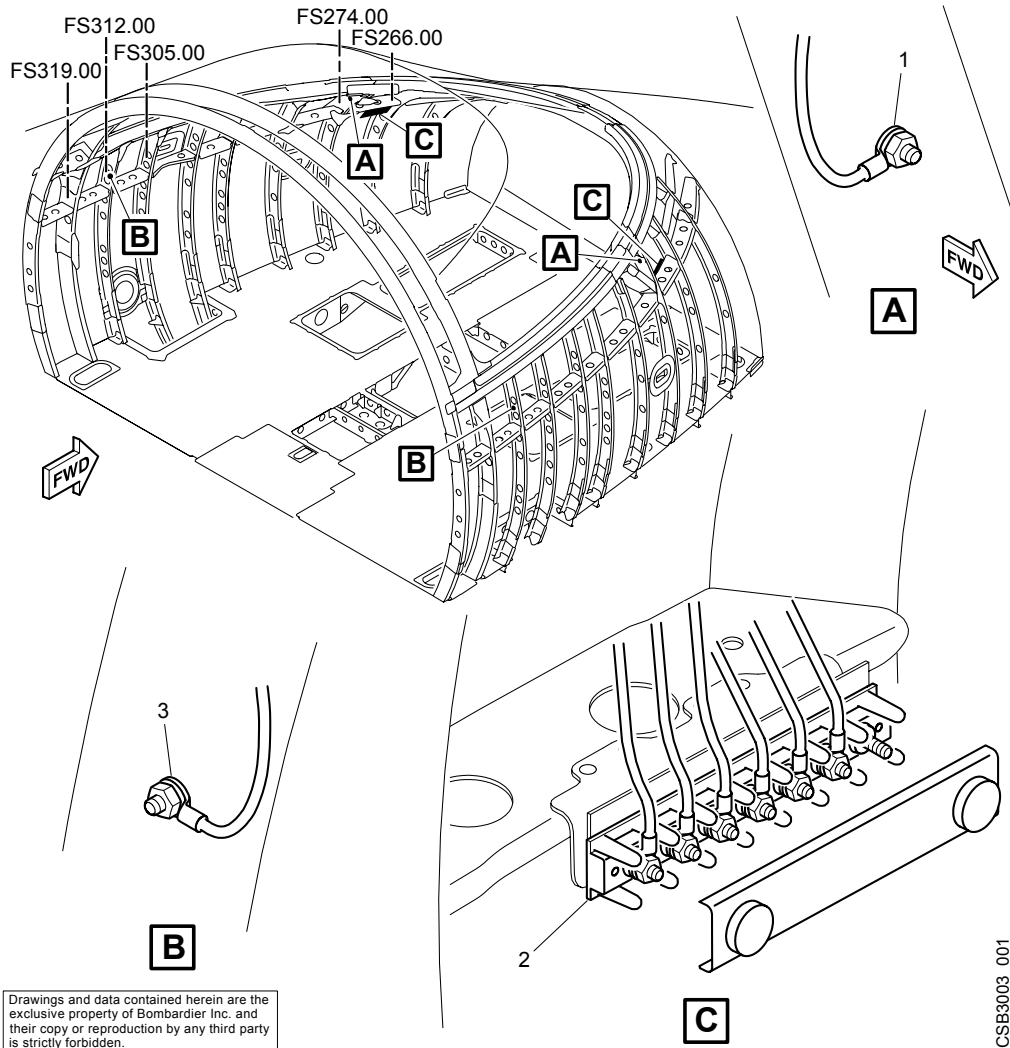
Figure 1

The purpose of the special check is to make sure that there are no loose electrical connections at the specified terminal blocks, ground studs and terminals. This will ensure good electrical continuity and prevent the possibility of overheating at the electrical connection points.

CALL OUT	ELECTRICAL DESIGNATOR	SIDE	AREA
1 (View A)	GS2269 GS2270	Left Right	FS274.00
2 (View C)	TB3 TB4	Left Right	Between FS266.00 and FS274.00
3 (View B)	GS2273 GS2274	Left Right	FS312.00

Torquing of Electrical Connections at Terminal Blocks TB3 and TB4, and Ground Studs GS2269, GS2270, GS2273 and GS2274

6. For the use of a torque wrench, refer to TASK 20-20-00-910-802.
- (1) Remove the cover from terminal blocks TB3 and TB4.
 - (2) Make sure that the electrical connections at terminal blocks TB3 and TB4 are tightened to 24 to 30 lbf in (2.7 to 3.4 Nm).

- (3) Install the cover back onto terminal blocks TB3 and TB4.
 - (4) Make sure that the electrical connections at ground studs GS2269 and GS2270 are tightened to 65 to 75 lbf in (7.4 to 8.5 Nm).

- (5) Make sure that the electrical connections at ground studs GS2273 and GS2274 are tightened to 32 to 37 lbf in (3.7 to 4.2 Nm).
