AW300-24-0085, Rev. 1

SUBJECT: DC Generator Shaft Spline Wear/Corrosion

EFFECTIVITY: Challenger 300 (20006 - 20999)

Subject : Drive shaft mounting check on DC generator P/N A3579-101.

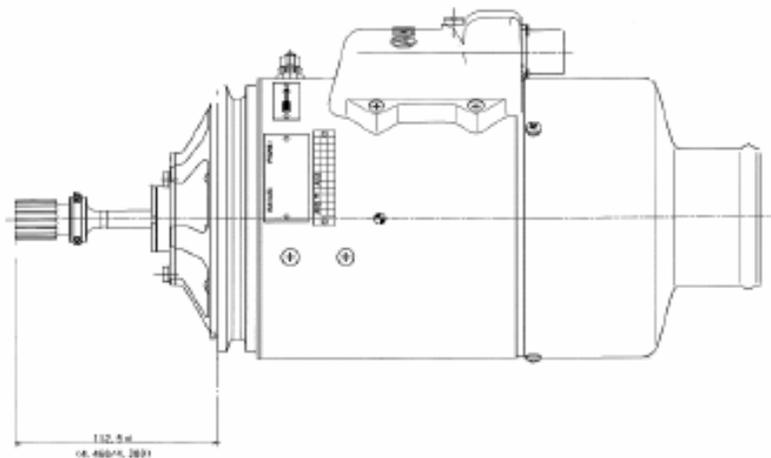
Here below is the outside dimension to be checked if the drive shaft is correctly connected inside the hollow shaft.

Dimension is 112,5 mm (+/- 1mm).

There is no action for Operators to take at this time. We are presently working with the vendor to provide an improved shaft retention mechanism and will inform operators when an improvement becomes available. If an operator has cause to remove their APU generator and would like to verify if the shaft is properly installed, they may do so by performing the dimensional check in the attached memo from Thales.
