Advisory Wire

REFERENCE NO: AW300-24-0141, Rev 11 EFFECTIVITY: Challenger 300
Challenger 350

ATA: 24-61

SUBJECT: Electrical System and Flight Display Issues During Flight

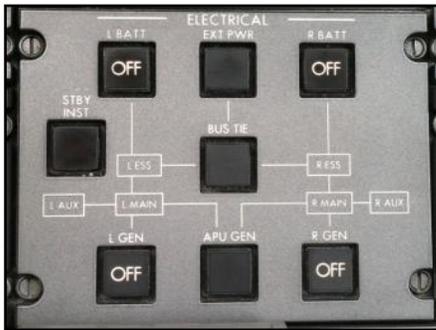
Generator(s) and or Battery(s) PBA showing OFF indications or cycling ON and OFF on the ECP while still physically on-line

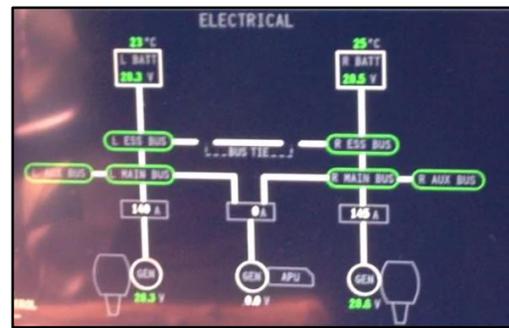
Electrical synoptic page displaying power source(s) outline(s) and associated flow tube(s) in white color, although distribution buses circled in green color indicating those buses are powered (Ref L & R generators amps outputs)

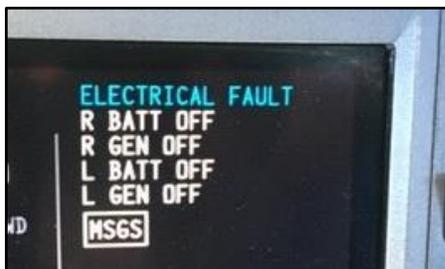
BATT OFF, GEN OFF CAS message(s) posted while the affected DC source(s) is physically on-line

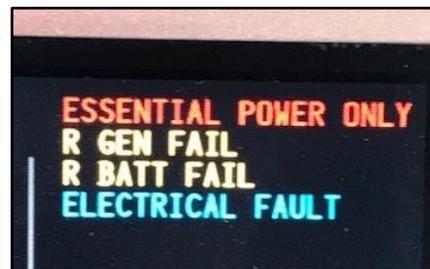
ESS POWER ONLY, BATT FAIL, GEN FAIL CAS message(s) posted while the affected DC source(s) is physically on-line
