# ADVISORY WIRE

REFERENCE NO:	AW300-24-0222	INFORMATION TYPE:	Maintenance Operational
ATA:	24	EFFECTIVITY:	Challenger 300 (20003 to 20500) Challenger 350 (20501 to 20635)
<b>SUBJECT:</b>	<b>Aft Fuselage - APU Generator Power Feeder Cable Fouling Condition</b>

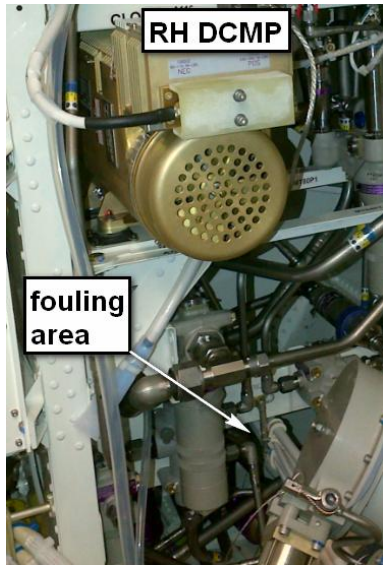
Rh Hydraulic Equip Rack

An APU generator power feeder cable was found touching the Ref. 1.1 hydraulic system return line, under the right hydraulic equipment rack, during a scheduled maintenance inspection in the aft equipment compartment of a Challenger 300. See photos on page 2.

There was no effect reported on the aircraft systems and only some minor damage was found on the insulation jacket of one of the two APU generator power feeder cables (photos next page). Neither the hydraulic line, nor the power feeder wire had to be replaced. The power feeder wires were pushed away slightly from the Ref. 1.1 hydraulic line to re-establish a proper clearance (minimum of 0.5") and the aircraft was returned to service.

1. Clearance should be 0.5 Inch or more between the APU generator power feeder cables and the Ref. 1.1 hydraulic line. If a low clearance is found, the power feeder cables should be pushed away from the hydraulic line to re-establish a proper clearance.
2. In case of fouling, if any damage on the power cables is found, a Service Request for Product Support Action (SRPSA) should be sent to "SRPSA@aero.bombardier.com" to further evaluate the damage and provide a proper disposition.
3. In case of fouling, if any damage on the Ref. 1.1 hydraulic line is found, the ref. 1.2 Standard Practices Manual (SPM) task should be used to evaluate the damage and provide a proper disposition.

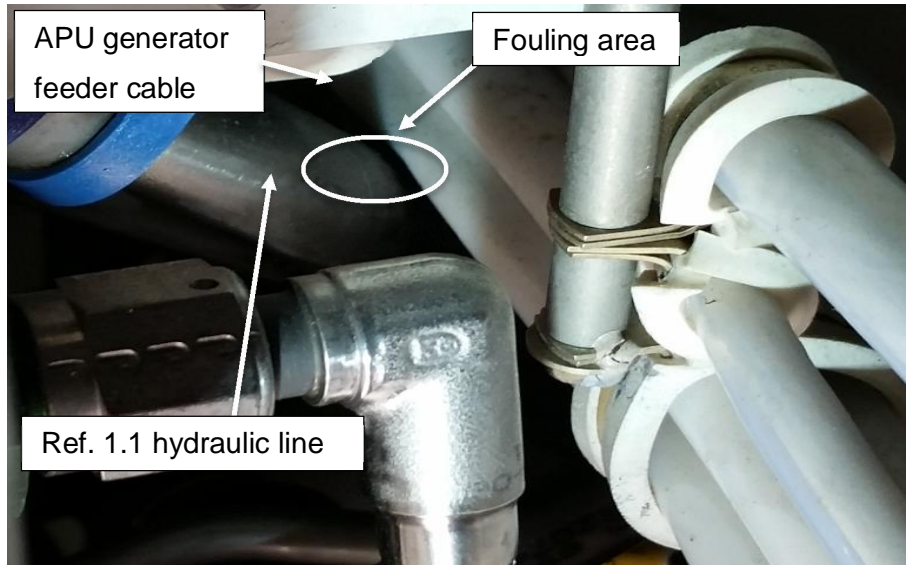
Close up view of fouling area

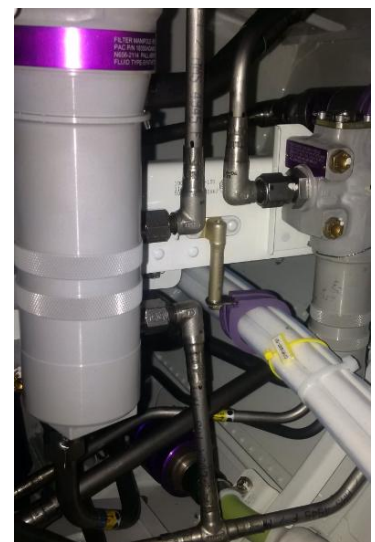
AC 20636 & Subs Supporting Hardware Configuration

On aircraft 20636 and subs, the power feeder cables supporting hardware installation has been modified to correct the fouling condition by a one-clamp configuration to provide improved clearance.

Service bulletins for the Challenger 300 and 350 models will be released shortly to address this fouling condition. The rework will consist of removing the existing power feeder cables supporting hardware (multiple clamps configuration) and replacing it with the one clamp supporting hardware configuration currently installed onto aircraft 20636 and subs.
