Advisory Wire

REFERENCE NO:	AW300-24-0284, Rev 01	INFORMATION TYPE:	Maintenance Operational
ATA:	24	EFFECTIVITY:	Challenger 300 (20003 – 20500) Challenger 350 (20501 – 20999)
SUBJECT:	Metallic Particles Found in the Left Direct Current Power Center (LDCPC) Battery Diode PCB Area

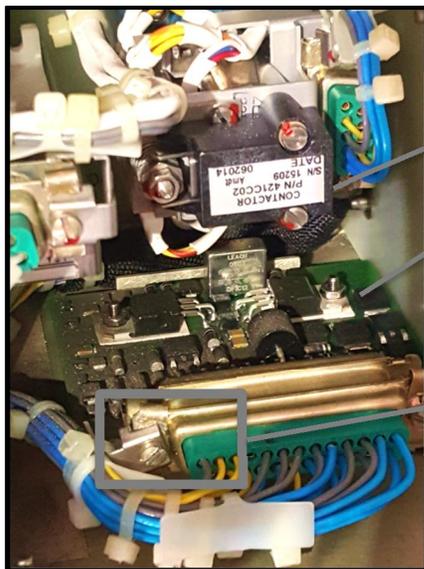
Some operators have reported finding an accumulation of fine particles on the Left Direct Current Power Center (L DCPC) battery diode printed circuit board PCB21 (Ref. 1.1). Our investigation revealed that the particles (metallic residue) were generated by wear of the Auxiliary DC Motor Pump (AUX DCMP) contactor (Ref 1.2). The manufacturer has determined that this type of wear is evidence of a contactor that has exceeded its normal service life.

Ref 1.2 Contactor

Ref 1.1 PCB

View looking at Ref 1.1 PCB and Ref 1.2 contactor in the LH DCPC

Finally, if maintenance is required in the left DCPC, we suggest maintenance crews visually inspect the ref 1.1 PCB for the presence of metallic residue. In case of findings, the ref. 1.4 Reference Information Letter should be performed to address the condition.

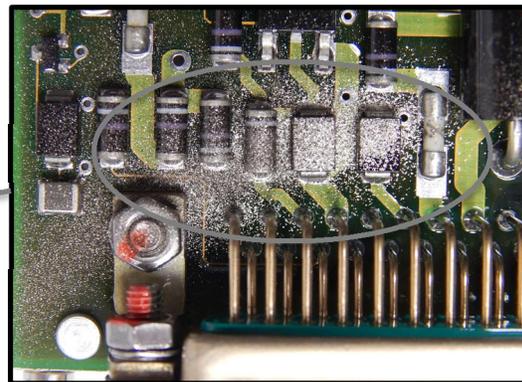
Metallic residue on Ref 1.1 PCB
