Advisory Wire

REFERENCE NO:	AW300-30-0328	INFORMATION TYPE:	Maintenance Operational
ATA:	30-41	EFFECTIVITY:	Challenger 300 (20003 – 20500) Challenger 350 (20501 – 20999)
SUBJECT:	Windshield Heat Fail CAS Messages

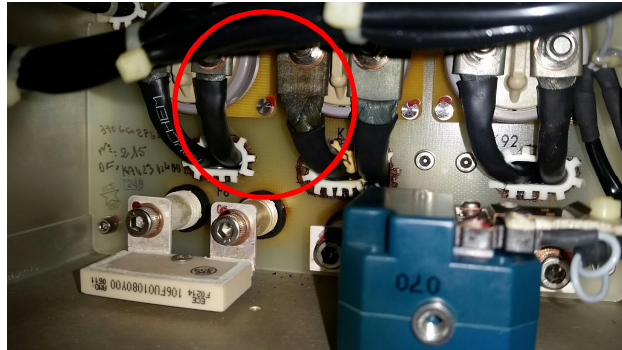
Sign of overheat on relay of the SPC

1. Verify the torque value of the screws on the windshield contacts and the resistance of the windshield sensors and heater elements per ref.1.2.
2. Verify the electrical connections at terminal blocks TB3 and TB4, at ground studs GS2269, GS2270, GS2273 and GS2274 per ref.1.1.
3. Verify the torque of the nuts on the WHTC studs per ref.1.3.
4. Perform the bonding check on the WHTC per ref.1.4.
5. Inspect relays K63/K64, K106/K107 in the SPC for signs of overheat.

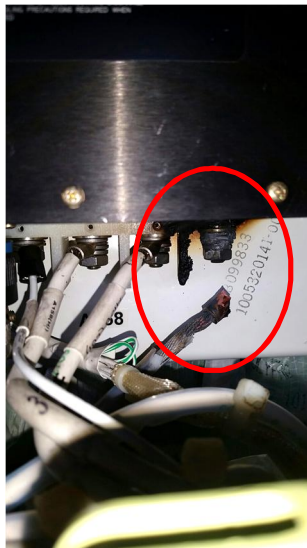
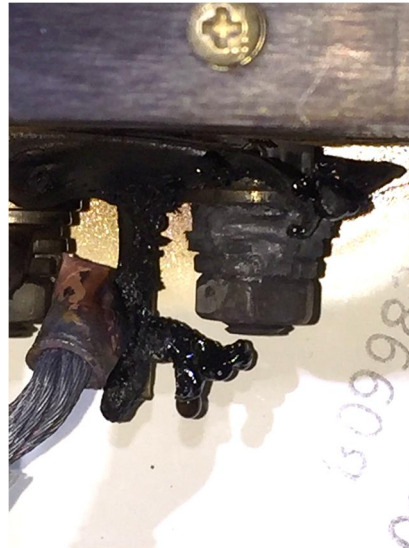
Electrical lug and WHTC stud damaged

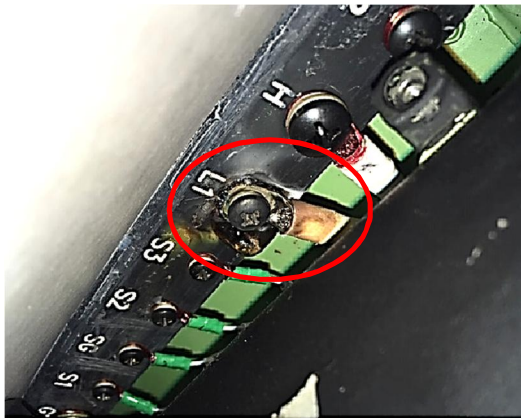
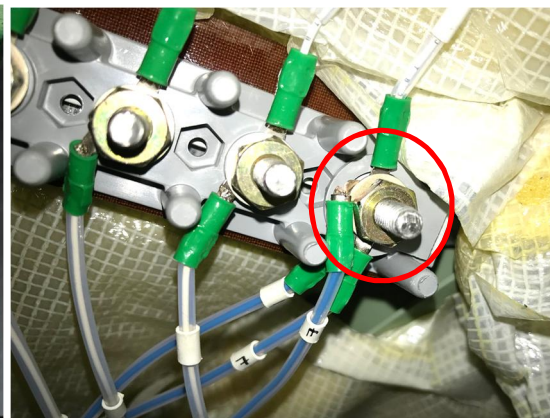
Sign of overheat on a windshield connector – Terminal lug stressed
