Advisory Wire

REFERENCE NO: AW300-30-0354, Basic Issue INFORMATION TYPE: Maintenance

**SUBJECT: Potential Piccolo Tube Damage
When Replacing a Bleed Loop
Element**

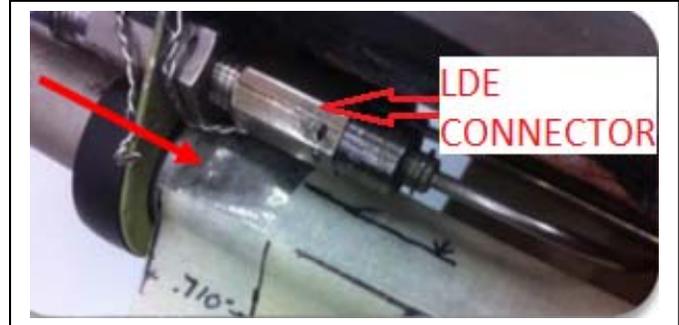
As shown in the photo to the right, a dent can be noted on the surface of the piccolo tube just above where the electrical connector of the Leak-Detection Element (LDE) is located. The dent on the piccolo tube is created when the wrench tool unintentionally comes into contact with the piccolo tube when tightening or loosening an LDE connector.

The following maintenance tips have been developed to mitigate the risk of damaging a piccolo tube when replacing an LDE:

- When loosening/tightening any LDE connector, ensure you have a firm grip on the wrench tool to prevent accidental slippage.
- Before loosening/tightening the LDE connector, place a non-metallic piece of material between the piccolo tube and the wrench tool.

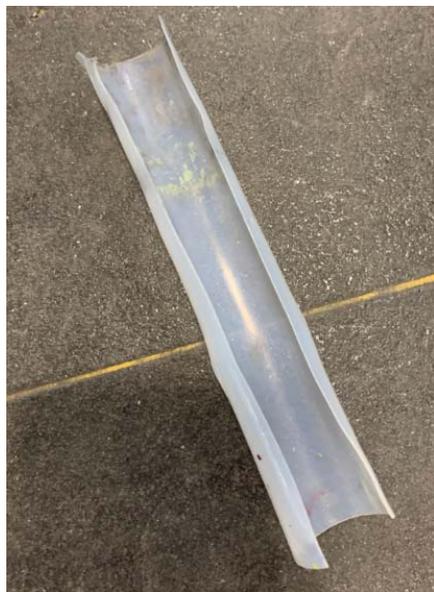
To the left is a picture of piece of Teflon™ material which can be placed over the piccolo tube surface before loosening/tightening the LDE connector.

Should the wrench tool come into contact with the Teflon material, damage to the piccolo tube could be avoided or minimized.

Similarly, a piece of cloth folded a couple of times over the piccolo tube can be just as helpful.

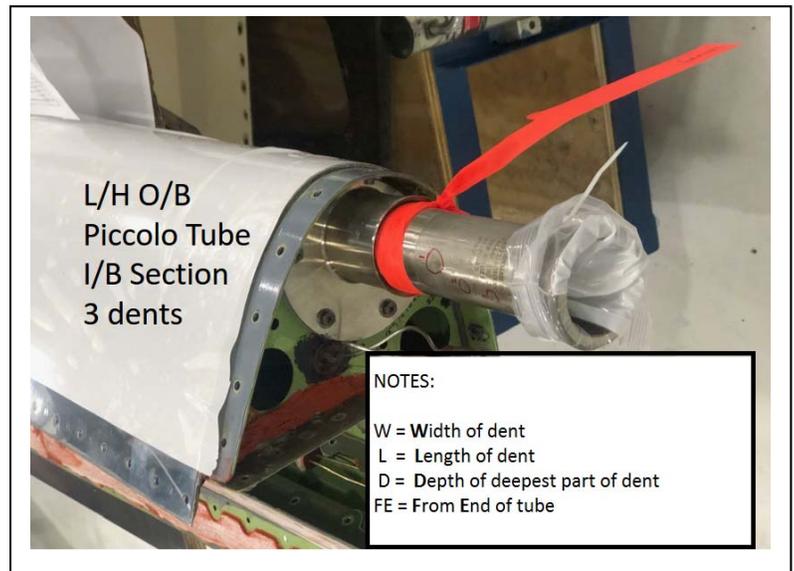
Example of damage as pictured below was provided by Operator

If damage is found on a piccolo tube, you can submit a Service Request for Product Support Action (SRPSA) to Bombardier to have service engineering perform a damage tolerance analysis. Once the damage has been evaluated, an engineering disposition will be provided to determine if the piccolo tube is considered serviceable or whether it must be replaced.

- Identify the size of the dent in terms of Width, Length and Depth
- Identify the location of the dent with reference to the piccolo tube
- Indicate whether the dent has sharp edges (cracks are not permissible rendering piccolo tube unserviceable)
- If more than one dent on the same piccolo tube, identify the space between each dent

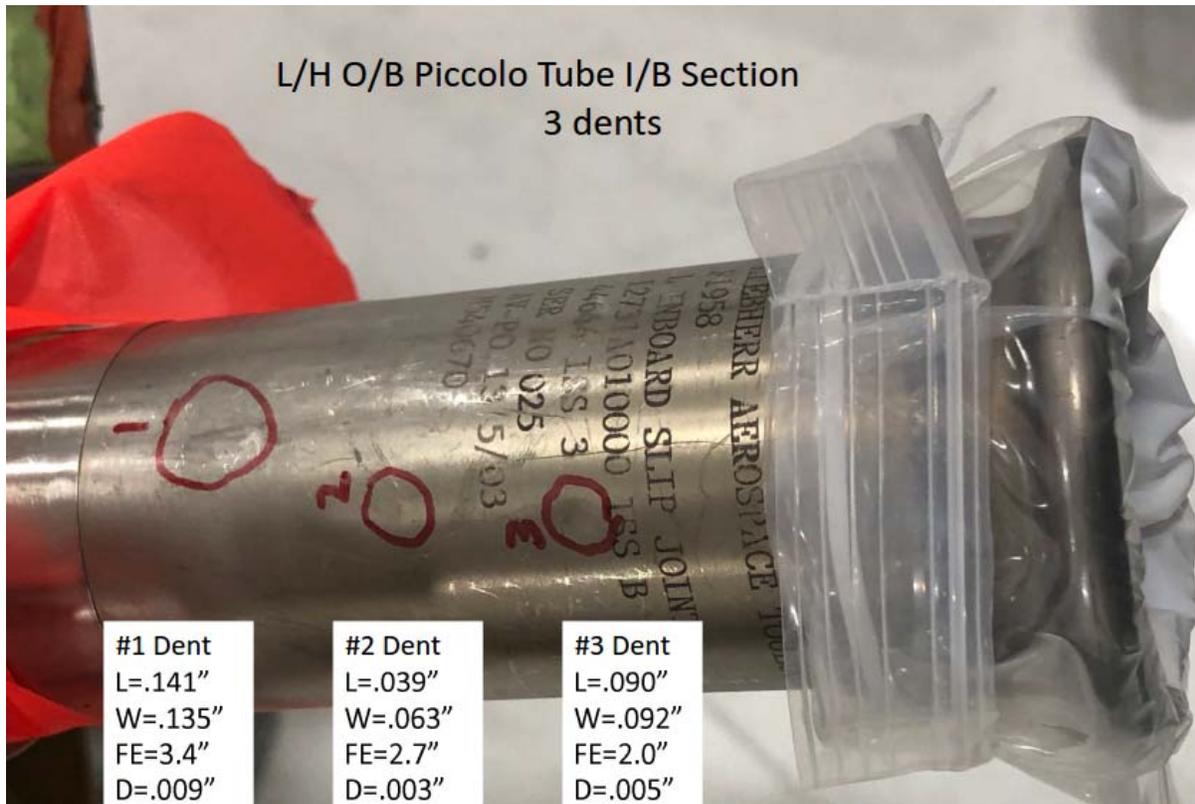
Example of damage provided by Operator
