Advisory Wire

REFERENCE NO:	AW300-31-0286	INFORMATION TYPE:	Maintenance
ATA:	31-31	EFFECTIVITY:	Challenger 300 (20003 to 20500) Challenger 350 (20501 to 20999)
SUBJECT:	Procedure to Clear “FDR FAIL” EICAS Message

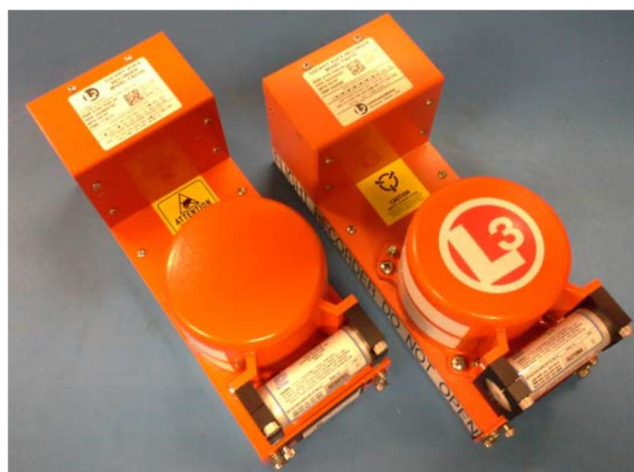
L3AP has discovered that the FA2100 FDR that have the new NAND type memory module in the Crash Survivable Memory Unit (CSMU) are more prone to latch non-fatal faults, causing the “FDR FAIL” EICAS message, which can lead to unwanted maintenance actions.

Figure 1. NAND Recorder with L3 Logo on the CSUM

The LN faults on NAND type FDR, which may cause "FDR FAIL" EICAS message, can be cleared using the Ref. 1.1 procedure. This procedure instructs a user how to download, release and clear fault history using the Ref 1.2 PI.

However, the Ref 1.1 procedure should not be performed to continuously clear the faults if they are persistent. If the same fault reappears consistently, the FDR unit should be returned for repair.

In order to avoid unnecessary FDR unscheduled removals, operators may follow the Ref. 1.1, procedure for downloading fault history and clearing latched faults using the Ref. 1.2 PI, applicable to FA2100 FDR.
