Advisory Wire

REFERENCE NO:	AW300-32-0323 Rev Basic	INFORMATION TYPE:	Maintenance
ATA:	32-11	EFFECTIVITY:	Challenger 300 (20003 – 20500) Challenger 350 (20501 – 20999)
SUBJECT:	MLG WOW Harnesses found not installed per SB/AMM instructions

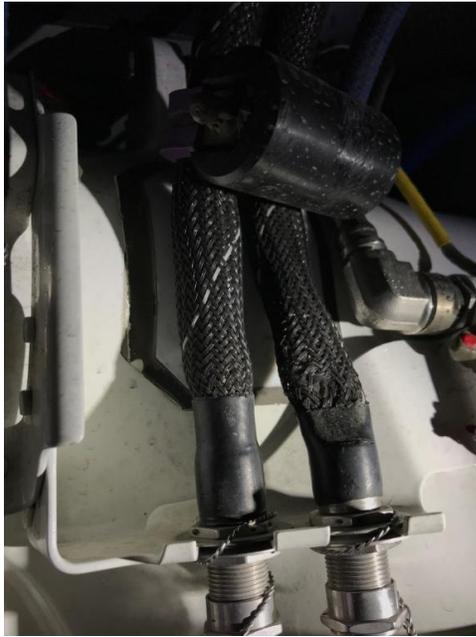
Figure 1 - Examples of damage reported

Bombardier has received reports of damage on the MLG WOW harnesses and Teflon™ protective plate as seen in figure 1. The reported cases also show incorrect adjustment / installation of the WOW harnesses and/or hardware as seen in figure 2.

Harness crushed near MLG Bracket

Maintenance technicians and Operators must ensure that the instructions given in the above Service Bulletins are adhered to avoid the possible damage of the MLG WOW harness and/or Teflon™ protective plate.

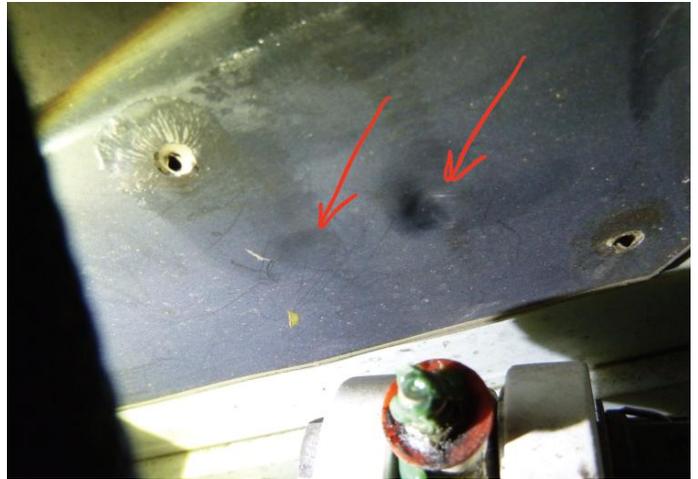
Indents on Teflon™ protective plate

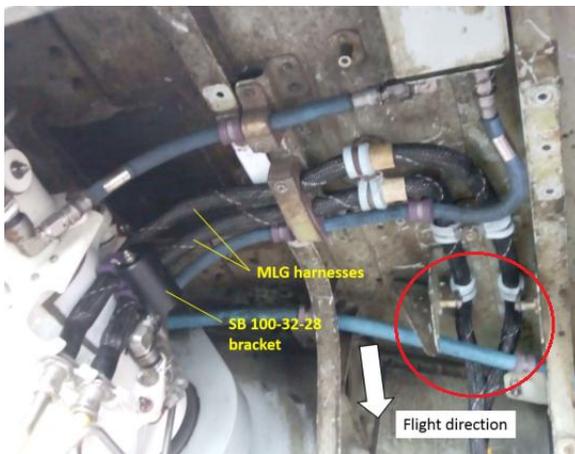
Figure 2 - Examples of incorrect adjustments / installations

Clamps installed 180 degree offset

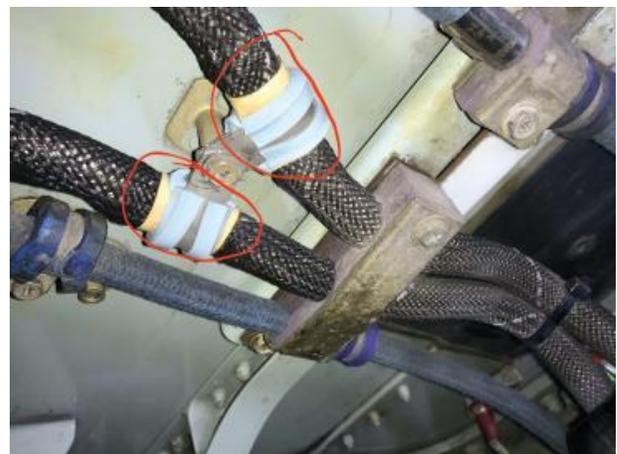
White sleeve too far from the block clamp

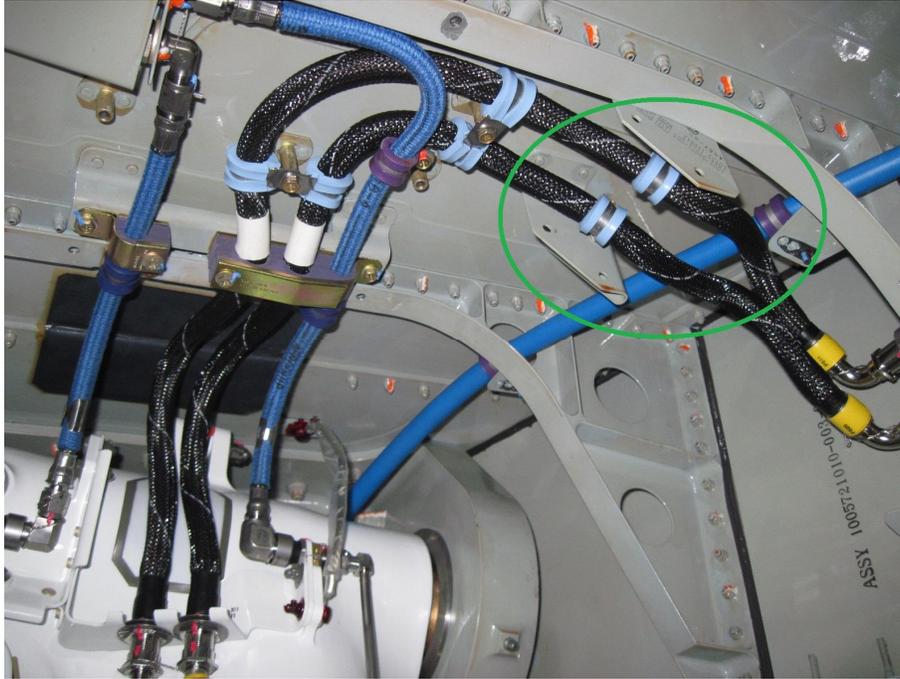
Figure 3 - Examples of correct installation of hardware and proper routing of harnesses

Correct harness routing before bracket installation

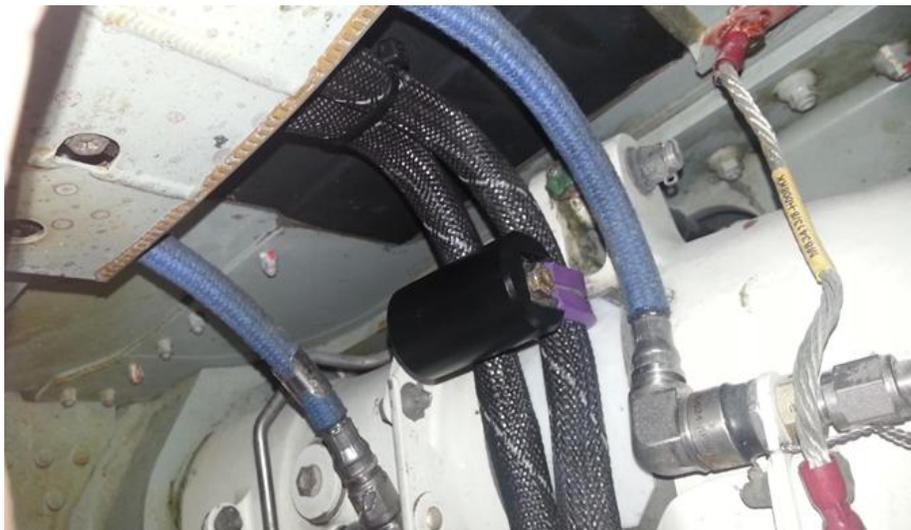
Correct bracket positioning
