Advisory Wire

REFERENCE NO: AW300-36-0008, Rev 05

EFFECTIVITY: Challenger 300
Challenger 350

SUBJECT: **“WING ANTI-ICE LEAK” EICAS
Message During Climb**

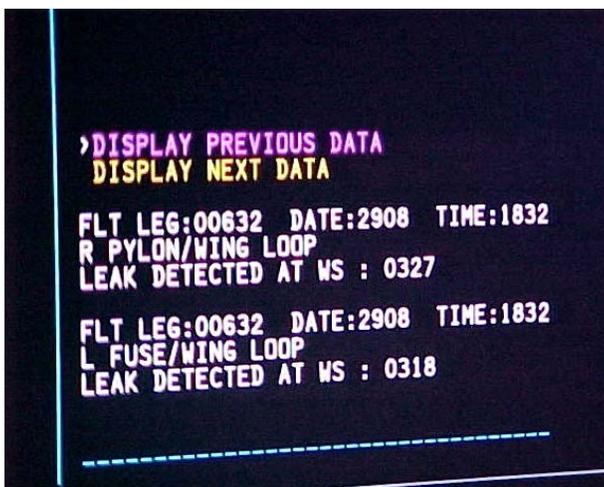
- In Wing Station or Fuselage Station when the IASC is P/N 92175A030400 – Post SB 100-21-05 (Left picture).

Example of leak displayed in fuse/wing station

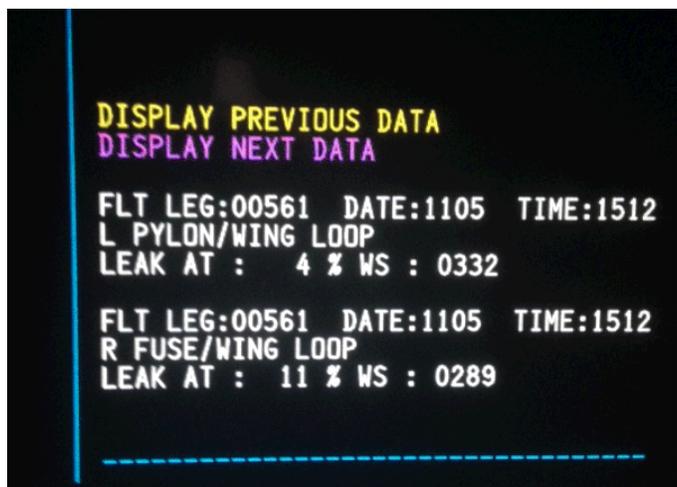
- In Wing Station or Fuselage Station and percentage when the IASC is P/N 92175A030500 – Post SB 100-21-10 (Right picture).

Example of Leak displayed in fuse/wing station and percentage
