Advisory Wire

REFERENCE NO: AW300-36-0387, Rev. 04

EFFECTIVITY: Challenger 300
Challenger 350

**SUBJECT: Bleed Air Leak Detection Loop
Elements**

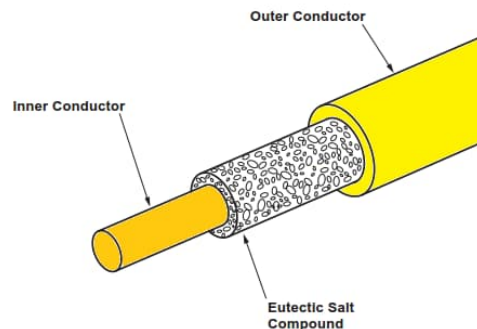
LDL elements contain thermo-resistive eutectic salt compounds embedded between an inner conductor and an outer casing. A local temperature increase causes the salt compound to become conductive resulting in a resistance drop between the inner conductor and outer casing which subsequently sets off the appropriate cockpit warnings.

Due to a manufacturing process error, some LDL elements may not be fully filled with eutectic salt compound, and this would result in the LDL elements being unable to detect a hot bleed air leakage.

Bombardier released SBs (Ref. 1.8) to test and replace any defective LDL elements on the affected aircraft. These SBs are also mandated by the ADs (Ref. 1.1, 1.2 and 1.3) within 7500 flight-hours or 96 months, whichever comes first from the effective dates as referenced in the respective AD. When possible, the incorporation of the SB should be planned during a scheduled maintenance event.

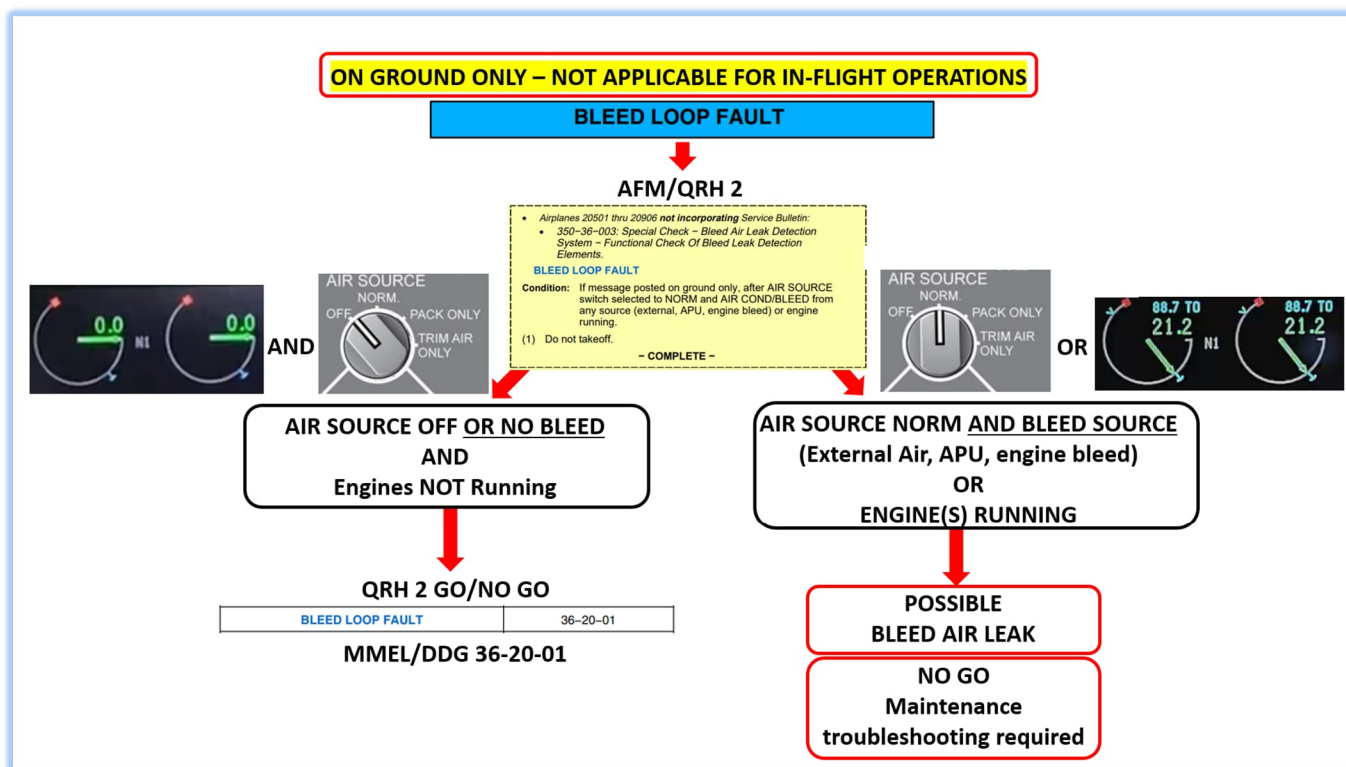
Aircraft dispatch with a BLEED LOOP FAULT Advisory CAS message and a potential non-conforming LDL element may result in an undetected bleed air leak. To prevent this condition, the AFM revisions (Ref. 1.5 and 1.6) adds the BLEED LOOP FAULT Advisory CAS message in the Non-Normal Procedures of Section 05-42, to prohibit takeoff if a BLEED LOOP FAULT Advisory CAS message is displayed on the ground when bleed air is present in the corresponding duct. In this case, maintenance action is required to troubleshoot the CAS message.

If it can be confirmed that the BLEED LOOP FAULT Advisory CAS message is not related to an actual bleed air leak, then relief for dispatch can be provided by complying with the instructions in Section 36-20-01 (Leak Detection Loops) of the applicable DDG (Ref. 1.7). The message may appear due to an open or shorted loop sensing element without the presence of bleed air in the corresponding duct.

The following summarizes both scenarios when a BLEED LOOP FAULT Advisory CAS message can occur:

It is very important that operators follow the specific instructions in the applicable AFM revisions (Ref. 1.5 or 1.6) and the applicable DDG (Ref. 1.7) when dispatching the aircraft with a BLEED LOOP FAULT advisory CAS message. These steps are required to confirm that the message is not related to an air leak event that could result in subsequent damage the aircraft.
