Advisory Wire

REFERENCE NO: AW300-79-0401 INFORMATION TYPE: Maintenance Operational
ATA: 79-10 EFFECTIVITY: Challenger 300 Challenger 350
SUBJECT: Oil filler cap installation

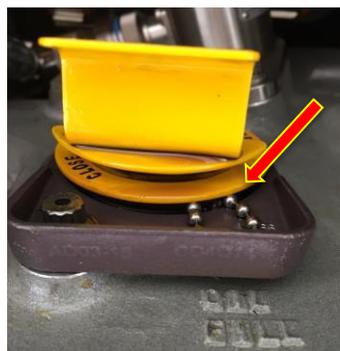
Figure 1

There have been reports that the oil filler cap has not been installed correctly due to the securing chain laying slightly over the threaded lip. (Figures 1 & 2) This can cause damage to the O-Ring and allow oil to escape. There have been also instances where the oil cap has not been secured at all allowing oil to escape. Both conditions can lead to an inflight shut down due to loss of oil or low oil pressure.

- Pre SB (Ref Item 1.1) When reinstalling the cap ensure that the chain is completely clear of the filler hole. Ensure that the cap has been securely installed.
- Post SB (Ref Item 1.1 & Figure 3) Ensure that the cap has been securely installed.
