Customer FORUM & Newsletter

TUESDAY, MAY 3, 2011

VOLUME 08 / ISSUE 09

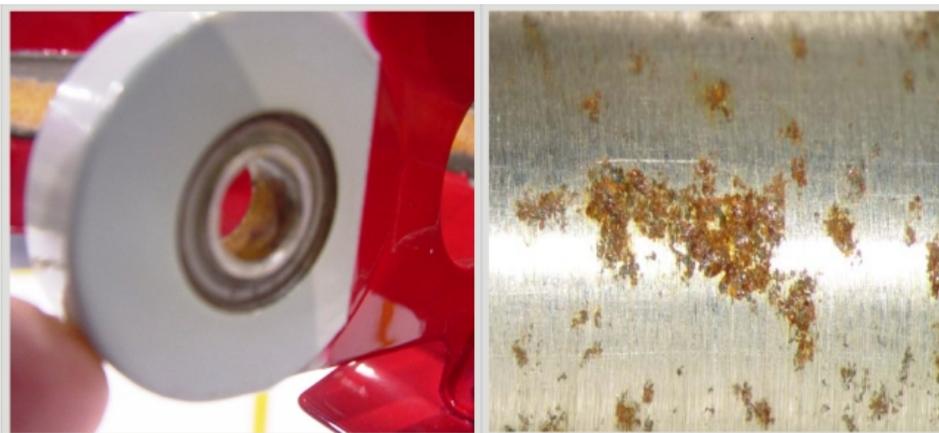
Follow the instructions below to inspect and identify if there is corrosion on the bearings and/or fretting/corrosion on the bolts:

1. Clean the bolt surface and the bearing inner bore with a clean no-lint cloth moist with isopropyl alcohol.
2. Visually inspect for corrosion - see pictures below.
3. The bearing inner bore surface and the bolts surface should be free of corrosion, smooth and without any sign of wear.

*Bearing MS21431-5, Condition of the inside surface
Details of the reddish deposits found on the surface of the ring.*

If corrosion on the bearing or fretting/corrosion on the bolt is found, the associated flight control surface will have to be removed to allow the bearing(s) replacement.

To allow the bearing replacement, Ground Support Equipments GSE 27C-00-05 was created and made available for rent through our parts distribution centre in Chicago.

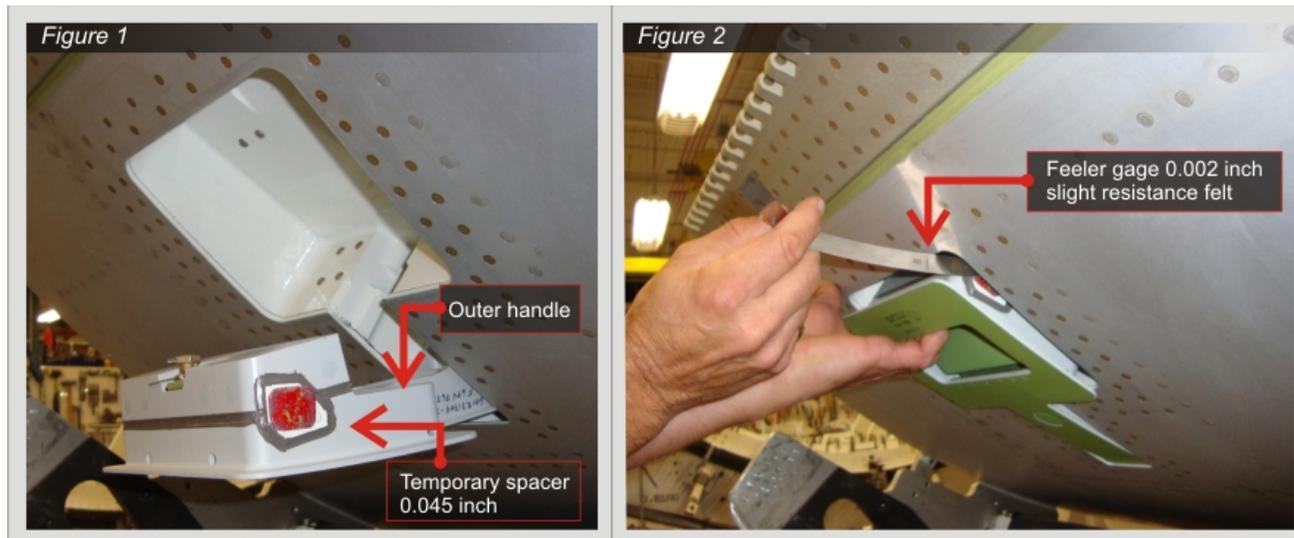
A review of the FRACAS data for the Passenger Phase 4 door has revealed that the Outer Handle Proximity Switch PS2MB for the Challenger 800 Series is one of the main drivers of reliability within ATA 5270. In most of these cases, the rectification is replacement and/or adjustment of Proximity Switch PS2MB.

The adjustment procedures within Aircraft Maintenance Manual (AMM) task 52-70-04-820-803, Sub Section C, CRJ100/200 "Adjustment of the Passenger Door Warning System" requires adjusting the switch to 0.050 +/- 0.005 inch gap.

Bombardier Aerospace recommends that the gap be adjusted using a metallic spacer of 0.045-inch thickness temporarily affixed to the target as per Figure 1. A 0.002-inch feeler gage is then inserted between the switch and target spacer and the switch adjusted until a

slight resistance on the feeler gage is felt as per Figure 2. The switch is then secured, the spacer removed and any material used to adhere the spacer to the target is cleaned.

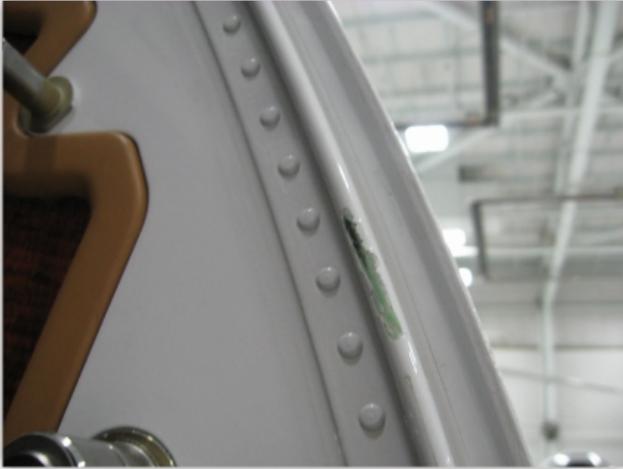
The intention of this article is to pass along some guidance that may help prevent or eliminate seal striker damage. Sometimes, as the passenger door is closing, the abutment pins on the door may foul on the door frame's seal striker. Below are some adjustments that will help eliminate this interference.

Typical seal striker damage

Finally, General REO 700-53-20-356 is available for repairing passenger door seal striker damage up to 0.050" deep.

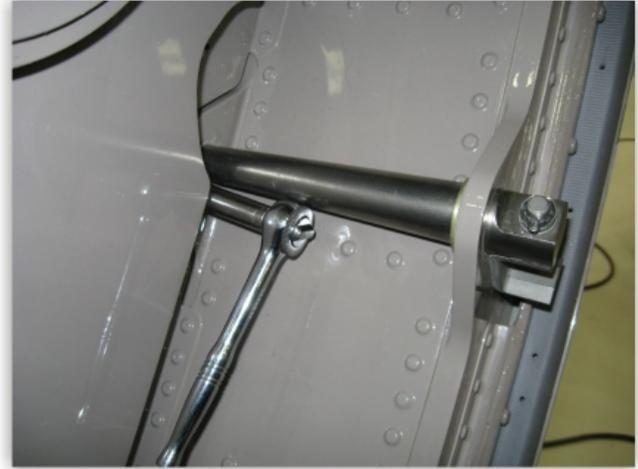
Door Abutment Pin
The socket is on the bolt that will receive shim washer.

If the lateral position of the door has been optimized, and the clearance at one or more of the abutment pins is still marginal, another approach we have authorized is to shim the abutment pin inboard. Two of the abutment pins on either side of the door also have hooks

attached, which will limit the potential inboard movement of the fitting to about 0.030". But, this is still enough to preclude a fouling condition.

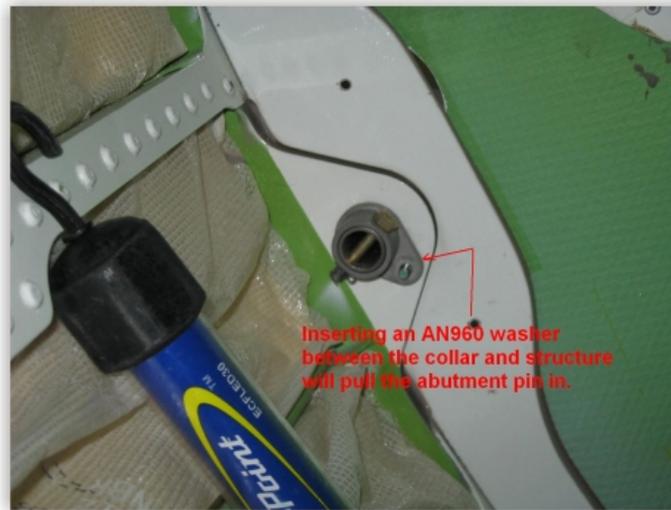
View from inside the airstair, depicting the location of the shim washer
