SERVICE BULLETIN REVISION TRANSMITTAL SHEET

MODEL BD-100-1A10 (CH-350)

350-23-004

MODIFICATION – DATALINK AND SELCAL SYSTEM – INSTALLATION OF DATALINK WITH SELECTIVE CALLING (SELCAL) OPTION (C23-406)

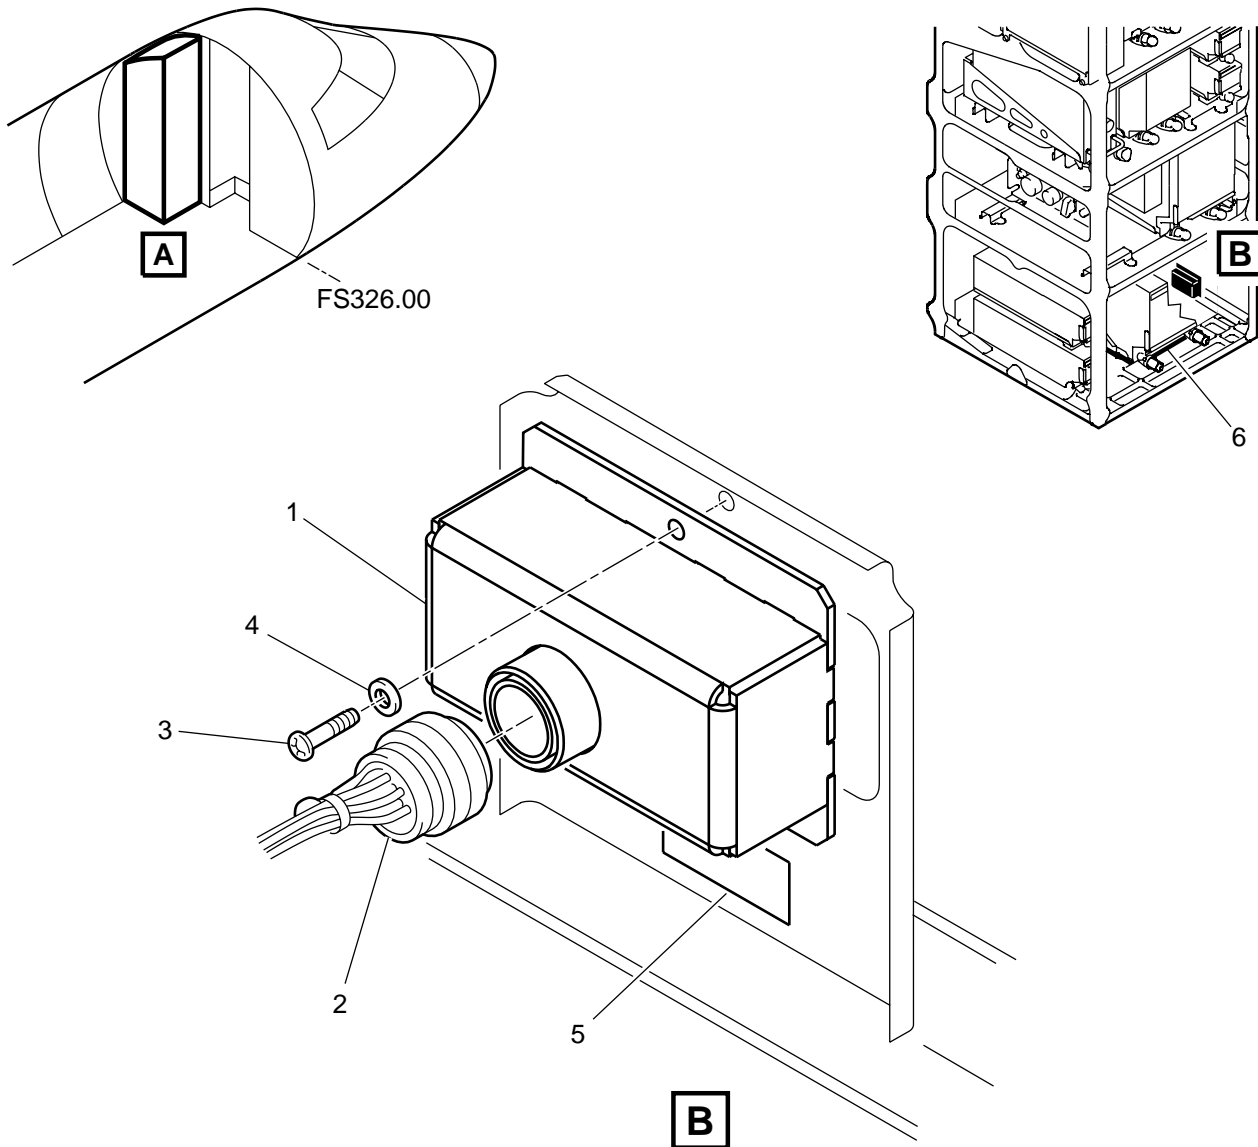
Datalink External Compensation-Unit – Installation
Figure 1

STEP 1 INSTALL, At WL79.56, forward of the Remote Data Concentrator (6)	PART NO.	QTY		
Datalink ECU (1)	822-1200-996	1		
Screw (3)	MS35206-215	2		
Washer (4)	NAS1149DN416J	2		
Connector (2)	A199P1	Electrical Ident Decal (5)	K1005330035-007/01	1
Electrical Ident Decal (5)	K1005330035-007/01	1

- (4) Install the datalink ECU, Part No. 822-1200-996. Refer to Figure 1 and to the steps that follow.

(a) Torque the screws from 10 to 13 lbf in (1.13 to 1.46 Nm). Refer to SPM-MM 20-21-00-910-801.

(b) Do the electrical bonding test of the datalink ECU. Refer to SPM-MM 51-80-00-760-801.

(c) Install the electrical identification decal, Part No. K1005330035-007/01. Refer to SPM-MM 20-80-01-400-801.

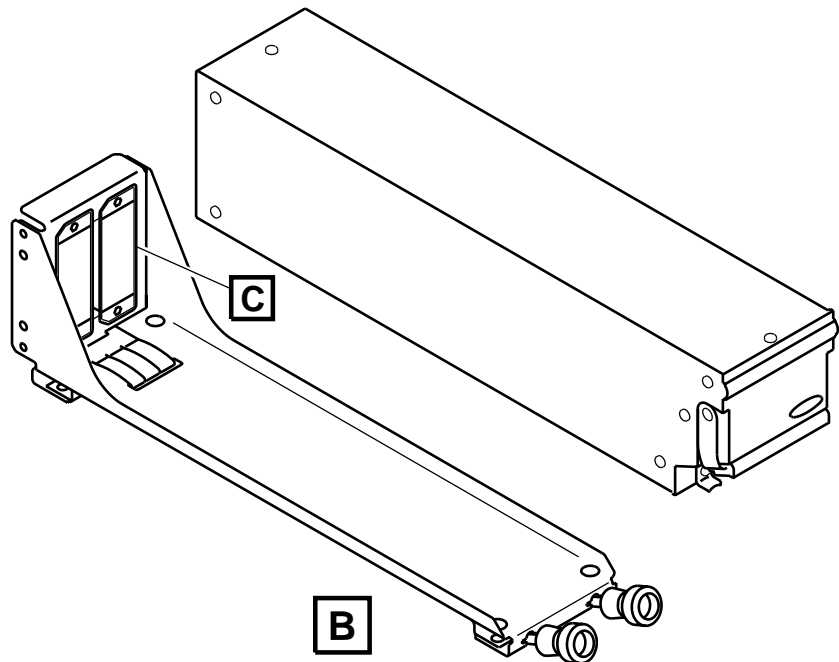
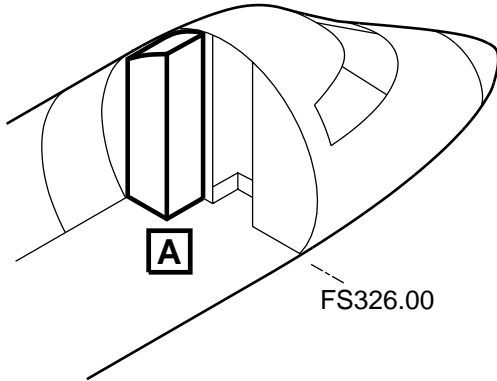
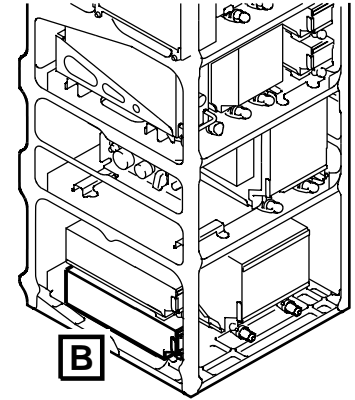
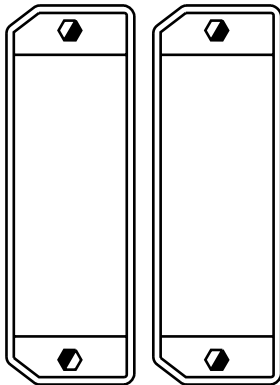
RIU – Indexing Key Modification
Figure 2

<p>STEP 1 01</p> <p>Set the polarizing keys on the RIU No. 1 mounting tray connectors.</p>	<p>NOTE: 01</p> <p>The darkened areas indicate the blocked portions of the polarizing keys.</p> <p>(the lightened areas indicate the extended portion of the polarizing keys, the portion which inserts into the openings of the mating connectors)</p>
---	--

- (1) Set the tray polarizing keys and replace the Radio Interface Unit (RIU) No. 1 (A17). Refer to Figure 2 and to the table that follows:
