Document Number BDP3009-SIL44-0001

Subject Blu-ray: explanation of AACS encryption warning message

Applicability BDP3009-00x-00x, Blu-ray Player. S/N: all

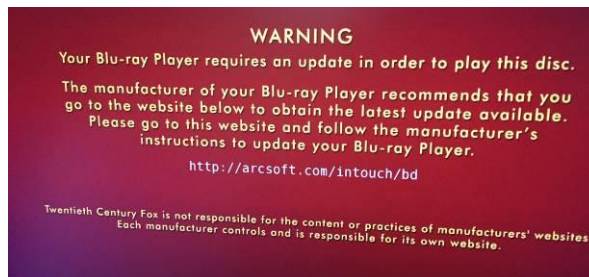
Figure 1: AACS warning message

Figure 1: AACS warning *message* shown above has been reported to be displayed when trying to play a recently issued blockbuster.

This behaviour corresponds to the one described under Background and requires a software update of the Blu-ray player in order to play this disc and newer ones.

Although a Blu-ray player affected by this behaviour needs a software update to play new discs, this cannot be performed following the instructions shown in Figure 1: AACS warning *message*.

Customers and operators are therefore requested not to follow the link shown in Figure 1.
