SERVICE BULLETIN

FLIGHT CONTROLS	ELEVATOR POWER CONTROL UNIT (PCU)	INSPECT, CLEAN, GREASE ROD END, AND TAILSTOCK BEARINGS; INTRODUCE 376100-1009 CONFIGURATION.
-----------------	-----------------------------------	--

376100-27-306

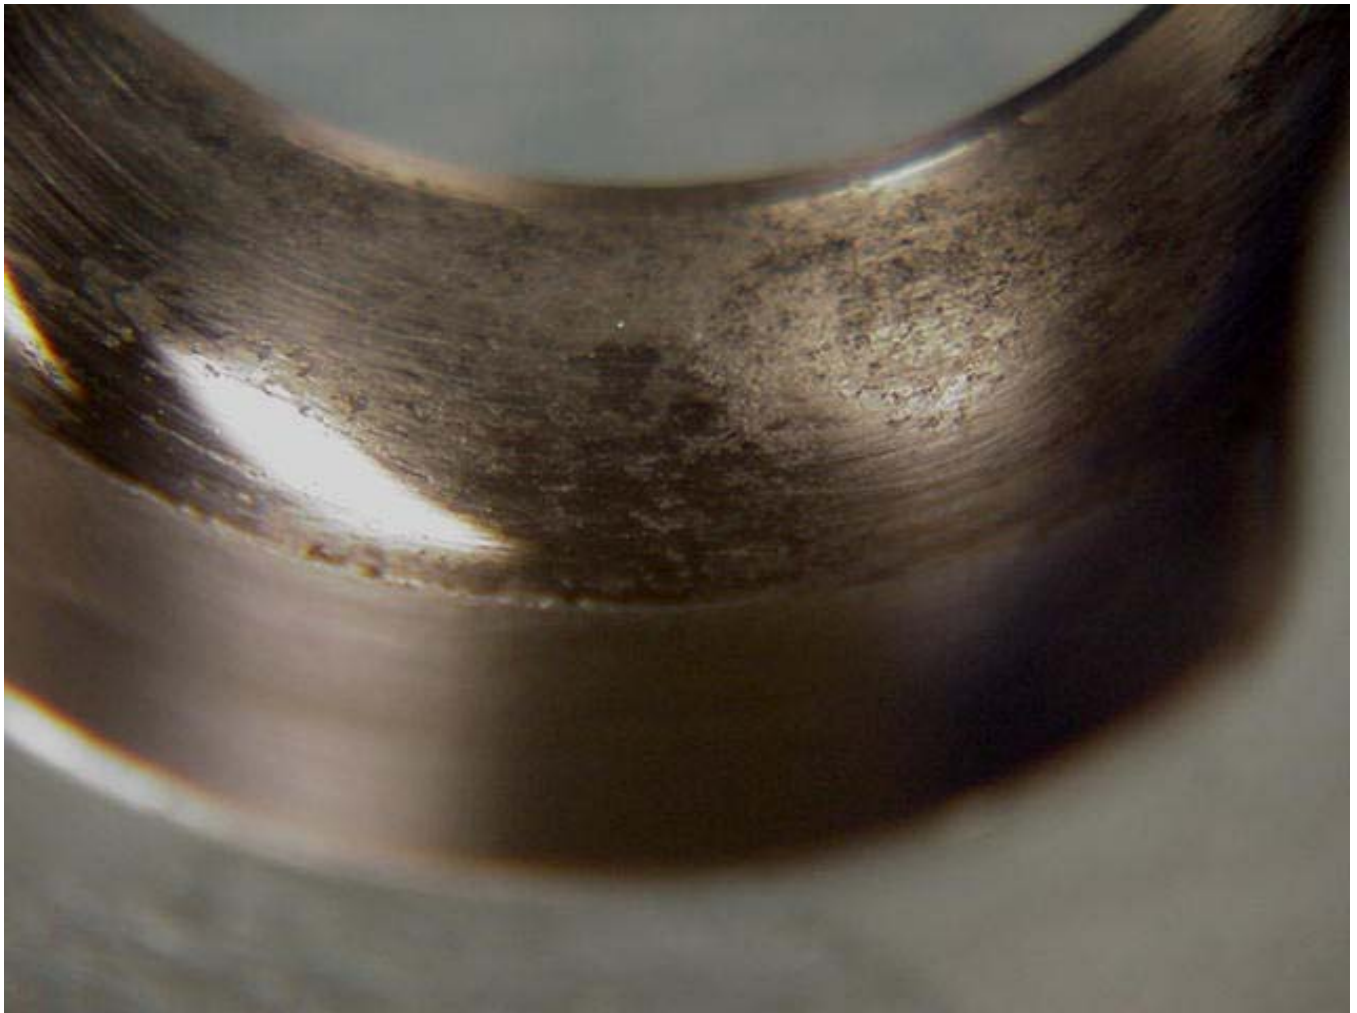
- (1) The following illustrations, Figures 1 through 5, reference acceptable conditions for the races. Damage estimated to exceed that depicted in Figure 5 may be considered on a case-by-case basis, or otherwise necessitates return of the PCU for modification per Part 2 of this service bulletin. While the photos are from an aileron PCU toggle link, the surface conditions shown apply also to the elevator PCU rod end and tailstock bearings.
- (2) During inspection, it may be observed that the swaged bearing race in the actuator tailstock has rotated such that the ball loading-slot is other than at a 90-degree angle to the piston rod. In some cases the race is free to rotate by hand.

Acceptable Condition
Figure 1

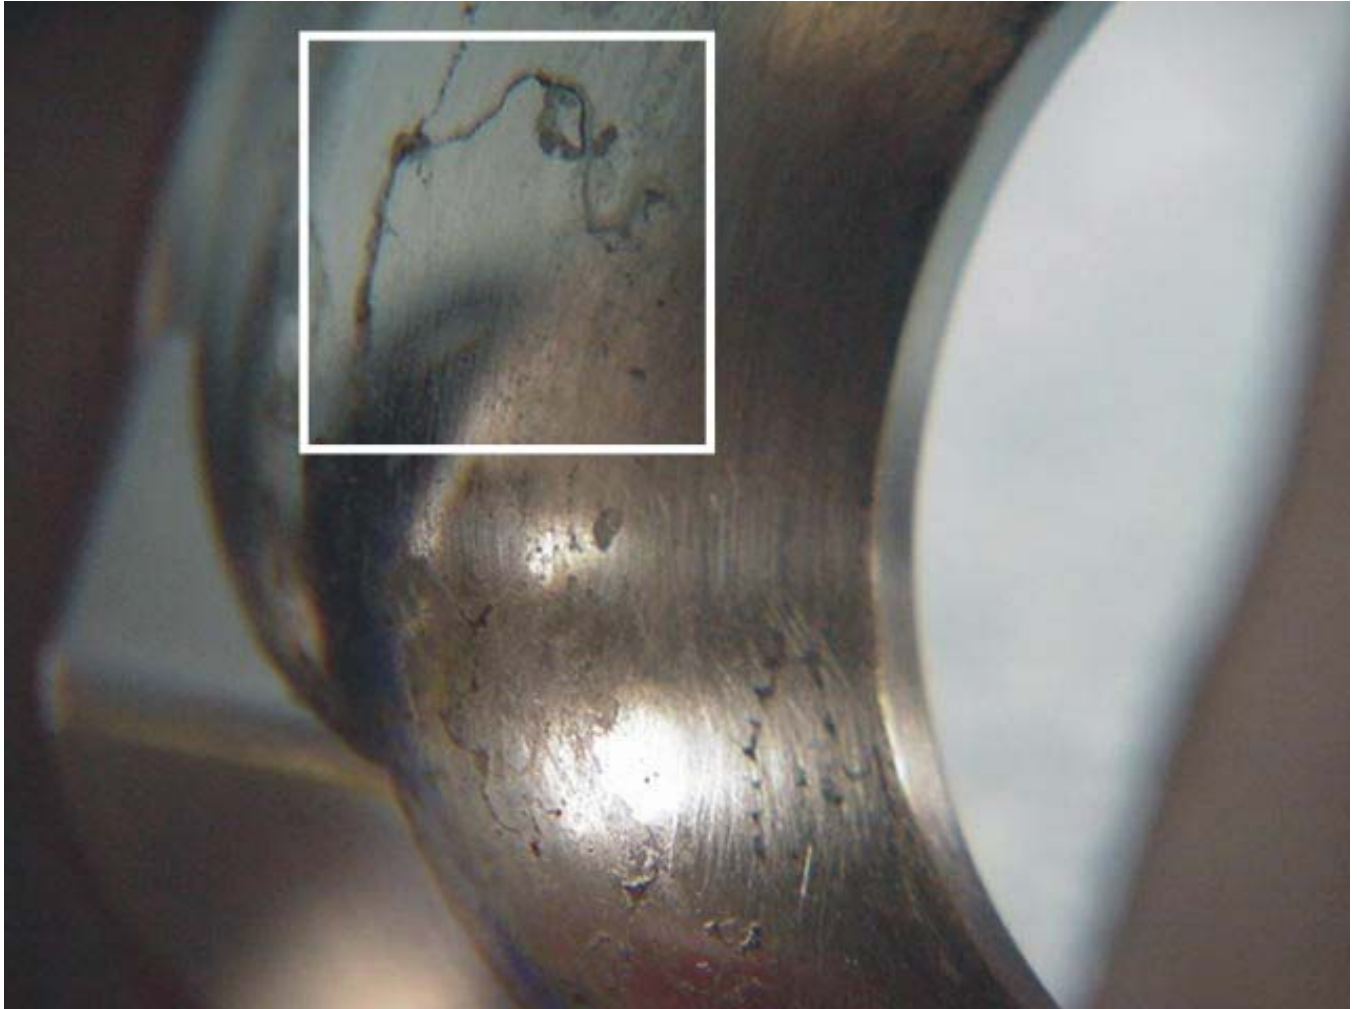
Acceptable Condition
Figure 2

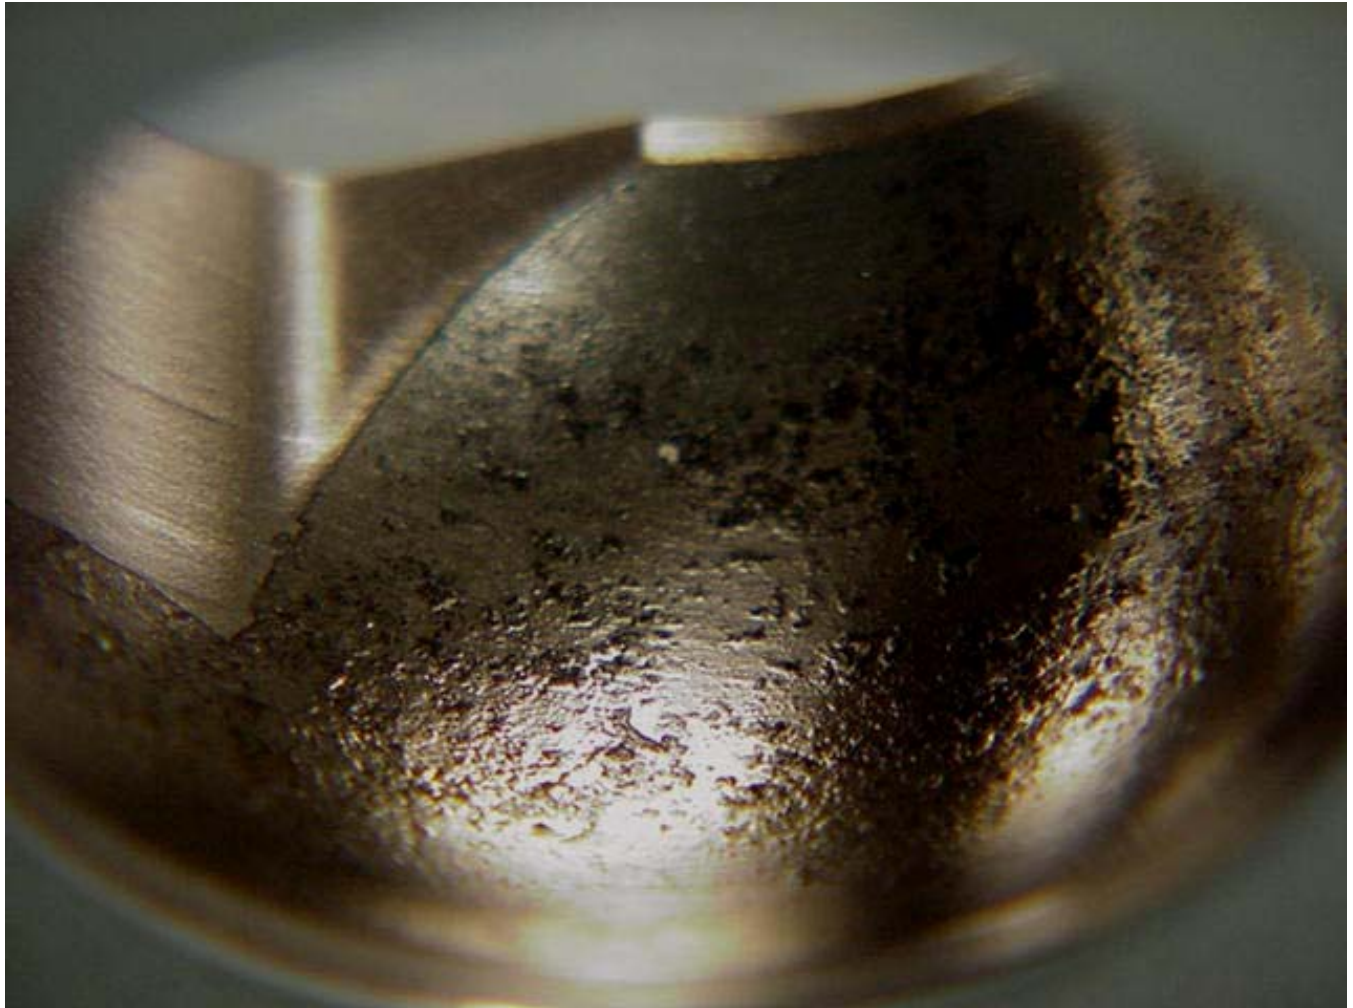
Acceptable Condition
Figure 3

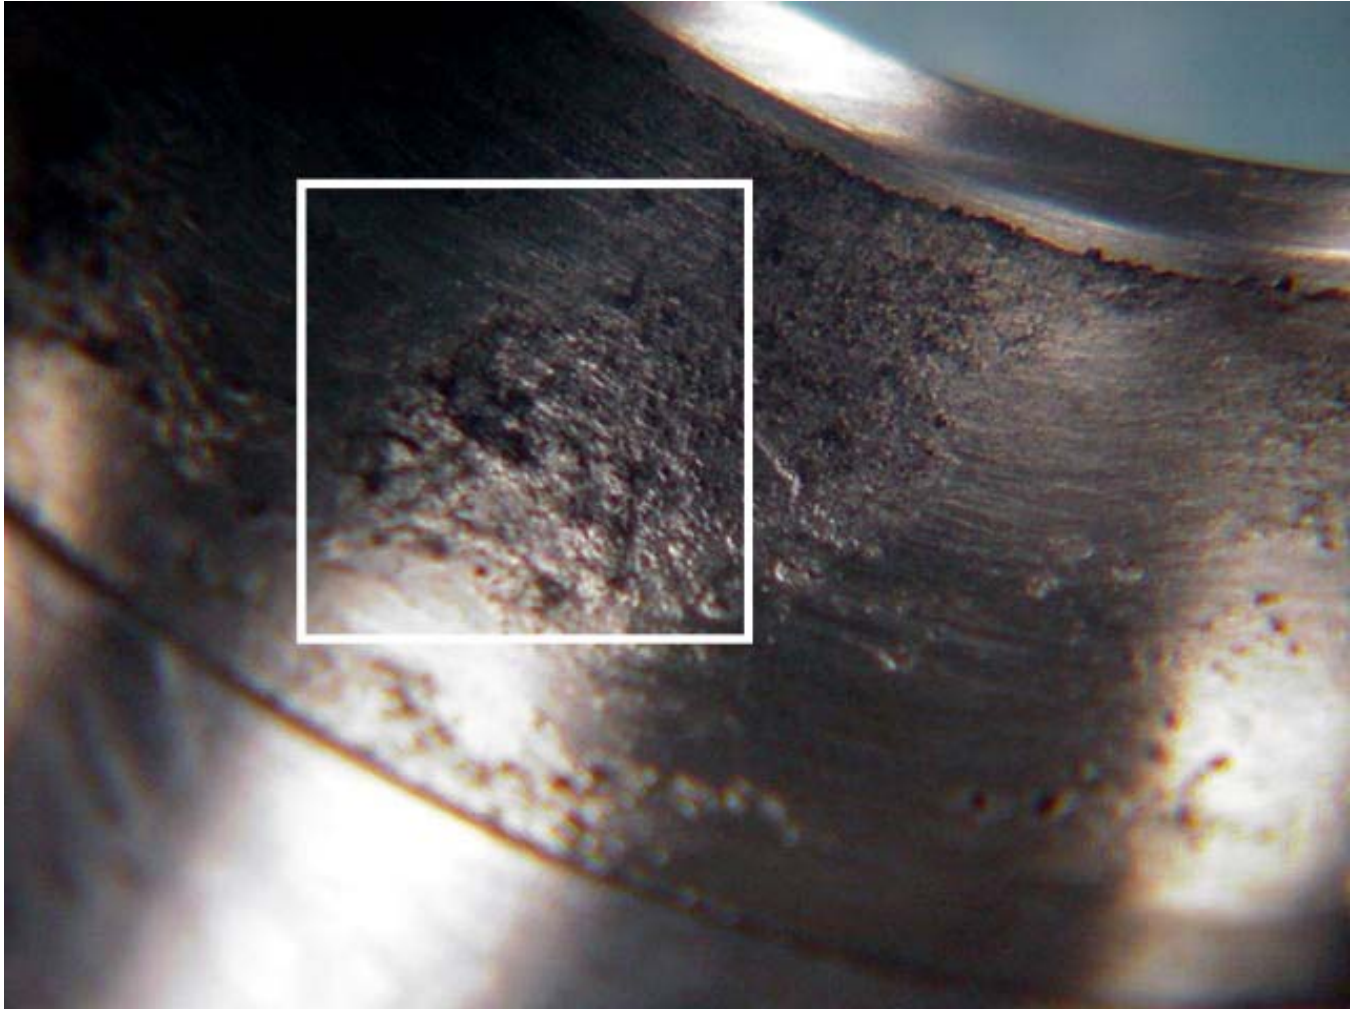
Acceptable Condition
Figure 4

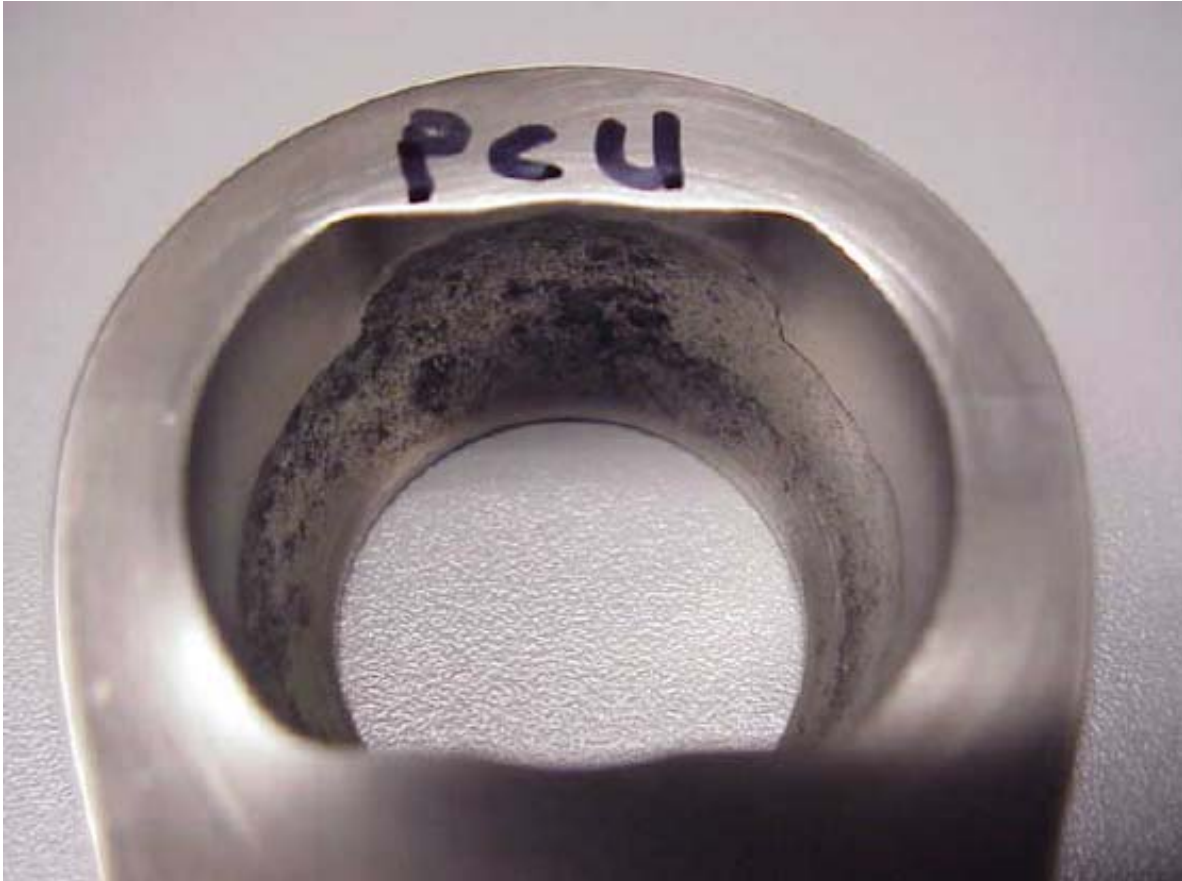
Acceptable Condition
Figure 5

PCUs found with loose tailstock bearing races that can be rotated by hand should be returned for repair or update per Part 2 until further notice.
