SERVICE BULLETIN

MODEL BD-700-1A11 (BD-700)

MODIFICATION – RADIO ALTIMETER SYSTEM – RADIO ALTIMETER ANTENNA CORROSION PROTECTION

SERVICE BULLETIN <u>700-1A11-34-008</u>	ISSUE: <u>Basic</u>	DATED: <u>Dec 15/2004</u>
TITLE: <u>Modification – Radio Altimeter System – Radio Altimeter Antenna Corrosion Protection</u>

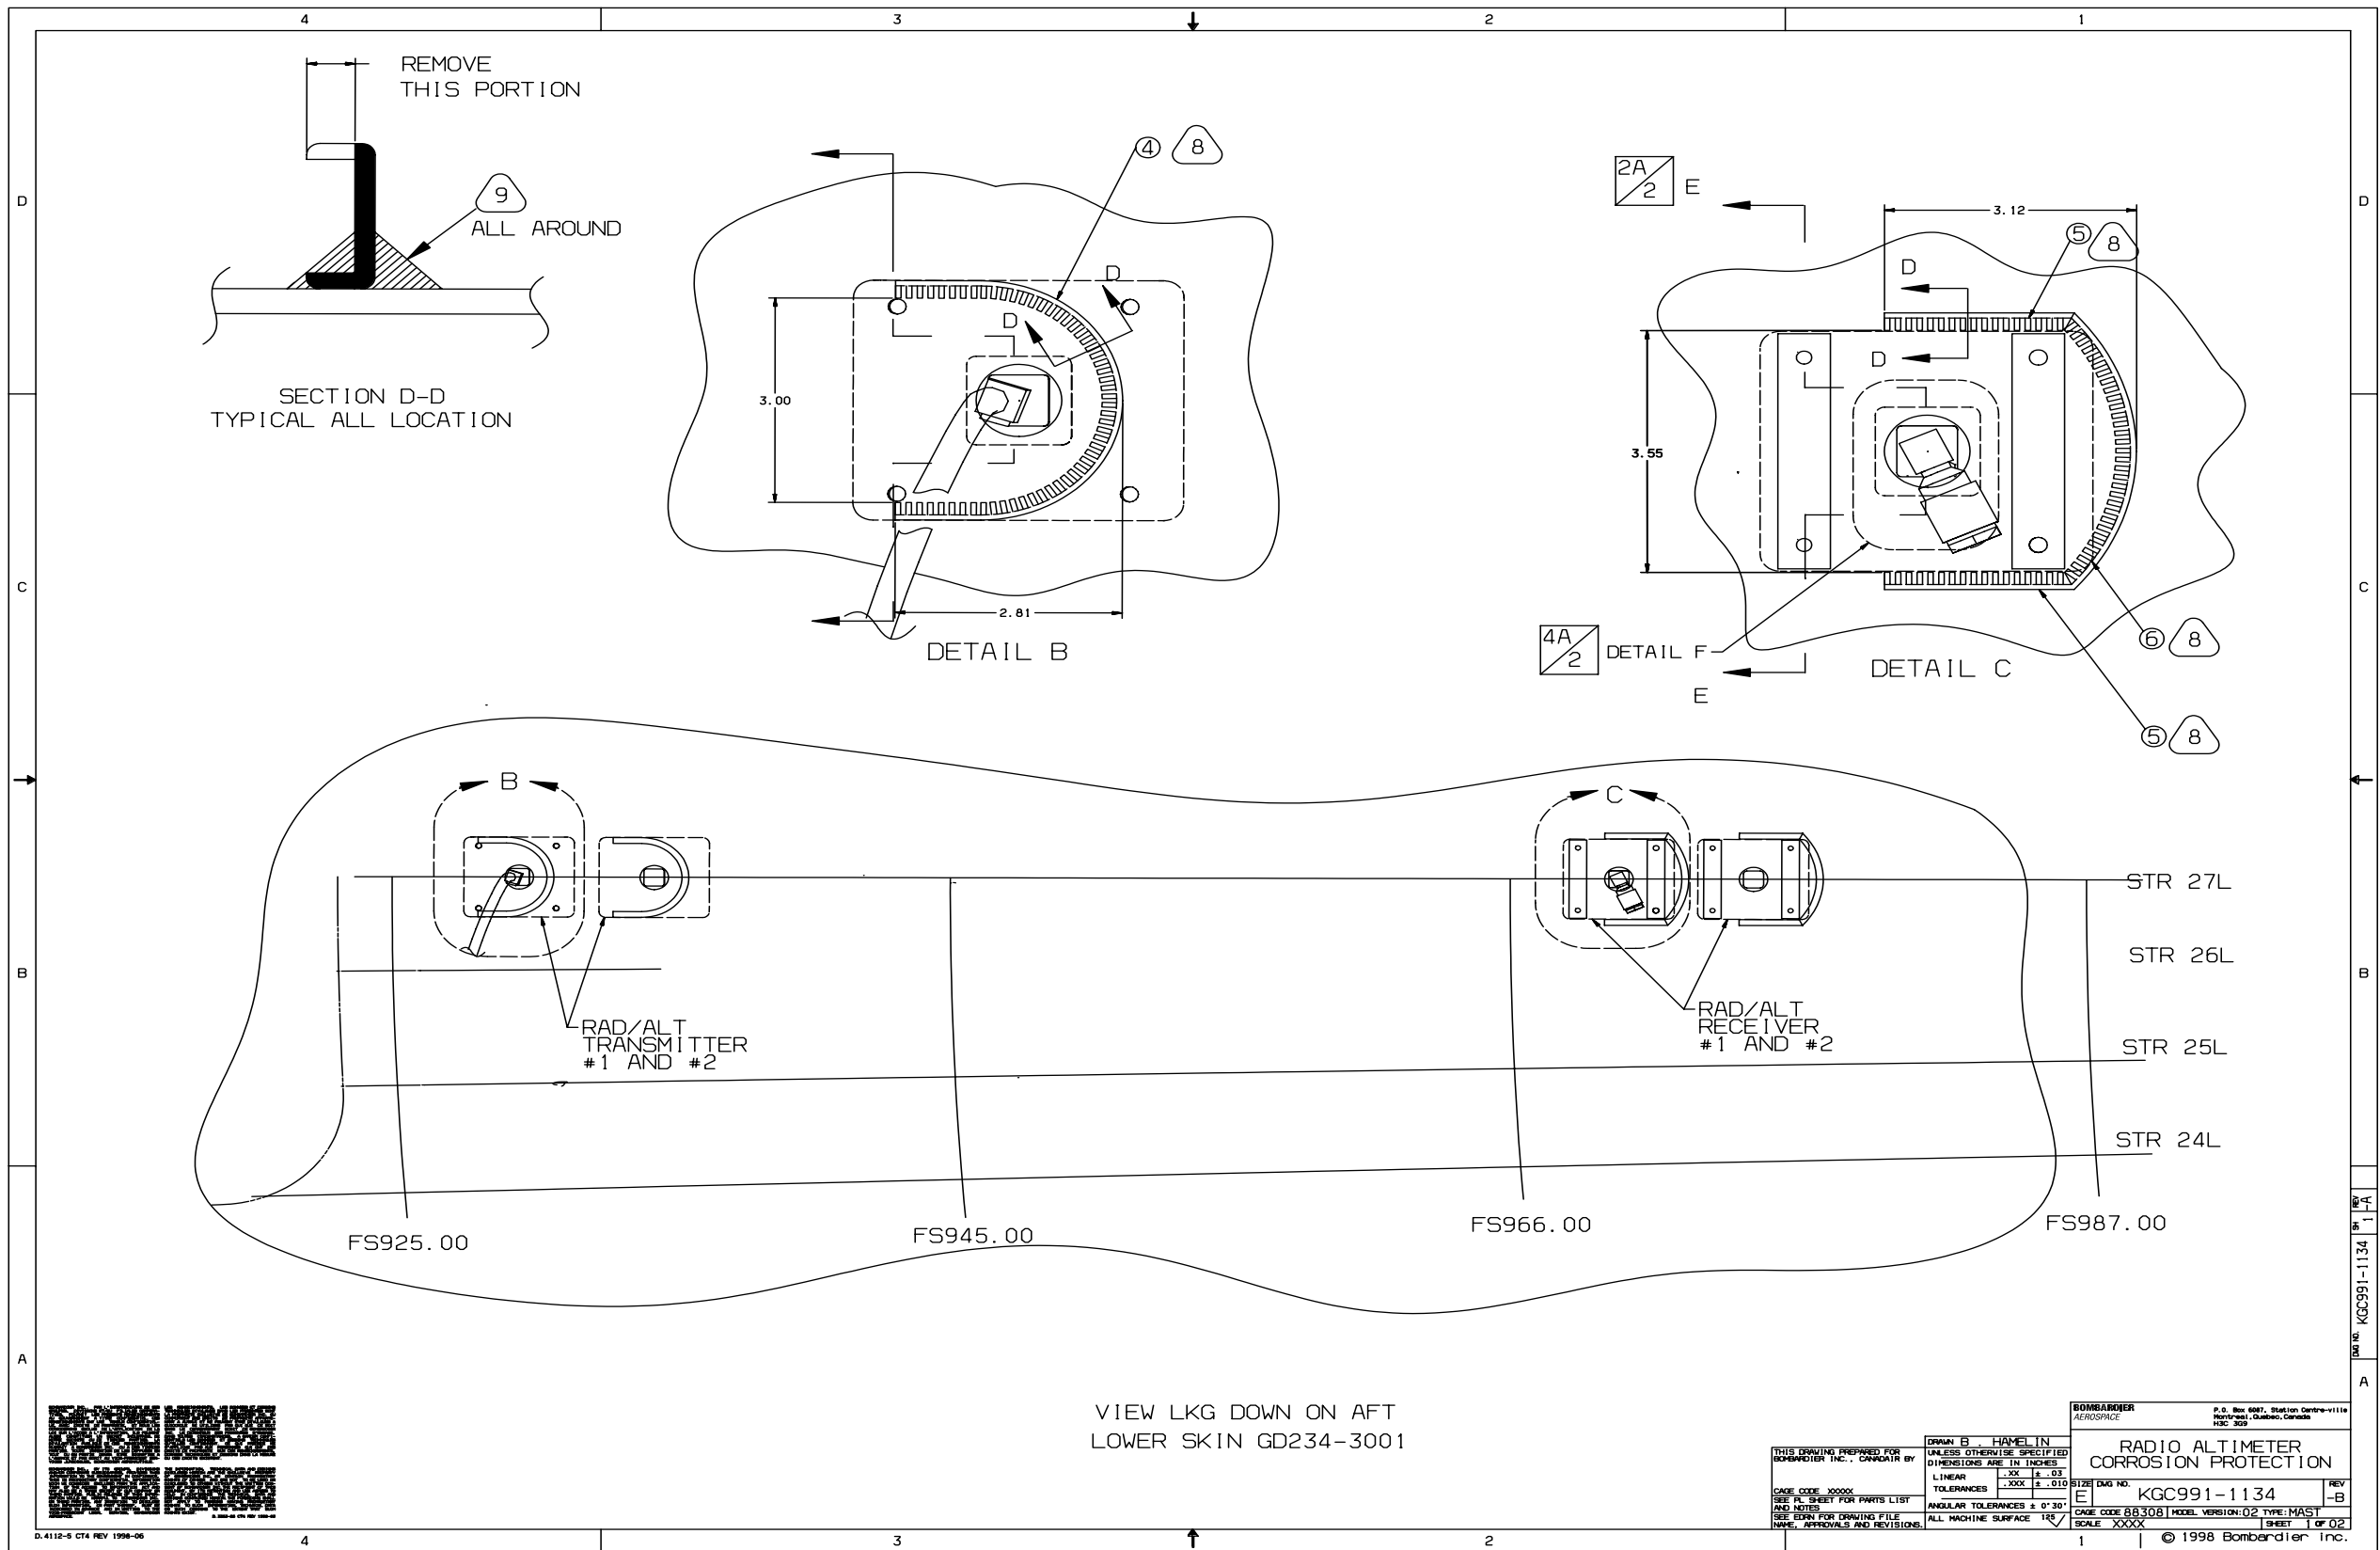
KGC991-1134 – Kit – Radio Altimeter Corrosion Protection
(Sheet 1 of 2, Rev. B)

Water may collect around the radio altimeter's transmitter and receiver antennas. This water may cause corrosion of the connectors and premature failure of the radio altimeter antennas.

- (1) Obey all electrostatic discharge safety precautions. Refer to TASK 24-00-00-910-802.
- (2) Remove the APU battery to gain access to the transmitter antenna connectors. Refer to TASK 24-32-09-000-801.
- (3) Remove the access panel, Part No. GD297-1500-9 that supports the transmitter antenna. Refer to the Illustrated Parts Catalog (IPC), Chapter 53-61-09, Figure 7.
- (4) Remove the radio altimeter antennas (transmitter and receiver). Refer to TASK 34-44-05-000-801.
- (5) Remove and discard the packing, Part No. M25988/1-025, from the receiver and transmitter antennas.
- (6) Rework the adapter plates, Part No. GD517-4352-1 for the radio altimeter receiver antennas as given in Kit Drawing KGC991-1134.
- (7) Re-identify reworked parts as KGC991-1134-3.

- (15) Make the water dam with the raw material, Part No. MS21266-8N provided in the kit. Refer to Kit Drawing KGC991-1134.
 - (16) Install the water dam on the transmitter and receiver antennas. Refer to TASK 51-21-21-340-801 and to Kit Drawing KGC991-1134.
