MODEL BD-700-1A10 (BD-700)

Service Bulletin No. 700-27-050
Date of Basic Issue Jul 02/2007
Revision No. 01 Dated Jul 03/2007

ATA 27-51

**MODIFICATION – CONTROL AND INDICATION SYSTEMS –
 SLAT/FLAP CONTROL UNIT (SFCU) UPGRADE TO PART NO. GT415-5900-15**

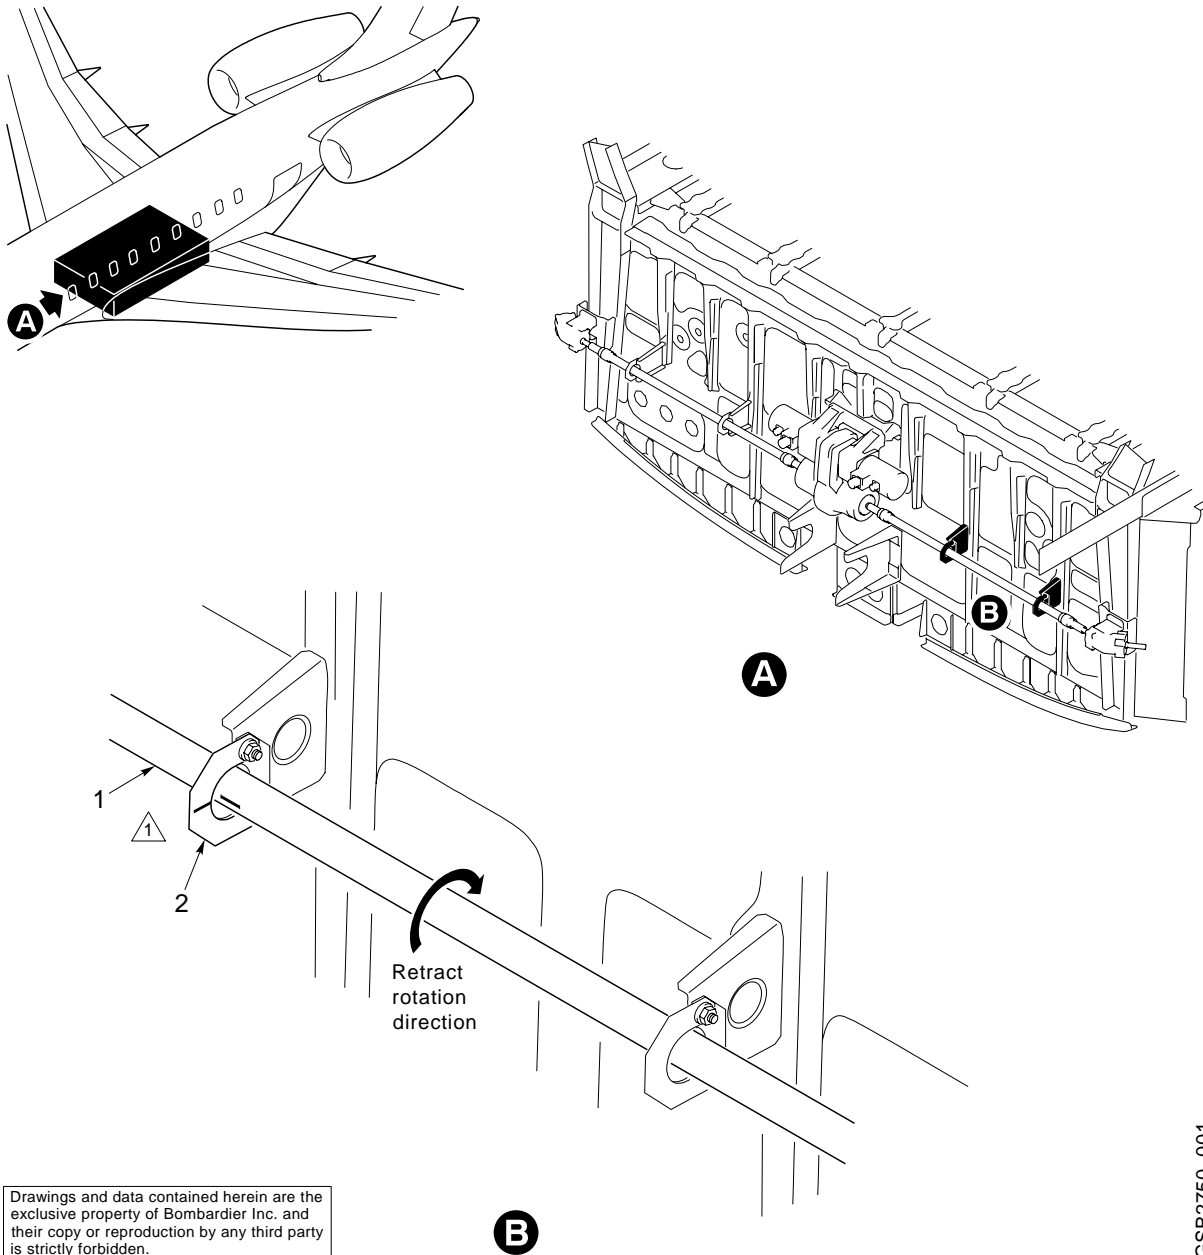
Reference of Torque Tube Initial Position
Figure 1

Put a reference mark on the torque tube (1) and on the adjacent pad (2).

- (6) Do the rigging of the slat system as follows:
 - (a) In the CAIMS PMAT, do as follows:
 - (i) Go to SYSTEM DIAG to get ATA SELECTION DISPLAY page (1/2).
 - (ii) Go to ATA 27-00 FLIGHT CONTROLS to get the LRU SELECTION PAGE.
 - (iii) Go to SLAT/FLAP CONTROL UNIT #1 to get the STORED FAULTS DISPLAY/LRU TEST page.
 - (iv) Go to LRU TEST to get the SFCU 1 LRU TEST MENU 1/1.
 - (v) Go to SLAT RIGGING – SFCU 1 to get the SFCU 1 SLAT RIGGING – PAGE 1/4 screen.
 - (vi) Go to CONFIRM to get the SFCU 1 SLAT RIGGING – PAGE 2/4 screen.
 - (vii) Go to SLAT RIG ENABLE COMMAND and push SELECT.
 - (viii) The indications LEFT/RIGHT SLAT RESOLVER (DEG) should show 20.0 ± 10.0 degrees.
 - (b) Put reference marks on the left hand or right hand torque tube and on the adjacent pad to record the initial position of the torque tube. Refer to Figure 1.

- (v) Go to RELEASE R SLAT MOTOR BRAKE.
 - (vi) Go to SELECT.
 - (vii) Go to RELEASE L SLAT MOTOR BRAKE.
 - (viii) Go to SELECT.
- (d) Retract the slats panels by manually rotating the torque tube until you reach the mechanical stop and record the number of turns required. Refer to Figure 1 for rotation direction.

- NOTE:** The mechanical stop must be reached within 0.5 to 1.5 turns from the reference marks previously made.
- (e) Return the torque tube to the initial position.

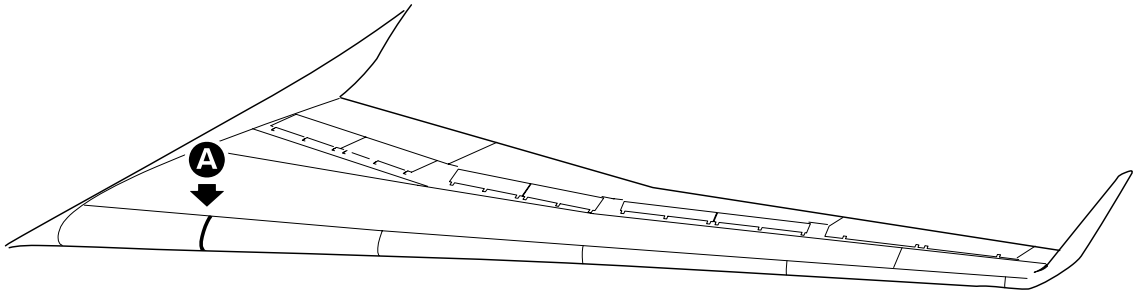
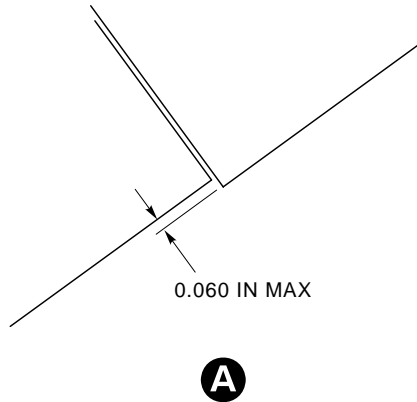
Steps Measurement
Figure 2

- (f) Measure the step between the leading edge of the No. 1 slat panel and the wing fixed leading edge. Refer to Figure 2.
- (g) If the step between the leading edge of the No. 1 slat panel and the wing fixed leading edge is greater than 0.060 in (1.52 mm), do as follows, otherwise go to next step (h):

- (i) Manually rotate the torque tube until the step between each leading edge of the No. 1 slat panel and the wing fixed leading edge is 0.060 in (1.52 mm) or less and record the number of turns required.

- NOTE:** The new reference position must remain within 0.5 to 1.5 turns from the mechanical stop.
- (ii) If the steps requirement cannot be obtained within 0.5 to 1.5 turns from the mechanical stop, refer to TASK 27-53-00-820-801.
