MODEL BD-700-1A10 (BD-700)

ATA 27-51

**MODIFICATION – CONTROL AND INDICATION SYSTEMS –  
 REPLACEMENT OF SFCU WITH PART NO. GT415-5900-17**

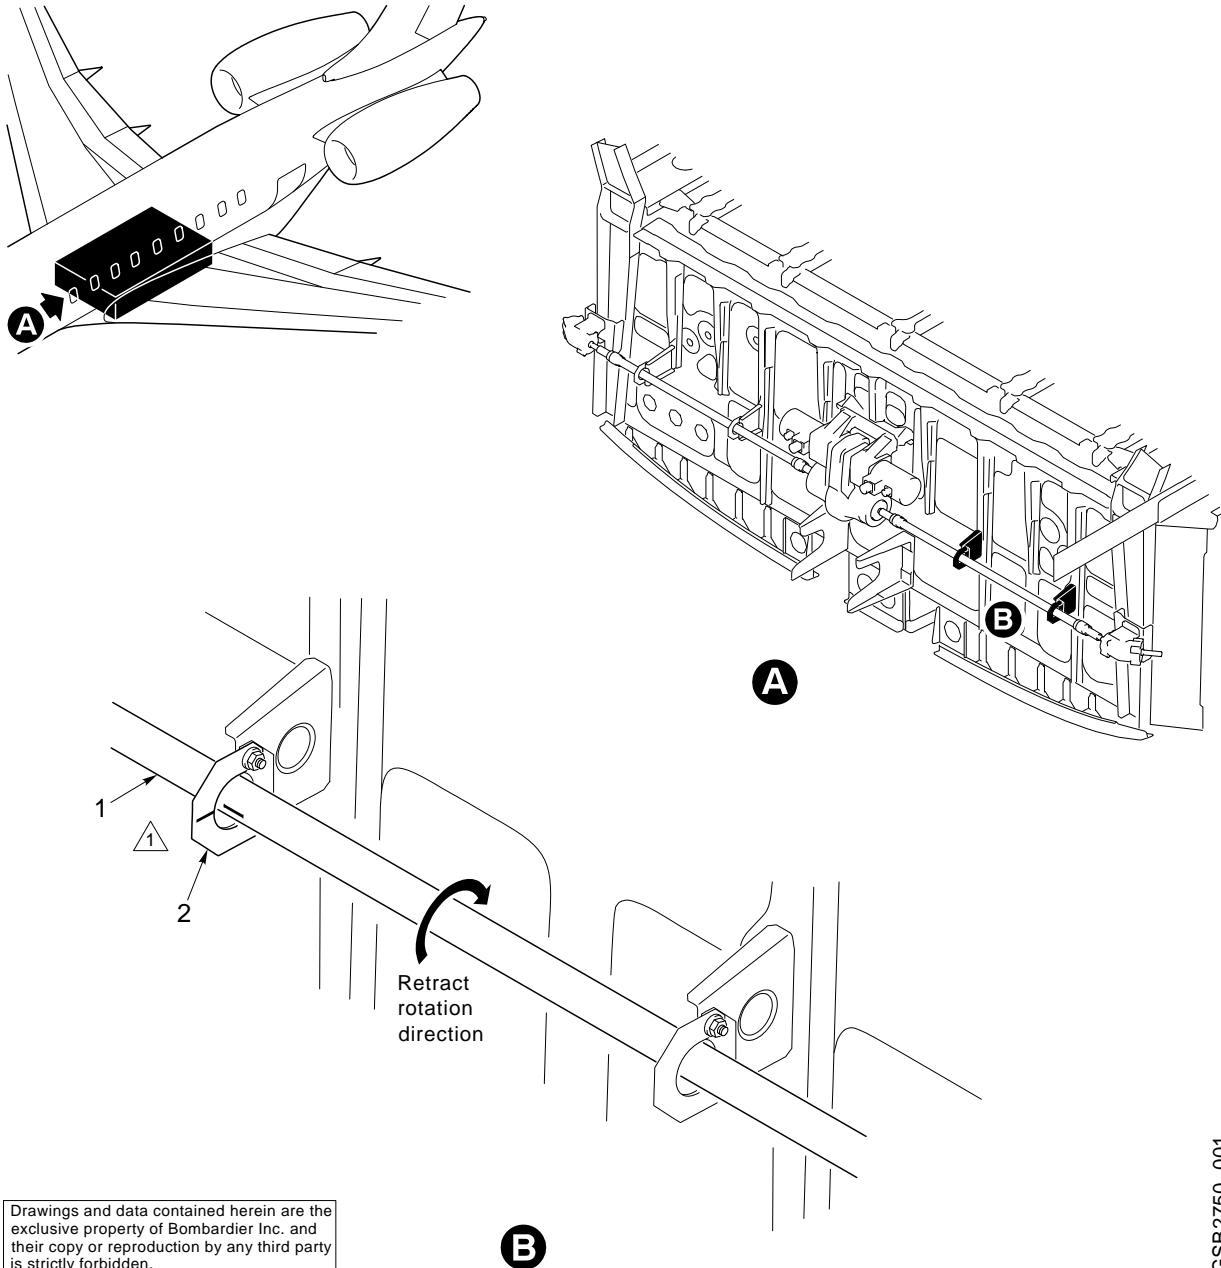
Reference of Torque Tube Initial Position  
Figure 1

Put a reference mark on the torque tube (1) and on the adjacent pad (2).

- (6) Do the rigging of the slat system as follows:
- (a) In the CAIMS PMAT, do as follows:
    - (i) Go to SYSTEM DIAG to get ATA SELECTION DISPLAY page (1/2).
    - (ii) Go to ATA 27-00 FLIGHT CONTROLS to get the LRU SELECTION PAGE.
    - (iii) Go to SLAT/FLAP CONTROL UNIT #1 to get the STORED FAULTS DISPLAY/LRU TEST page.
    - (iv) Go to LRU TEST to get the SFCU 1 LRU TEST MENU 1/1.
    - (v) Go to SLAT RIGGING – SFCU 1 to get the SFCU 1 SLAT RIGGING – PAGE 1/4 screen.
    - (vi) Go to CONFIRM to get the SFCU 1 SLAT RIGGING – PAGE 2/4 screen.
    - (vii) Go to SLAT RIG ENABLE COMMAND and push SELECT.
    - (viii) The indications LEFT/RIGHT SLAT RESOLVER (DEG) should show  $20.0 \pm 10.0$  degrees.
  - (b) Put reference marks on the left hand or right hand torque tube and on the adjacent pad to record the initial position of the torque tube. Refer to Figure 1.

- (v) Go to RELEASE R SLAT MOTOR BRAKE.
  - (vi) Go to SELECT.
  - (vii) Go to RELEASE L SLAT MOTOR BRAKE.
  - (viii) Go to SELECT.
- (d) Retract the slats panels by manually rotating the torque tube until you reach the mechanical stop and record the number of turns required. Refer to Figure 1 for rotation direction.

- NOTE: The mechanical stop must be reached within 0.5 to 1.5 turns from the reference marks previously made.
- (e) Return the torque tube to the initial position.

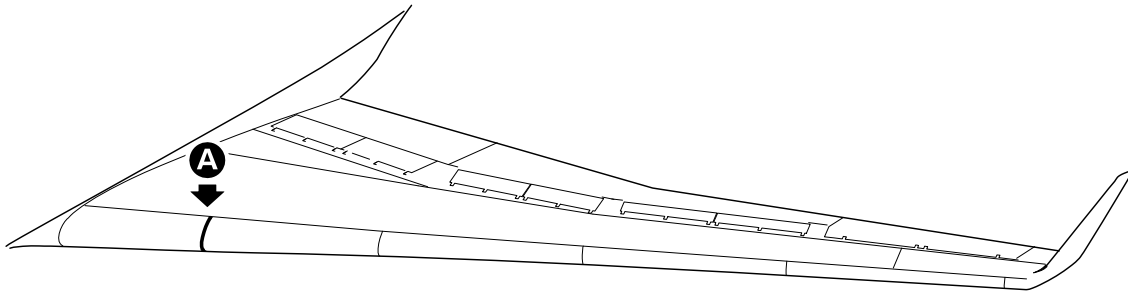
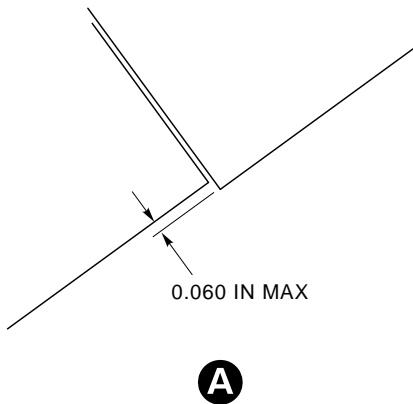
GSB2750\_004

- (f) Measure the step between the leading edge of the No. 1 slat panel and the wing fixed leading edge. Refer to Figure 2.
- (g) If the step between the leading edge of the No. 1 slat panel and the wing fixed leading edge is greater than 0.060 in (1.52 mm), do as follows, if it is less go to the next step (h):

- (i) Manually rotate the torque tube until the step between each leading edge of the No. 1 slat panel and the wing fixed leading edge is 0.060 in (1.52 mm) or less and record the number of turns required.

- NOTE: The new reference position must remain within 0.5 to 1.5 turns from the mechanical stop.
- (ii) If the step requirement cannot be obtained within 0.5 to 1.5 turns from the mechanical stop, refer to TASK 27-53-00-820-801.
