MODEL BD-700-1A10 (BD-700)

**MODIFICATION – BAGGAGE DOOR –
 ADDITION OF A NYLON BLOCK TO THE BAGGAGE DOOR TO
 PREVENT AN UNWANTED EICAS MESSAGE**

SERVICE BULLETIN: 700-52-032 **ISSUE:** Basic **DATED:** Jun 02/2008

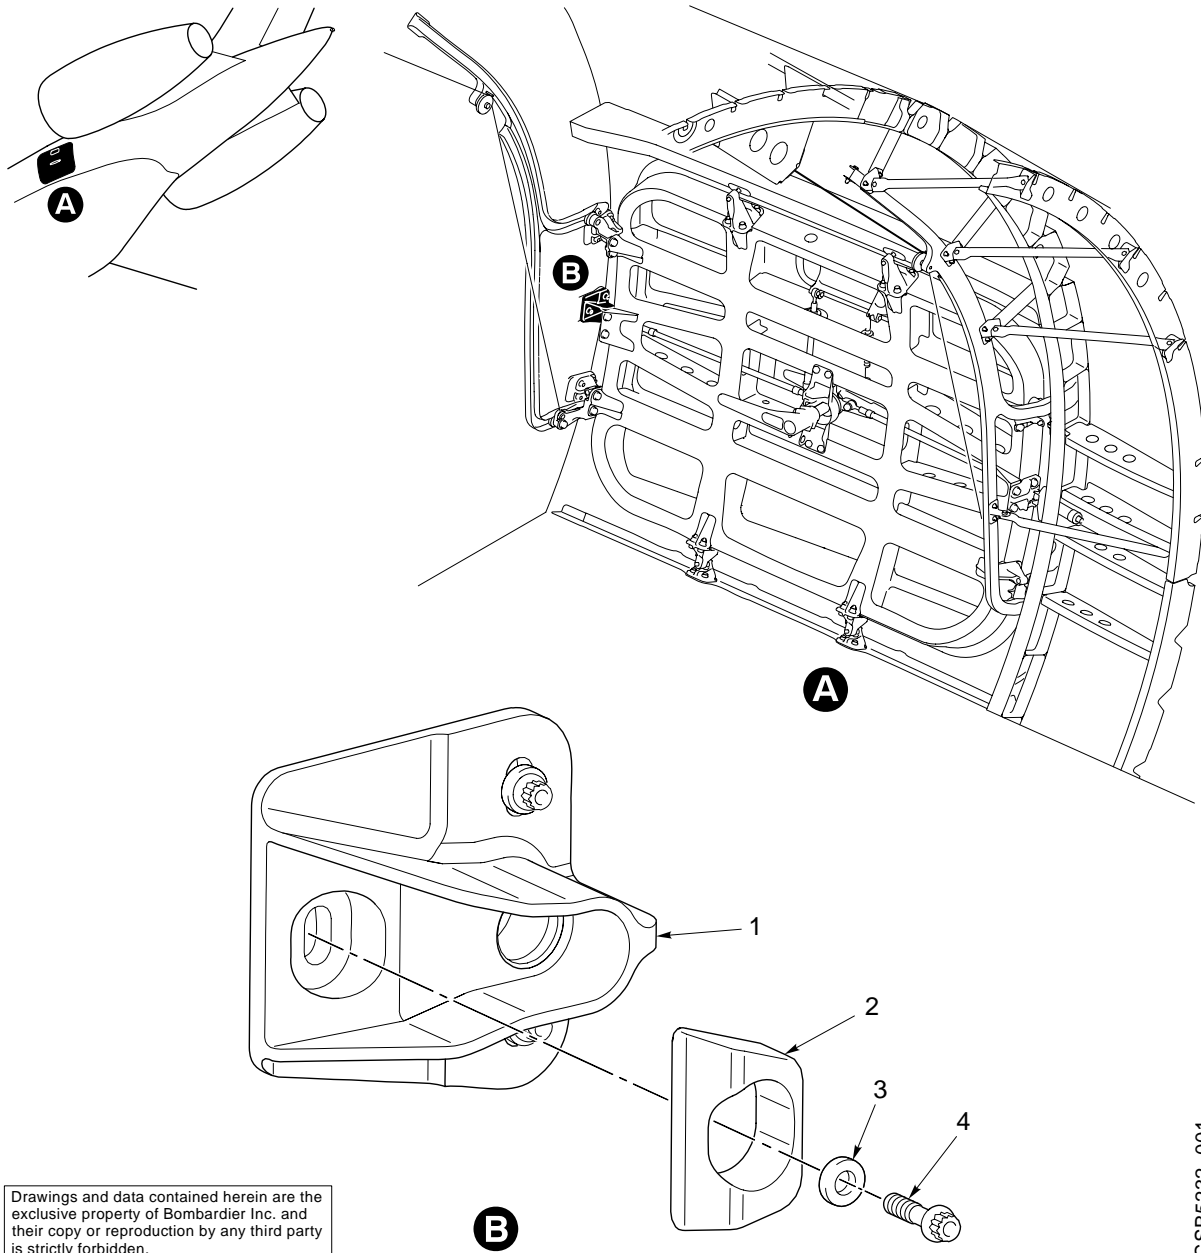
Installation of the Nylon Block on the Aft Latch Fitting
Figure 1

This Service Bulletin introduces a nylon block in the recess of the baggage door aft-latch fitting. The addition of this nylon block will prevent the aft-latch bolt assembly on the baggage door from accidentally entering the recess in the baggage door aft-latch fitting. If the aft latch bolt accidentally entered the recess, the EICAS would indicate that the baggage door is closed, when in fact it is still open.

- (1) Remove the bolt (4) and washer (3) on the aft latch fitting (1). Refer to Figure 1 and kit drawing KGC991-1336.
- (2) If necessary, solvent-clean the mating area of the aft latch fitting (1) and nylon block (2). Refer to TASK 51-25-00-110-801.
- (3) Install the nylon block (2) in the aft latch fitting (1) as follows:
 - (a) Install the nylon block (2) as per the instructions given in kit drawing KGC991-1336.
 - (b) Make sure that the nylon block (2) is mechanically secured in place until fully cured. The nylon block (2) must be secured in place with a mechanical pressure from 2 psi to 10 psi.

2. If epoxy is cured as given in Note 1, do not do the Testing until two hours have elapsed. If normal curing is done, do not do the testing until 24 hours have elapsed.
- (4) Wet-install the bolt (4) and washer (3) on the aft latch fitting (1). Refer to TASK 51-23-00-390-809.
- (5) Torque the bolt (4) from 70 to 90 inch-pounds (7.9 to 10.1 Nm). Refer to TASK 20-21-00-910-801.
