MODEL BD-700-1A10 (BD-700)

**MODIFICATION – BAGGAGE DOOR –
 REPLACE BAGGAGE DOOR TRACK ROLLERS TO IMPROVE OPERATION**

SERVICE BULLETIN: 700-52-033 **ISSUE:** Basic **DATED:** Sep 15/2008

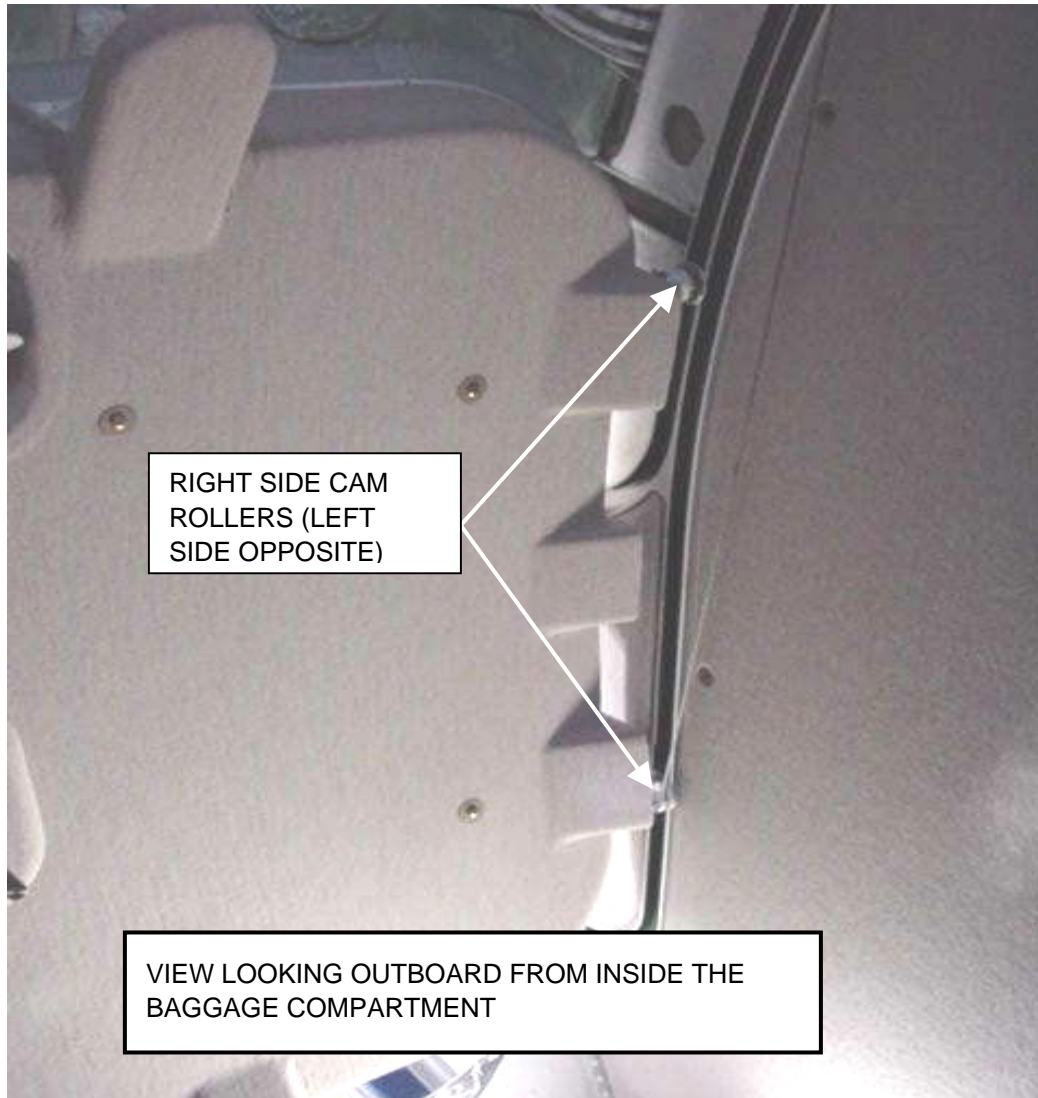
Baggage Door – Cam Roller Location
Figure 1

Because of a build-up of tolerances, excessive gaps between the baggage door tracks and cam rollers were found on some aircraft. On several occasions, this condition caused the baggage door to come off its tracks during open/close operations.

- (2) For each cam roller, do as follows before removal (refer to Figure 1 for cam roller location):

- (3) Remove and keep for reference the four cam rollers, Part No. NAS562-5R25. Refer to Figure 1 item 390 in the BD-700 AIPC, Chapter 52-31-01.

- (4) Install the four new cam rollers, Part No. GD322-3175-1 with kept hardware.

NOTES: 1. Use the recorded measurement from the kept cam rollers as reference to install and adjust the new cam rollers at each position on the door.

2. Torque the cam roller nuts 100 to 140 lbf-in (11.30 to 15.82 Nm) and safety with new cotter pins. Refer to TASK 20-50-00-400-801.

NOTE: If necessary, adjust the cam rollers with the jam nut(s) on the threaded sleeve(s) of the cam roller(s) and make sure that the distance between the cam rollers and the track flange with the door closed is between 0.020 and 0.025 inch (0.508 and 0.635 mm).
