ALERT SERVICE BULLETIN REVISION TRANSMITTAL SHEET

MODEL BD-700-1A10 (BD-700)

Service Bulletin No. A700-27-066
Date of Basic Issue Oct 02/2008
Revision No. 01 Dated Oct 03/2008
Revision No. 02 Dated Nov 10/2008

**SPECIAL CHECK/REWORK – ELEVATOR CONTROL SYSTEM –
 INSPECTION OF ELEVATOR PCU, P/N GT411-3800-5 & -7,
 ATTACHMENT FITTINGS AND SLOTTED ENTRY BEARINGS**

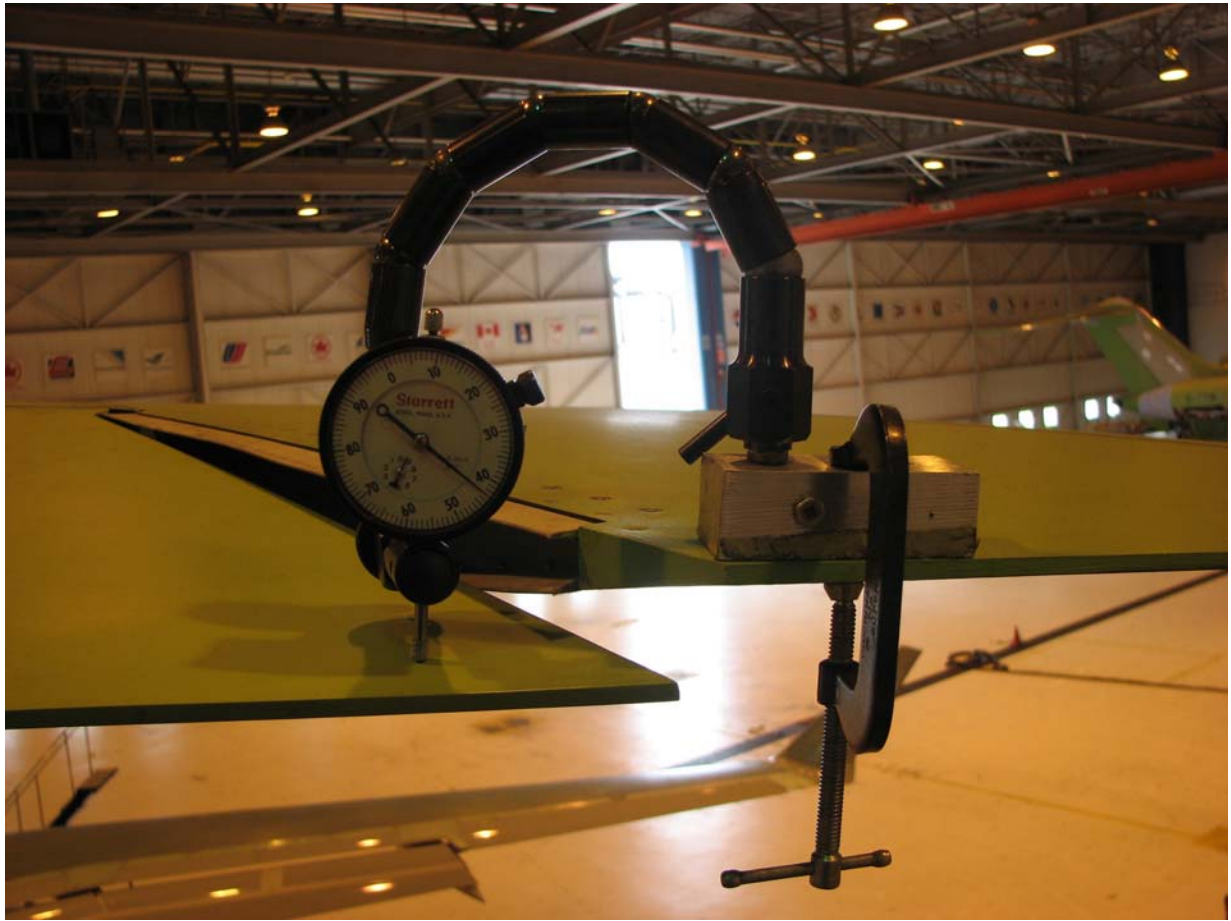
Elevator Backlash Check – Alternative Dial Indicator Mount
Figure 1

- Notes:
1. Do not do the remainder of the TASK.
 2. If the GSE for supporting the dial indicator is not available, an alternative method to mount the dial indicator is as follows;
Mount the dial indicator base on the outboard edge of the elevator fairing under a protective tape. Clamp the base to the elevator fairing. Refer to Figure 1 and use the procedure in TASK 27-31-21-720-801 to determine the backlash.
 3. If the backlash is in excess of AMM requirements, send an SRPSA with the details.
