ADVISORY WIRE

REFERENCE NO:	AW700-24-0370, Rev. 2	INFORMATION TYPE:	Maintenance
ATA:	24-25	EFFECTIVITY:	Global Express / XRS (9002 - 9312, 9314 - 9380, 9384 - 9429)
SUBJECT:	Variable Frequency Generator (VFG) #4 Feeder Cable Chafing		Global 5000 (9127 to 9383, 9389 to 9400, 9404 to 9431 and 9998) Global 5000 feat. Vision Flight Deck (9386, 9401, 9445 - 9492) Global 6000 (9313, 9381, 9432 -9492)

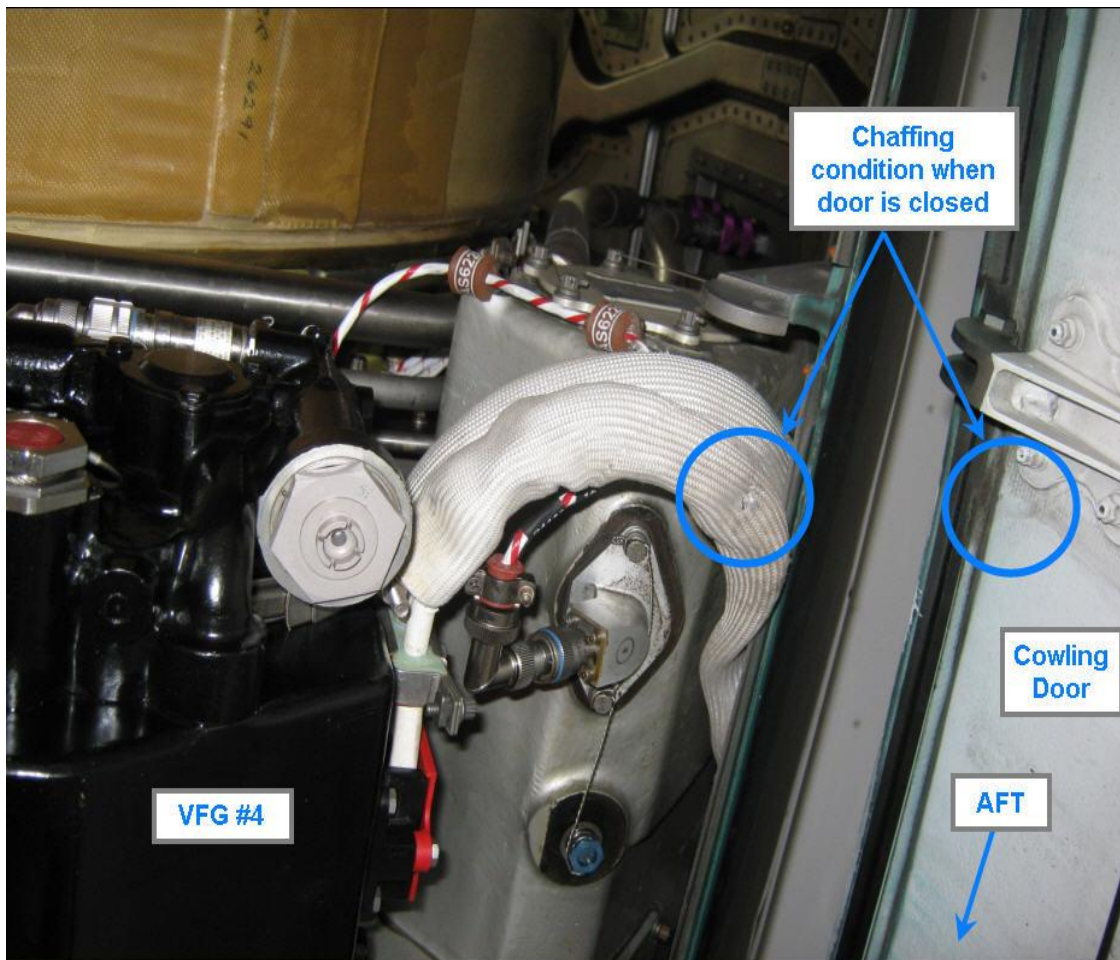
This condition is limited to the VFG power feeder cables routed in lower position which connects with the VFG in position #4 (right-hand engine, inboard position). The clearance between the cowling door and the power

feeder cables are reduced in position #4 when compared to other positions due to the cowling door shape and the hinge installed in this area.

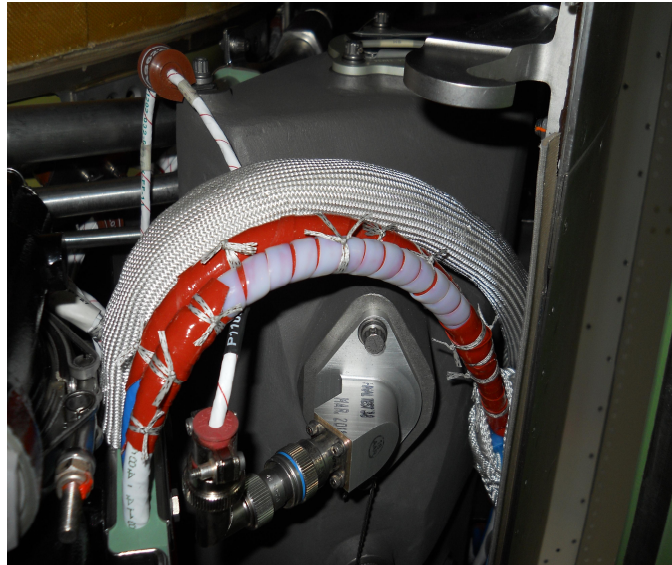
Picture 1: Final installation without the existing white sleeve

Bombardier has conducted an investigation which has revealed an inconsistency in the length of VFG-connecting cables during the manufacturing process. This variability could slightly modify the cables' routing path, resulting in a clearance reduction between the VFG cables and the cowling door. To rectify this situation, Bombardier released an In-Service Modsum (Ref. 1.1) which consists of installing silicone tape and Spirap in addition to the existing white protection sleeves (see picture 1). The four cables will then be attached together with lacing cord in order to maximize the clearance between the cables and the cowling door (see picture 2).

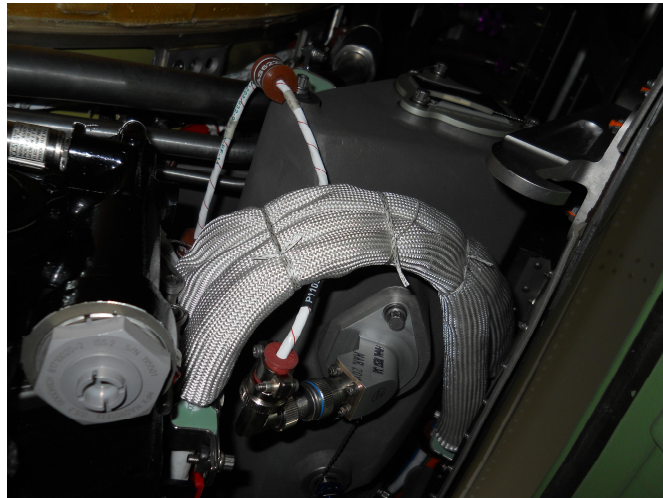
Picture 2: Final installation
