ADVISORY WIRE

REFERENCE NO:	AW700-28-0469	INFORMATION TYPE:	Maintenance Operational
ATA:	28-41	EFFECTIVITY:	Global Express 9002 to 9153
SUBJECT:	Fuel Management and Quantity Gauging Computer Tray Connector Inspection		Global 5000 9127 to 9411, 9417 to 9431, 9998
			Global Express XRS 9159 to 9429
			Global 5000 feat. Bombardier Vision Flight Deck 9386, 9401, 9445 to 9571,9574
			Global 6000 9313, 9381, 9432 to 9572

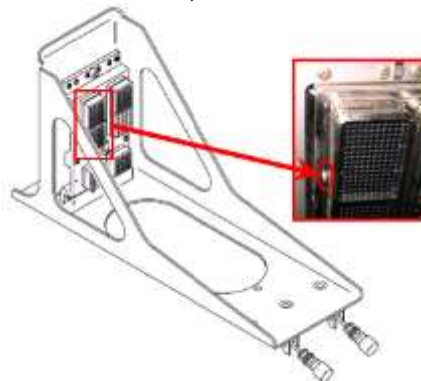
Figure 1: FMQGC tray connector (A47P1).

During installation of the FMQGC on the aircraft production line, it was reported that a screw installed on the insert fitting at the rear of the FMQGC tray connector was excessively long and protruding on the opposite side of the connector (A47P1--refer to Figure 1). The screw is used to maintain the connector blocks in the connector shell and, on certain aircraft, is also used as a shield termination.

A longer screw caused a fouling condition with the backside of the FMQGC and prevented the unit from being fully inserted into its mounting tray. The extent of the physical damage observed on the FMQGC was limited to minor paint damage (screw print) on the external casing.

Bombardier recommends that Operators inspect all the screws surrounding block E of the FMQGC connector (A47P1) for possible fouling condition, in accordance with the ISMS (ref. 1.1). Following the visual inspection, should the Operator confirm a fouling condition, the applicable screws should be replaced with a shorter one as instructed in the ISMS.

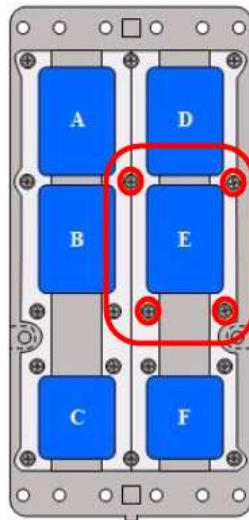
Figure 2: View looking inboard of FMQGC connector tray (A47P1).

Bombardier has conducted an investigation which has revealed an inconsistency with the assembly manual, resulting in having longer screws installed surrounding connector block E (A47EP1) of the FMQGC tray connector (refer to Figure 2).

Based on measurements taken from the affected aircraft and the Aeronautical Radio Incorporated (ARINC) connector specification, an analysis was performed and revealed that the protruding screw would have no effect on the electrical engagement of the FMQGC into the connector and consequently have no impact on the safety of flight.

In order to eliminate the potential fouling condition during aircraft production, the assembly manual has been revised starting at A/C S/N 9573 to install a shorter screw on the connector assembly. Bombardier has released an In-Service Modsum (ISMS--ref. 1.1) which consists of an inspection of the FMQGC tray connector (A47P1) for any protruding screws.
