# ADVISORY WIRE

REFERENCE NO:	AW700-32-0581	INFORMATION TYPE:	Maintenance Operational
ATA:	32-43	EFFECTIVITY:	Global Express (9002 to 9153)
SUBJECT:	<b>Wheel Speed Transducer (WST)</b>		Global 5000 (9127 to 9413, 9415 to 9442, 9998)
			Global Express XRS (9159 to 9431)
			Global 5000 feat. Bombardier Vision (9386, 9401, 9445 to 9997)
			Global 6000 (9313, 9381, 9432 to 9997)

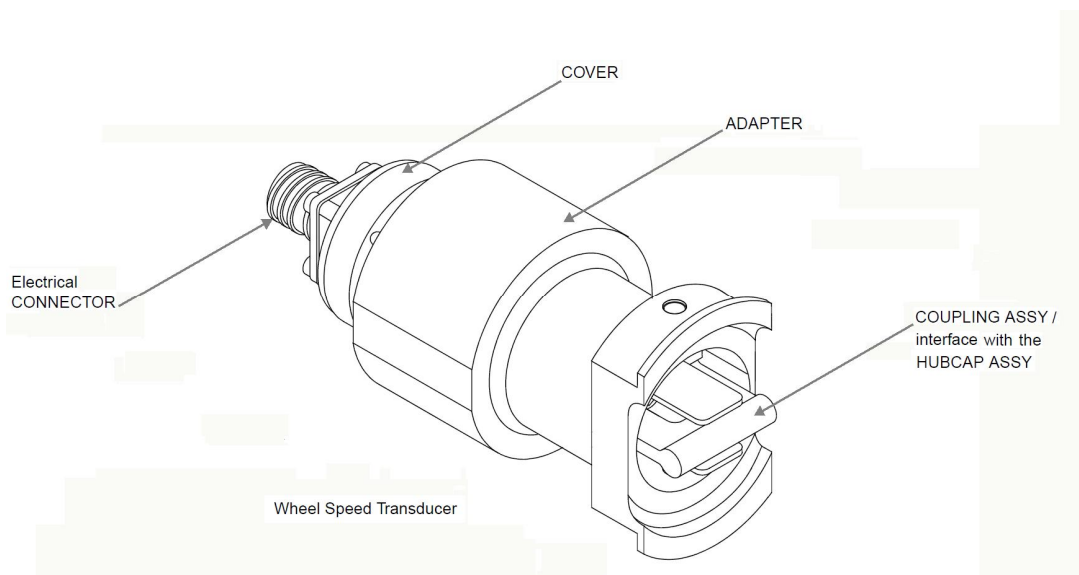
Recently, Bombardier has seen an increase in reported in service cases of atypical WST failures. The latest event occurred on landing when the crew was alerted by a R OUTBD BRAKE FAIL (caution) message on the Engine Indication and Crew Alerting System (EICAS). The Flight Crew achieved an uneventful landing. After landing, inspection revealed that the WST (MLG OUTBOARD) electrical harness had sheared from the WST inside the landing gear axle. It appears that the WST cover, including the electrical connector, had rotated causing the harness to spin and shear.

There have been three (3) other WST events of this type since January 2016 on the Global Express that resulted in the replacement of the electrical harness. Bombardier has also been informed of a fifth event where the WST Hub Cap Assembly was damaged, the condition of the unit revealed that the WST shaft had locked causing the WST Spring Coupling Assembly to break.

Preliminary observation indicates that only the WST's BA Part Number GW415-1050-7 and GW415-1050-9 located at the LH or RH OUTBOARD position are impacted, regardless of SB (Ref 1.2) incorporation.

The Failure Analysis Reports (FAR) provided by the vendor did not reveal a single root cause that can be attributed to all failures. In some cases, insufficient torqueing of the adapter or lack of application of loctite may have caused the rotation of the cover. However, in all cases, traces of water have been found inside the analyzed WSTs.

Bombardier has launched an investigation into these events and is focusing on water infiltrating in the landing gear trailing arm. Although not confirmed, Bombardier is suspecting that the presence of water in the axle may contribute to this failure mode.

There is no a particular action required at this time. However, BA reminds operators that have complied with the SB (Ref 1.2) to report your findings as instructed by the Advisory Wire AW700-32-0573 (Ref 1.3). We also suggest that flight crews review the appropriate non-normal Airplane Flight Manual (AFM) procedures associated with a L/R OUTBD BRAKE FAIL.
