# Advisory Wire

REFERENCE NO:	AW700-32-0581, Rev 3	INFORMATION TYPE:	Maintenance Operational
ATA:	32-43	EFFECTIVITY:	Global Express / XRS (9002 - 9312, 9314 - 9380, 9384 - 9429)
SUBJECT:	<b>Wheel Speed Transducer (WST) – MLG Trailing Arm Water Ingress</b>		Global 5000 (9127 - 9383, 9389 - 9400, 9404 - 9431 and 9998) Global 5000 feat. Vision Flight Deck (9386, 9401, 9445 - 9862, and 9868 - 9997) Global 6000 (9313, 9381, 9432 to 9860, 9863 - 9871, 9873 - 9997 and 60005 - 61999) Global 5500, Global 6500 (9861, 9872, 60001 - 61999)

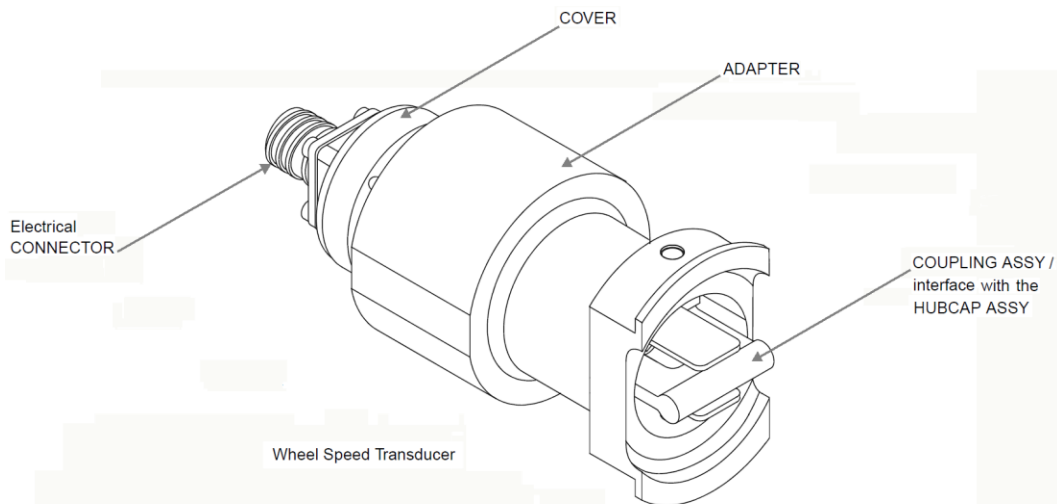
After landing, inspection revealed that the WST (MLG OUTBOARD) electrical harness had sheared from the WST inside the landing gear axle. It appears that the WST cover, including the electrical connector, had rotated causing the harness to spin and shear.

There have been seven (7) WST events of this type since January 2016 on the Global Express that resulted in the replacement of the electrical harness. Bombardier has also been informed of another event where the WST Hub Cap Assembly was damaged, the condition of the unit revealed that the WST shaft had locked causing the WST Spring Coupling Assembly to break.

Bombardier Aviation recommends that this SB (Ref. 1.2) be accomplished at your earliest convenience or at the same time as the 30-month brake assembly - Functional Test of the Brake Disk for Drive Slot Enlargement (Ref 1.3).
