AW700-28-0306, Rev. 1

SUBJECT: Fuel System – Aft Tank Flexible Fuel Cell

EFFECTIVITY: Global Express (9002 to 9153)
Global Express XRS (9159 to 9431)
Global 6000 (9313, 9381, 9432 to 9997)

ATA: 28-12

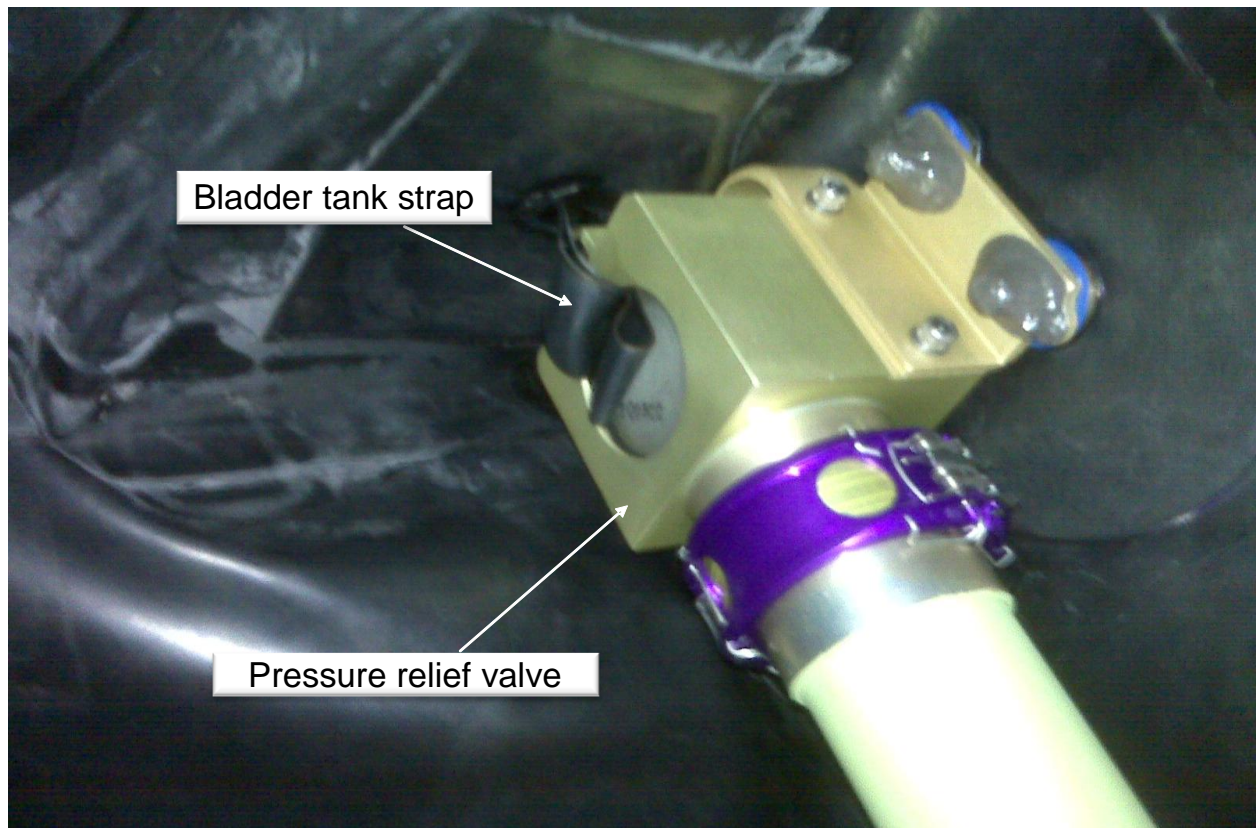
Image 3.1

An Operator reported that fuel was leaking from the AFT Tank drain under the aircraft. Investigation revealed that the source of the leakage was coming from the aft tank pressure relief line. Subsequently, it was found that the aft tank bladder internal strap was caught in the aft tank pressure relief valve (see reference 1.1 above and image 3.1 below.)

Several months prior to this event, the aircraft experienced an aft tank refuel/defuel valve that was stuck open during refueling and fuel had spilled over via the pressure relief line. As designed, the relief valve opened at 3.5 psig (in the event the refuel shutoff valve fails to close) and prevented an overpressure of the aft tank. It is suspected that during the fuel spill, the fuel flow going through the pressure relief valve caused the bladder strap to go into the valve due to the strap location and length.

The bladder strap was cut via SRPSA to prevent re-occurrence of this issue and the aircraft was returned to service without re-occurrence.

Bombardier released the reference 1.2 and 1.3 Service Bulletins, which authorize cutting the bladder tank strap (or pull tab) next to the pressure relief valve. This will prevent the condition originally reported by this Advisory Wire.

Operators should familiarize themselves with the reference 1.2 and 1.3 Service Bulletins which are recommended at the next "8C" check.
