Hamilton Sundstrand

SERVICE BULLETIN

Flight Controls - Asymmetry Brake Assembly - Add Drain Holes

Hamilton Sundstrand Asymmetry Brake Assembly, Model FAS02AB, part number 763053, serial numbers 0001 through 0603, used on Bombardier Global aircraft.

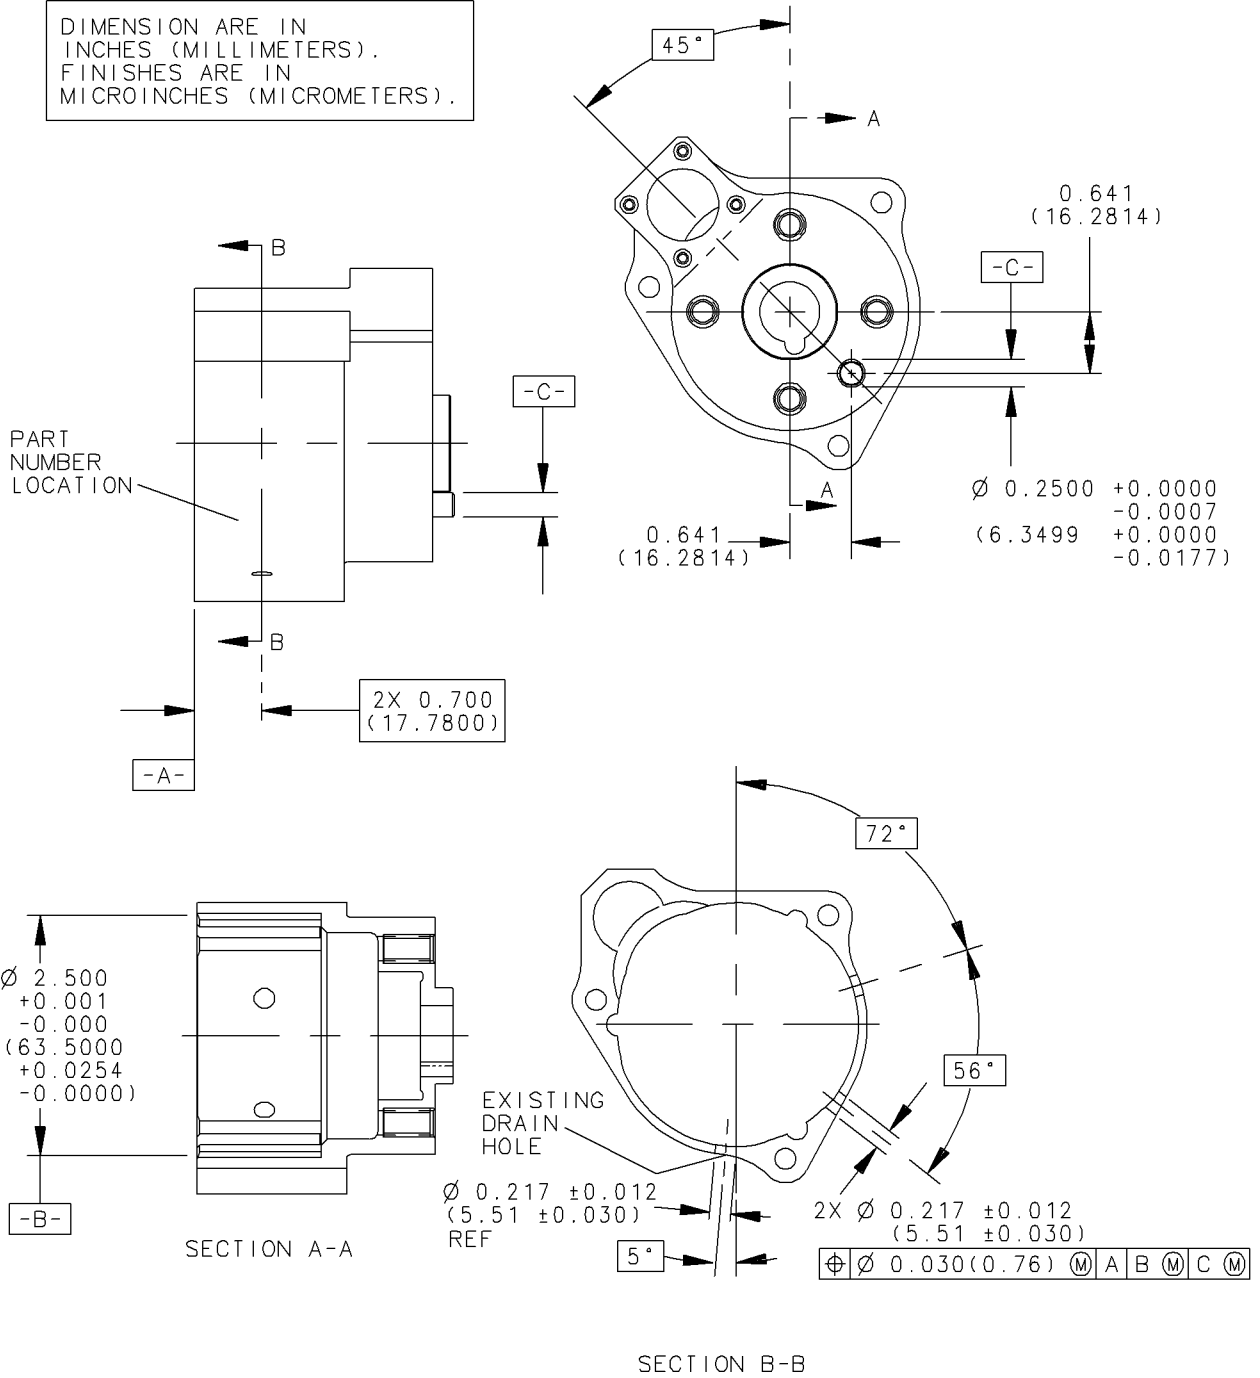
Inseparable Housing Assembly Modification
Figure 1 (Sheet 1 of 2)

Field experience has shown that water can build up inside the asymmetry brake assembly when it is installed in certain positions on the aircraft. This is caused by the absence of multiple drain holes in the housing. The presence of the water can cause the asymmetry brake assembly to malfunction. Machining two additional drain holes in the housing will allow water to drain when installed in any position on the aircraft and reduce malfunctions. Incorporation of this bulletin will improve the reliability of the asymmetry brake assembly.

- (1) Modify the inseparable housing assembly (30) (refer to Figure 1 of this bulletin).

1. Locate and drill two 0.217 ± 0.012 inch (5.51 ± 0.030 millimeter) drain holes (refer to the view).
2. Deburr the machined areas.
3. Clean the housing (refer to SPM 20-00-00, CLEANING).
4. Change the part number from 763965 to 1701855 (refer to the view and SPM 20-00-00, ASSEMBLY).
5. Apply chemical conversion coating to the machined areas and to the area where the part number was changed (refer to the view and SPM 20-00-00, REPAIR).
6. Touch up paint as needed (refer to CMM 27-52-53, ASSEMBLY).
