Customer FORUM & Newsletter

TUESDAY, APRIL 5, 2011

VOLUME 08 / ISSUE 07

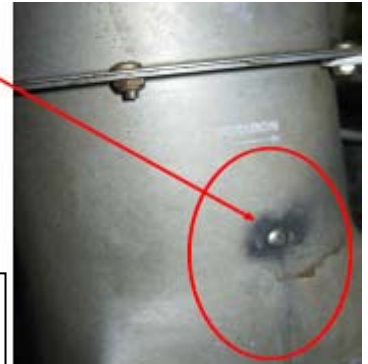
Cause
 The fan support hole in the hydraulic heat exchanger housing had become elongated.

Explanation
 The elongated hole in the hydraulic heat exchanger housing had allowed the fan assembly to shift. This caused in the fan blades to contact the housing which resulted in the vibration/buffeting.
 The hydraulic heat exchanger support rods are connected to the bulkhead at FS 755.00, which would transmit the vibration to the air frame.

Once found, there was no doubt the Heat Exchanger Fan had failed. As shown in the pictures below:

Notice hole is now elongated, allowing movement of the motor. This allows the fan blades (shown in next image) to make contact with the housing.

The corrective action states: Upon inspection, found fan for Hydraulic Heat Exchanger worn and vibrating. Removed and replaced hydraulic heat exchanger IAW CRJ 200 AMM 29-11-42, OPS check good. Enter the "Symptoms," Consider the "Possible Solutions," troubleshoot to the root cause of the Squawk, and you are done.

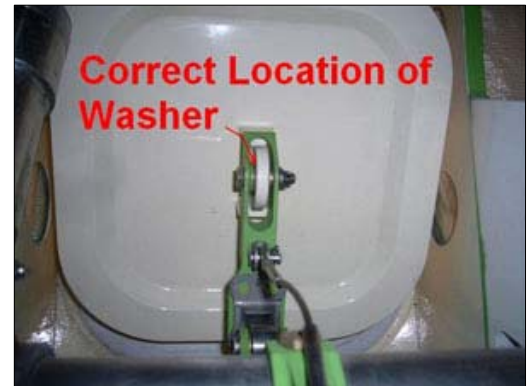
Recently we have received two reports that the vent flap assembly has been found misassembled. One with the hardware in the incorrect sequence, the other with the hardware in the incorrect sequence with a washer that was not the correct part.

They discovered an incorrect washer with a smaller I.D. in the installation. Due to the smaller I.D., the washer would have sat on the bearing, rather than surrounding it. This would actually increase potential vent flap rotation rather than limit it.

Specifically, the area of concern is the installation of a washer that helps reduce "rotation" of the vent flap. The correct washer is P/N B0202008L10. If you refer to the IPC (52-11-01 {fig. 2 GX, Fig. 11 Global 5000, Fig. 21 XRS} view F), this washer (item 227) is to be installed between the vent flap bearing (item 255) and the spacer (item 230).

This washer will fit over the vent flap bearing ball and fills the space between the spacer and bearing ball, limiting possible side-to-side rotation of the bearing, thus limiting rotation of the vent flap.

Sometimes the washer is found installed between the spacer and the vent flap beam. This will not prevent rotation of the vent flap and will cause a minor misalignment between the vent flap and the vent flap beam.

Although the IPC and AMM tasks are correct, a user comment was raised to add a caution to use the correct washer and emphasize the correct location of the washer.
