Air Conditioning System Troubleshooting

Eff.: Global Series Aircraft

ATA 21

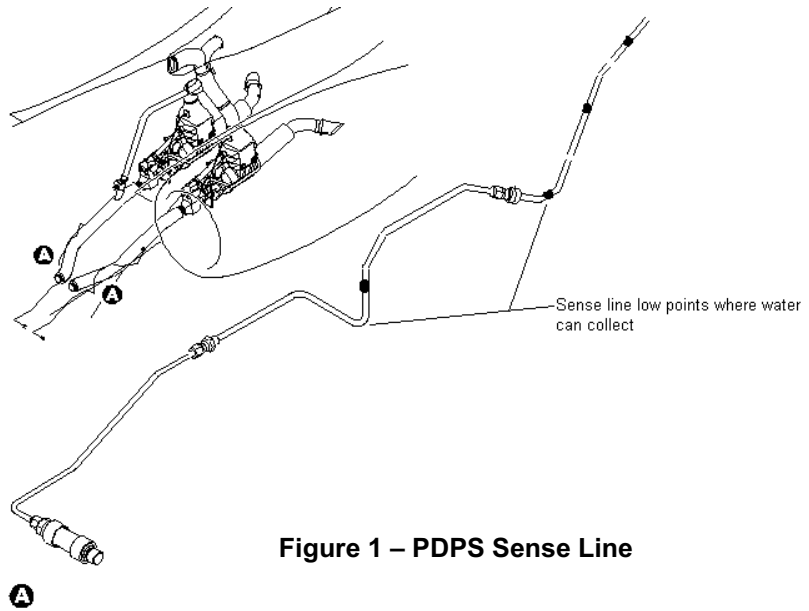
Figure 1 – PDPS Sense Line

During our investigation, we encountered an unusual scenario where water was found in the PDPS sense line. The PDPS sense line runs from the ACM turbine outlet to the PDPS located within the pressurized cabin, which is located at a lower waterline than the sense port on the ACM. So, if water does accumulate in the PDPS sense line it could freeze when the aircraft is at high altitude, trapping the pressure in the PDPS sense line (Ref. Figure 1). As the aircraft descends to a lower altitude, the cabin pressure increases accordingly and when the cabin pressure exceeds the trapped pressure in the PDPS line by 1.5 psid for a period of 15 seconds, a pack under-pressure condition is falsely created. The ACSC would then command the associated cooling pack to shutdown. There are several reasons that can explain how water collects in the PDPS line.

Firstly, the PDPS line is susceptible to condensation within the line. Secondly, the air conditioning system incorporates a water extractor to remove water vapor content before the air enters the ACM turbine. However, the extractor is not 100% effective and a portion of air leaving the water extractor still contains a small percentage of water vapor. As the air is cooled further at the ACM turbine stage, the remaining water vapor condenses to form water droplets. Most of the water droplets are expelled through the discharge duct and the cooling pack drains but some may enter the PDPS line. Over time, there may be enough water accumulation in the PDPS sense line to cause complete obstruction when it freezes at altitude. Thirdly, the cooler a pack runs, so does the effects of condensation increase, which brings us to the next topic.

The causes for the conditions described are not recent discoveries but were part of our focus study in an effort to understand the pack under pressure and pack temperature split conditions. The investigation has helped us to develop new troubleshooting procedures and improve on the existing ones. The Fault Isolation Manual (FIM) will be revised to include additional information based on lessons learned for a pack under pressure condition and a pack temperature split condition. The revised FIM should be available in the fourth quarter of 2006. ●
