SERVICE BULLETIN

**BD700-1A10, BD700-1A11
NLG SHOCK STRUT ASSEMBLY
REMOVAL OF A SECTION OF THE SHRINKABLE TUBING**

1285A-32-06

LANDING GEAR - NLG STRUT ASSY PNR 22175-10X (Liebherr
PNR 1285A0000-0X) - Harmonization of Shrink Sleeve Design

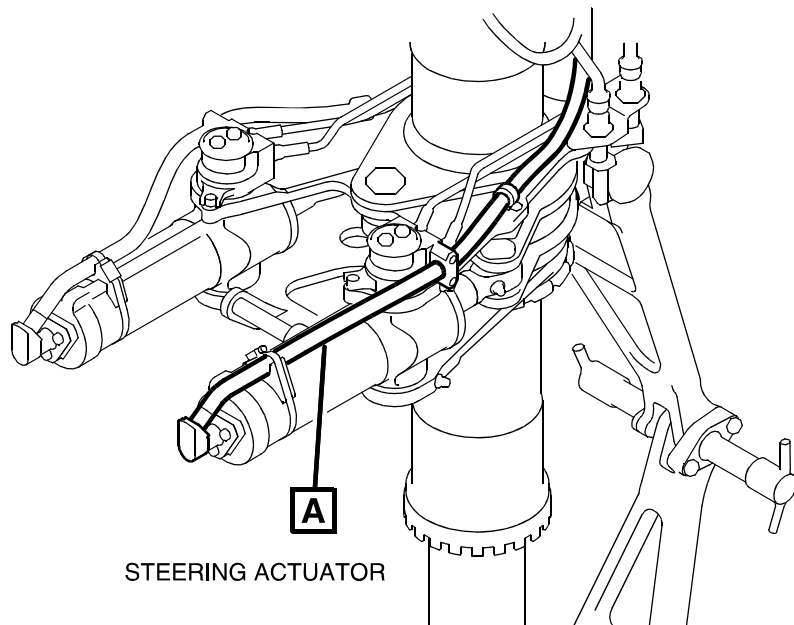
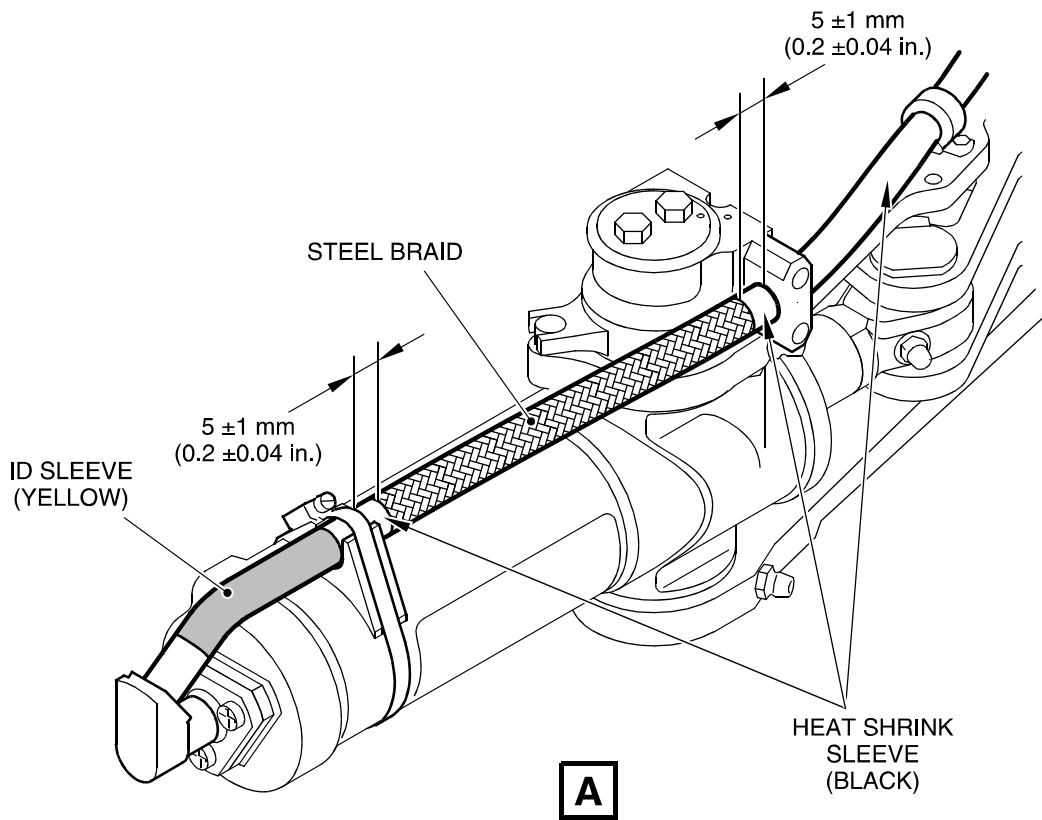
IN-SERVICE REWORK OF THE STEERING ACTUATOR
Figure 1

- Harmonization of shrink sleeve design of LVDT harnesses to improve the harness flexibility

- (1) Inspect the black heat shrink sleeve in the flexible area of the harness of each Steering Actuator Assy for signs of damage.
 - (a) If the damage affects the braided steel sleeve of the LVDT harness, remove the steering actuator and replace per CMM requirements. Send the damaged steering actuator to LIEBHERR-AEROSPACE.
 - (b) If the damage affects only the black heat shrink sleeve, continue with step 3.A.(2).

NOTE: The procedure can be done on aircraft or in the repair shop. It has to be done for the two Steering Actuators PNR 1287A0000-0X (LH) and PNR 1288A0000-0X (RH). Refer to Figure 1 of this Service Bulletin, to the LIEBHERR-AEROSPACE and Messier-Dowty CMMs 32-21-01 and 32-51-25 for a repair in the shop and to the Messier-Dowty SB700-32-032 for a repair on aircraft.

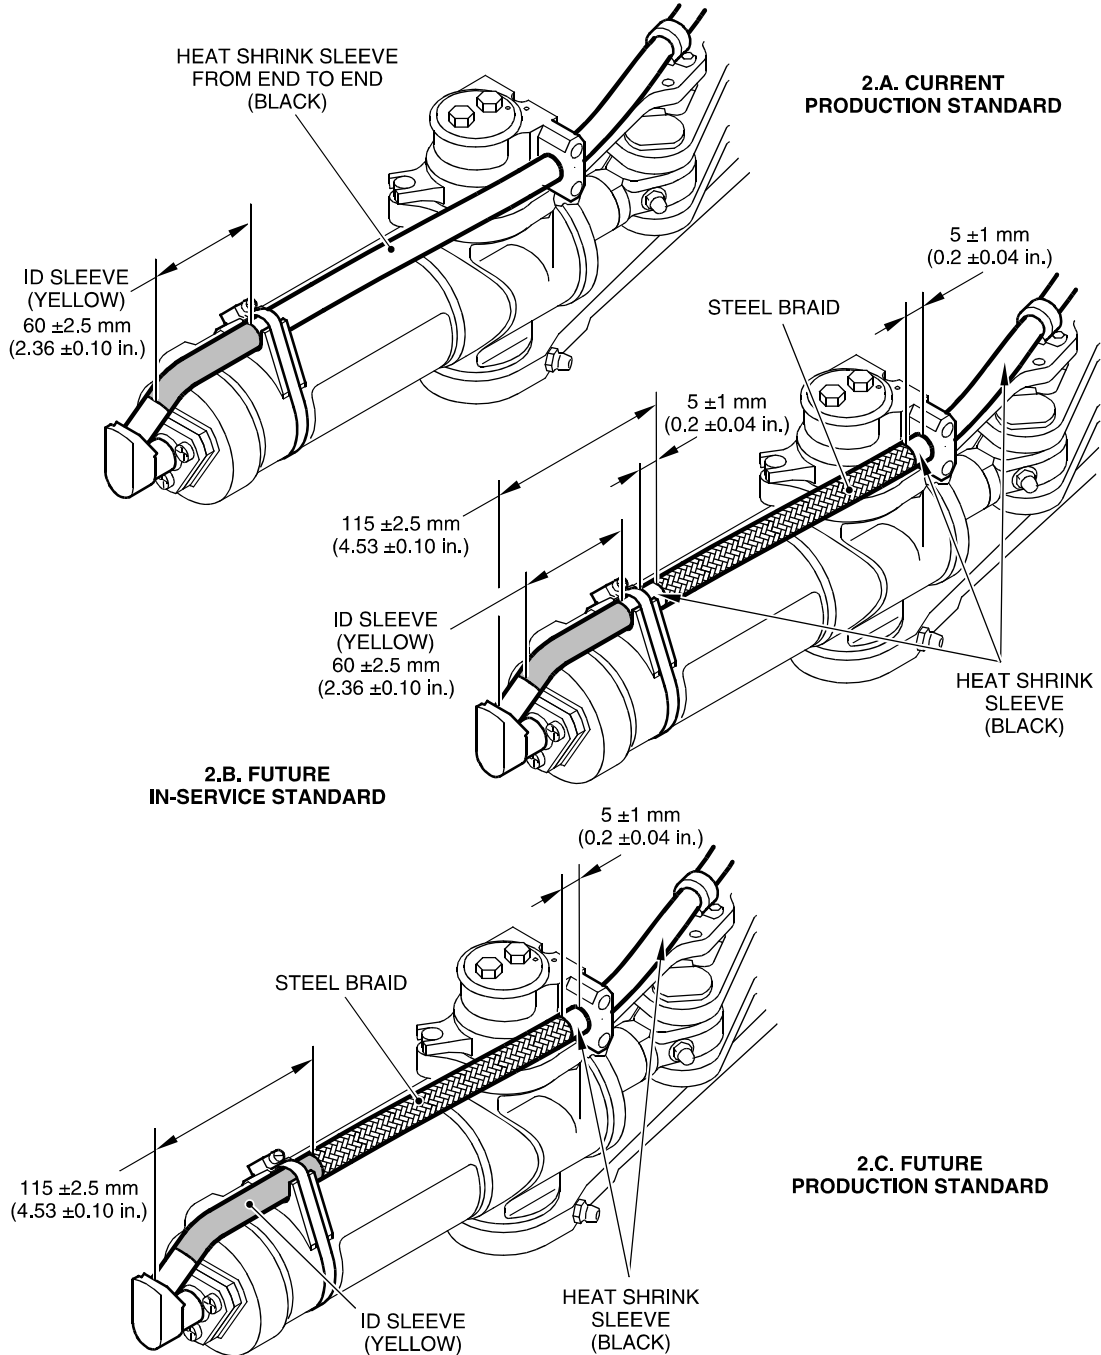
CHANGES TO STEERING ACTUATOR
Figure 2

- (1) Refer to Figure 2. This Service Bulletin informs the operator about a future production standard and the necessary steps for an in-service rework.
- (2) Removal of the black shrink sleeve in the flexible areas where the harness is bending when the LVDT harness moves between the Steering Actuator's forward clamp (refer to LIEBHERR-AEROSPACE / Messier-Dowty CMM 32-51-25, fig. 1-270) and the swivel valve bracket (refer to LIEBHERR-AEROSPACE / Messier-Dowty CMM 32-21-01, fig. 2-90).
- (3) Thus, the harness without heat shrink sleeve is more flexible.
- (4) The modification can be done without a part number change.
