## REFERENCE INSTRUCTION LETTER

<b>TO:</b> ALL OPERATOR	<b>FROM:</b> Customer Support Eng.	<b>CONTROL NO:</b> RIL # GX-0076		<b>REVISION:</b> C
<b>ATTN:</b> ALL MAINTENANCE	<b>ORIGINATOR:</b> Sylvain Bossé	<b>PAGE:</b> 1 of 2		
<b>PHONE NO:</b>	<b>PHONE NO:</b> 514-855-0230	<b>A/C MODEL:</b> Global 5000  Global XRS  G5000 GVFD G6000	<b>A/C S/N:</b> 9130 to 9383, 9389 to 9400, 9404 to 9431, 9998 9167, 9171 to 9312, 9314 to 9380, 9384 to 9429 9386, 9401, 9445 to 9997 9313, 9381, 9432 to 9997	
<b>FAX NO:</b>	<b>FAX NO:</b> 514-855-7634	<b>ATA NO:</b> 38-11		
<b>DATE OF REQUEST:</b> 08/05/2012	<b>PUBLICATION AFFECTED:</b> SMM 12 -23 -52 (Water sanitization procedure)			
<b>TITLE:</b> Potable Water System vent valve P/N 4E3261-4 & 4E3261-5 cleaning procedure.				
<b>REFERENCE:</b> SB 700-38-022, SB 700-1A11-38-008, SB 700-38-023, SB 700-1-A11-38-009, SMM 12 -23 -52				
<b>ISSUE:</b> Water system serviced in a region with a high level of mineral in water could induce contamination in the vent valve causing there malfunctions.

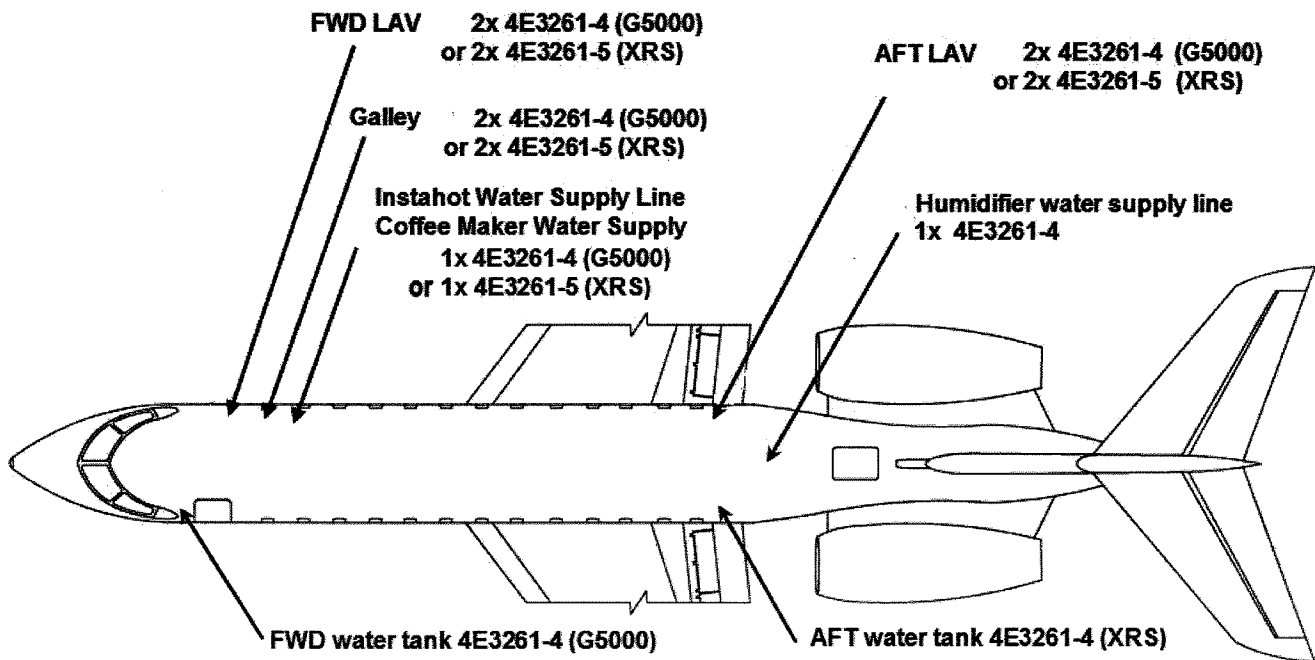
Figure 1. Approximate location for vent valves installation.
