**MT-9042A DUAL COUPLER MOUNT ASSEMBLY
ROCKWELL COLLINS PART NUMBER (RCPN) 622-8124-001**

SERVICE BULLETIN MT-9042A-23-1

**COMMUNICATIONS - MT-9042A - TUNE FAULT MITIGATION REGARDING
HIGH ANTENNA LOOP RESISTANCE**

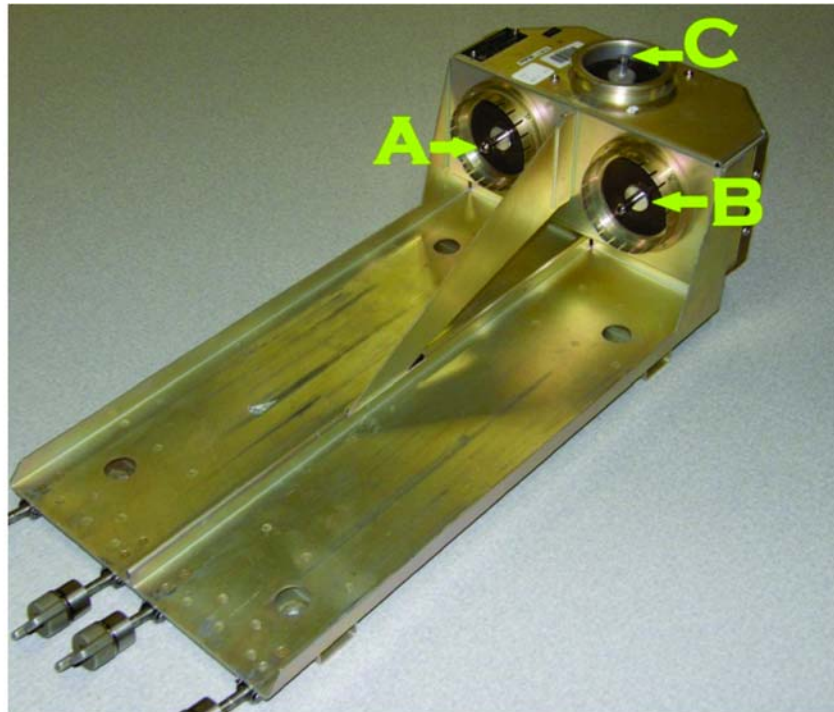
Measure Resistance
Figure 1

- (1) Pretest the dual coupler mount prior to modification. Testing where applicable can take place on the airborne platform.
 - (a) Use a milliohmeter to measure the resistance from center pin A to antenna center pin C and from center pin B to antenna center pin C. Refer to Figure 1, points A, B and C. This measurement should be less than 1 milliohm. If measurement is greater than 1 milliohm then installation of this service bulletin is recommended.

- (1) Using a milliohmeter measure the resistance from coupler mating center pin A to antenna center pin C and from coupler mating center pin B to antenna center pin C. Refer to Figure 1, points A, B and C. This measurement should now be less than 1 milliohm.
- (2) Using a milliohmeter measure the resistance from ground ring D to chassis E and from ground ring F to chassis E. Refer to Figure 2, points D, E and F. This measurement should now be less than 1 milliohm.

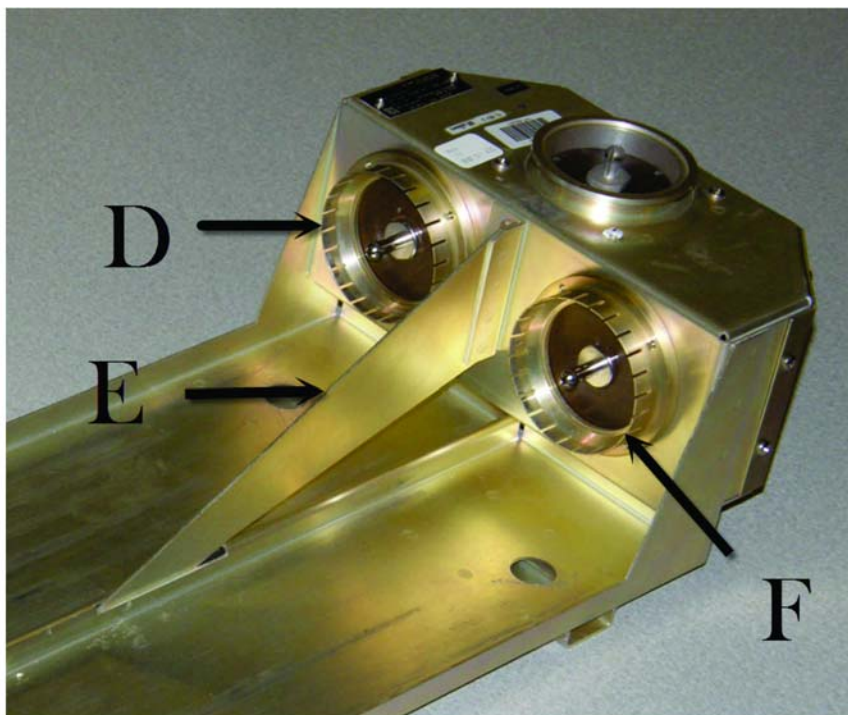
Measure Resistance From Ground
Figure 2

- (b) Use a milliohmeter to measure the resistance from ground ring D to chassis E and from ground ring F to chassis E. Refer to Figure 2, points D, E and F. This measurement should be less than 1 milliohm. If measurement is greater than 1 milliohm then installation of this service bulletin is recommended.

- (c) Reinstall ground rings ensuring ground rings bottom out on mount chassis and torque four (4) screws each ring to 12 +/- 1.1 inch pounds. Refer to Figure 4.
- (d) Repeat Step 3.A.(2)(b) and Step 3.A.(2)(c) for both ground rings D and F. Refer to Figure 2, D and F.
