## SERVICE INFORMATION LETTER

### Troubleshooting Guide for Airborne Weather Radar

Publication Number A23-2000-018

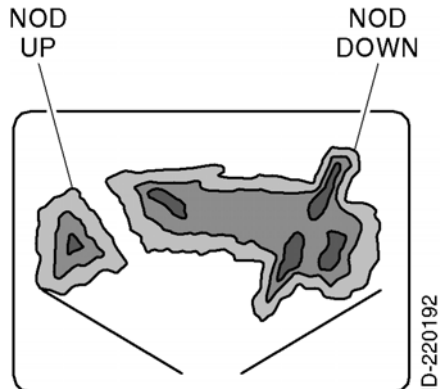
**Figure 1. (Sheet 1 of 1) Antenna Glitching**

- 2 The antenna on most weather radars is able to move in the elevation plane to accommodate stabilization and tilt commands. As the antenna is also scanning in the azimuth plane, the signals required to do this must be transferred to the moving part of the antenna. This is usually accomplished by means of a flexible cable but in some cases (now rare) it is done with slip rings. Thus, if breaks in the cable develop, it can cause the elevation axis to make small up or down jerks or glitches as it rotates. These glitches very often occur repetitively at the same azimuth angle.

- 3 This tends to be difficult to duplicate on the ground in the early stages as the high altitude coldsoak will make the wiring stiffer and shrink, thus aggravating the problem.

- 6 Corrective action: Remove and repair or replace the radar antenna or the receiver/transmitter antenna (RTA) unit.
- (e) Interference
- 1 This is a normal radar phenomenon. It is an unfortunate fact that all X-band radars use the same frequency band (approximately 9,000

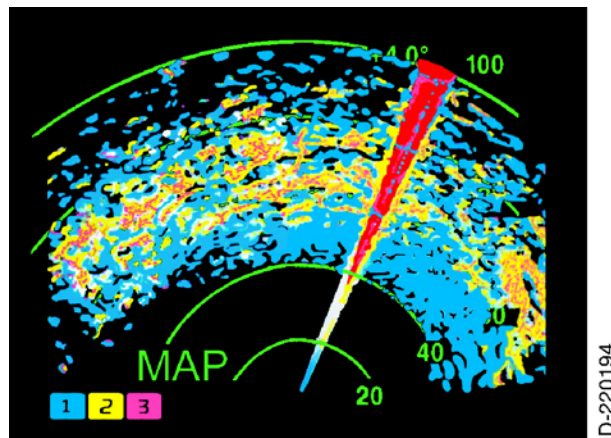
Figure 3. (Sheet 1 of 1) Interference

megahertz [MHz] to 9,600 MHz) and they tend to interfere with each other. It is a bit like being in a roomful of people who are all talking to each other. There are other frequency bands available, but the great consensus of opinion is that the current frequency choice is by far the best for airborne weather radars.

- 3 Generally, interference sources can be broken down as follows:
  - Other airborne radars
  - Marine radars
  - Military radars or jamming.
- 4 As the radar antenna scans past the source of the interference, interfering signals are picked up and processed for display. The processing in most radars is designed to ignore such signals as much as possible. However, when such signals penetrate the processing system, they will be displayed in the form of radial spokes. The radar antenna has the property of receiving mostly in one direction, but has some weak side lobes. (Refer to Figure 2) If the interference is strong enough, it will be received through the antenna sidelobes, and several spokes may be seen. This is complicated by the fact that if the source is a nearby rotating radar, the target illuminations of that radar may be seen. Thus a complex cluster of spokes may be seen in severe cases. (Refer to Figure 4)

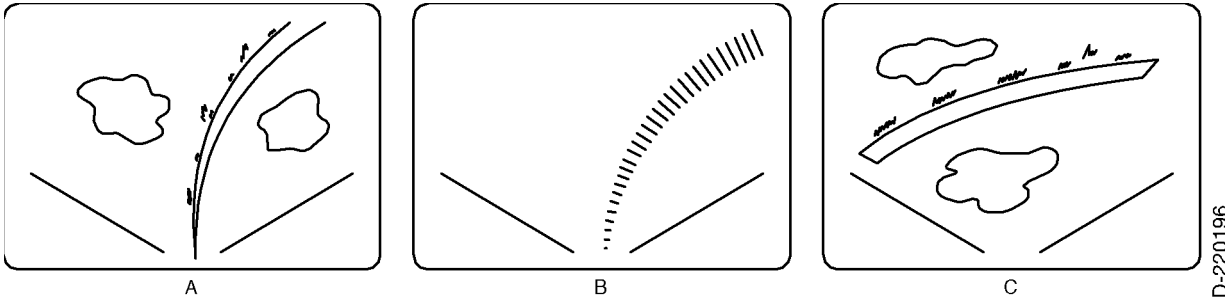
**Figure 5. (Sheet 1 of 1) Rabbit Tracking**

1 The term rabbit tracking was probably coined by some Women's Auxiliary Air Force radar operator in the Royal Air Force on a Type 7 metric search radar during World War II. This is a form of external interference that merits special discussion.

3 When the interference source is another (alien) radar, and when the pulse repetition frequency (PRF) is related to the radar being interfered with, curved lines will be seen.

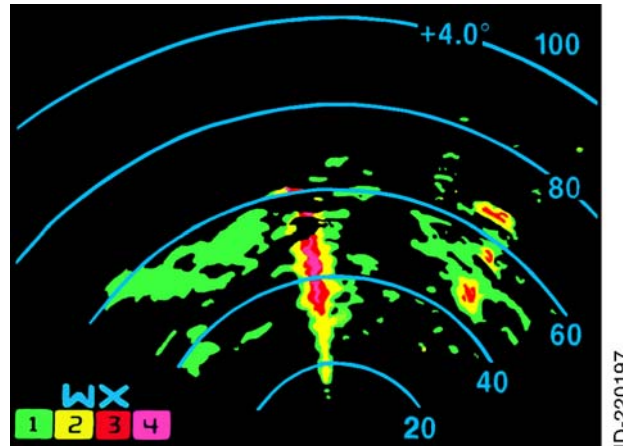
**Figure 6. (Sheet 1 of 1) REACT Pumping**

are small. This will cause the REACT to increase signal level behind the ground target and form a spoke.

- 3 The signature of this kind of spoking is as follows:
- Fairly transient - usually only lasts a minute or so.
  - Deselecting REACT will eliminate.
  - Spokes only present where targets are displayed.
  - Tilt change will eliminate.

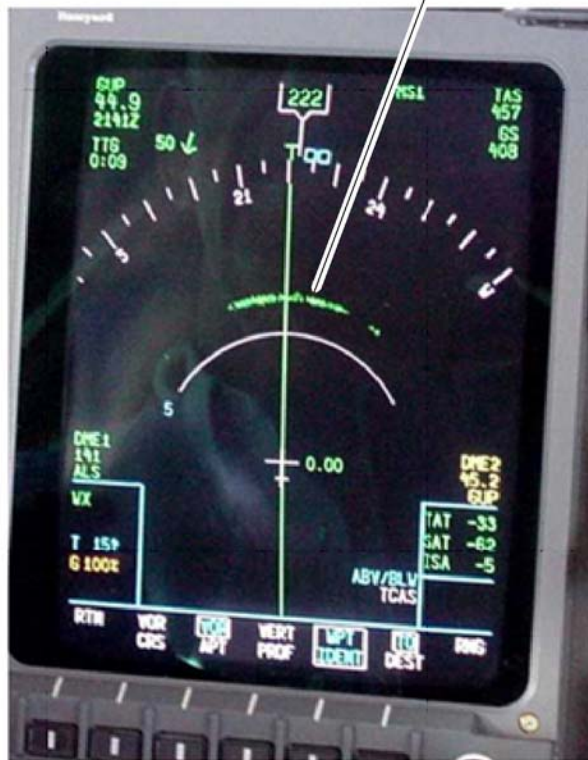
Figure 7. (Sheet 1 of 1) Altitude Rings or Arc Phenomenon

- 1 Altitude rings are a feature of all radars. If the radome is perfect and the flat plate antenna in good condition (not bent), they should be so weak as to be invisible. Altitude rings are caused when energy reflects off the inside of the radome and forms a sidelobe that points directly downwards. The exact path is often complex, involving reflections of various metal objects inside the radome. However, the first suspect is always the radome.

no radome is perfect so an altitude ring is not a cause for concern, unless it suddenly appears or gets stronger on a specific aircraft.

- 4 If an altitude ring suddenly appears or gets stronger on a specific aircraft, the user should suspect water ingress into the radome laminations through pinholes in the outer skin. It is possibly due to a small lightning strike. Remember, aircraft get hit by lightning when parked on the ground.
- 5 In the display shown in Figure 7, taken aboard an airplane flying at about 40,000 feet AGL. A narrow ring is seen at about 7 NM. This is a typical altitude ring. However, altitude rings can also be bean shaped targets at each side of the aircraft, or a complete circle from one side to the other. It will be noted that the range to the ring very closely relates to the airplane altitude in miles. An altitude ring that is not symmetrical about the fore and aft axis is a cause for concern as it indicates that something (probably the radome) is asymmetrical.

NOTICE THE ALTITUDE RING IS LOCATED AT ABOUT 7 NM. THE AIRCRAFT IS 6.9 NM ABOVE THE GROUND.

- a Altitude rings do not indicate a radar malfunction, unless the flat plate radiator is damaged. They are caused by reflections off the inner surface of the radome, which in a well designed radome are minimal.
- b Inspect the radome for signs of water in the laminations or physical damage. Use a radome moisture meter. See the section on radomes that begins in Paragraph 1.E.(2)(j).

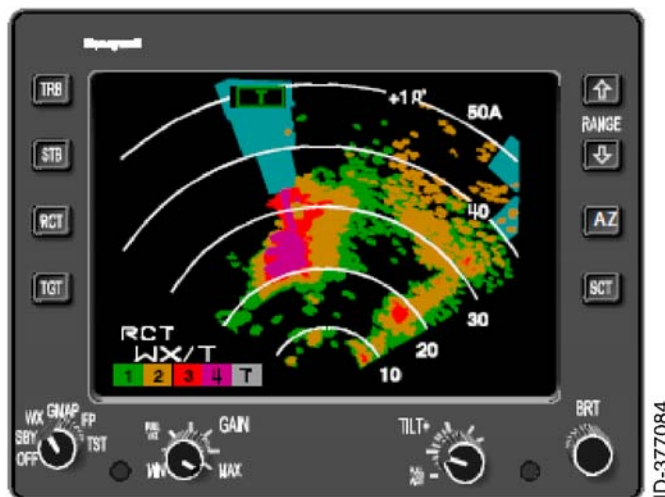
**Figure 8. (Sheet 1 of 1) Areas of Attenuation in Cyan, Honeywell REACT System**

- 3 What is happening is that after travelling 5 or 10 miles through the rain and back to the radar, there is little if any energy left due to the losses caused by the rain. This was the cause of the Air Wisconsin Flight 965 accident on 12 June 1980. The crew saw about 11 miles of solid, fairly low level targets ahead of the aircraft and kept wondering why it did not end. One of the surviving persons on board watched the sequence on the radar (an RCA AVQ47) and saw the black contour hole of the thunderstorm appear at about 9 miles.
- 4 The Honeywell REACT system detects this condition and adds a cyan field in areas where the radar is blinded by attenuation. Refer to Figure 8

- 5 Corrective action: none or educate aircrew. This is a normal radar behavior.
- (3) **Troubleshooting With TEST Mode Fault Annunciations**
- (a) Critical functions in both the P-650/870 and P-660/880 RTAs are continuously monitored. For each weather radar system, troubleshooting information is provided for each monitored fault condition, as shown in Table 2:
