# ADVISORY WIRE

<p>REFERENCE NO: AW700-22-0333, Rev. 1</p> <p>ATA: 22-12</p> <p><b>SUBJECT: Aileron and Elevator Auto-Pilot Servo</b></p>	<p>INFORMATION TYPE: Maintenance</p> <p>EFFECTIVITY: Global Express 9002 to 9153</p> <p>Global 5000 9127 to 9411, 9417 to 9431, 9998</p> <p>Global Express XRS 9159 to 9429</p> <p>Global 5000 feat. Bombardier Vision Flight Deck 9386, 9401, 9445 to 9997</p> <p>Global 6000 9313, 9381, 9432 to 9997</p>
---	---

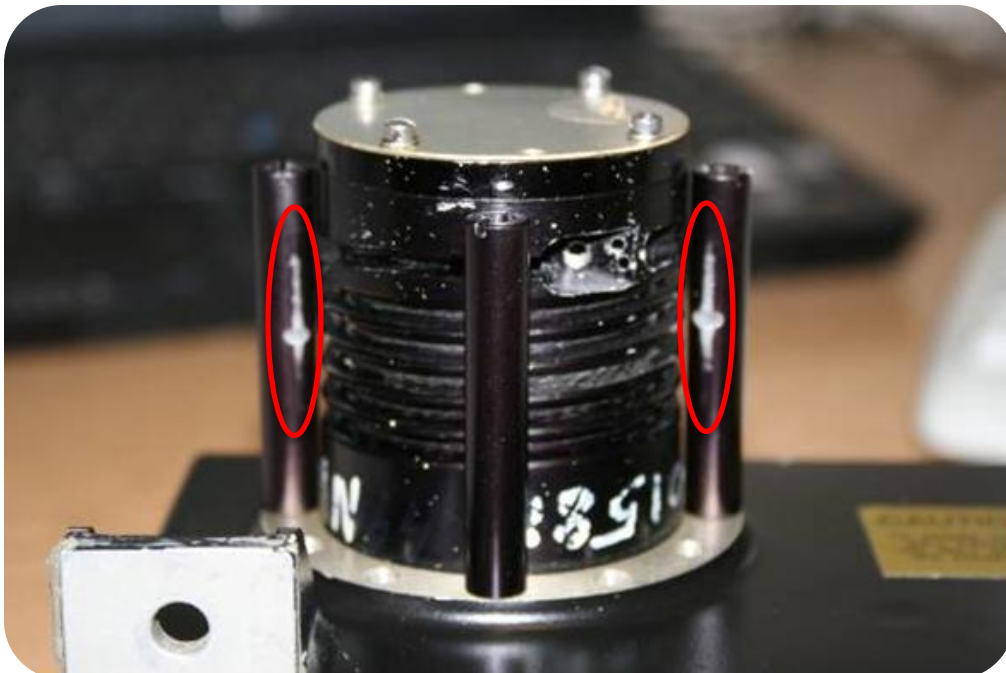
Recently, an operator reported that, during removal of the elevator servo bracket, two of the cable keepers had been worn by the cables (see Figure 1) and that the cables were found to be under-tensioned. Further inspections of the elevator AP servo confirmed that the same condition existed on other aircraft in their fleet. Furthermore, the aileron AP servo cable capstan bracket was also found with similar wear to the keepers and the cables were under-tensioned.

Figure 1 - Cable Keeper Wear

Operators should familiarize themselves with their applicable SBs (ref. 1.4 through 1.7). These SBs are recommended at the next access, or no later than the next "4C" check from the SB release date.
