Advisory Wire

REFERENCE NO:	AW700-23-0578, Rev 04	INFORMATION TYPE:	Maintenance Operational
ATA:	23-23	EFFECTIVITY:	Global Express / XRS (9002 - 9312, 9314 - 9380, 9384 - 9429) Global 5000 (9127 to 9383, 9389 to 9400, 9404 to 9431 and 9998)
SUBJECT:	FMS CDU 'ACARS DMU FAILED' message observed post Batch 3.3

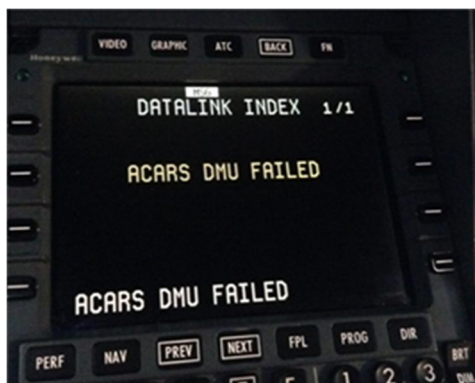
- 'ACARS DMU FAILED' amber message shows on the FMS CDU DATALINK INDEX page when the IAC (Integrated Avionics Computer) does not receive the correct health status from ADLU (Airborne Data-Link Unit) on the ARINC 429 bus, and
- 'ACARS DMU FAILED' message is displayed on FMS CDU scratchpad as shown in Figure 1 below.

Figure 1 – 'ACARS DMU FAILED' messages displayed on FMS CDU

In the reported cases, the 'ACARS DMU FAILED' FMS CDU scratchpad messages occurred during both FANS (Future Air Navigation System) and non-FANS operations, on ground and in flight at various times. Most occurrences last for a few seconds only and in few others cases the occurrence lasts longer, but in all cases the system recovers on its own. In most cases the crew would only notice the scratchpad message and if the failure condition is no longer present, simply acknowledge and clear the message using the CDU CLEAR key.

A condition was identified where there was an issue with an output from the FMS that preceded the Datalink reset. Honeywell has completed the root cause analysis and has determined that this issue was the reason for the failures experienced in the fleet.

Batch 3.3 upgrade (Ref. 1.1) is a prerequisite to Batch 3.4 upgrade (Ref. 1.6) and must be done before, or at the same time as Batch 3.4 (Ref. 1.6).

It is not recommended to replace Datalink unit exhibiting intermittent 'ACARS DMU FAILED' associated with the condition described in this AW and that successfully passes the Aircraft Maintenance Manual (AMM) Operational Test of the Data Link System (TASK 23-23-00-710-801).
