Advisory Wire

REFERENCE NO:	AW700-27-0631, Rev 2	INFORMATION TYPE:	Maintenance Operational
ATA:	27-51	EFFECTIVITY:	Global Express / XRS (9002 - 9312, 9314 - 9380, 9384 - 9425) Global 5000 (9127 - 9383, 9389 - 9400, 9404 - 9431 and 9998) Global 5000 feat. Vision Flight Deck (9386, 9401, 9445 - 9862, and 9868 - 9997) Global 6000 (9313, 9381, 9432 to 9860, 9863 - 9871, 9873 - 9997 and 60005 - 61999) Global 5500, Global 6500 (9861, 9872, 60001 - 61999)
SUBJECT:	Slat/Flap HALFSPEED Messages - Intermittent Slat/Flap Resolver

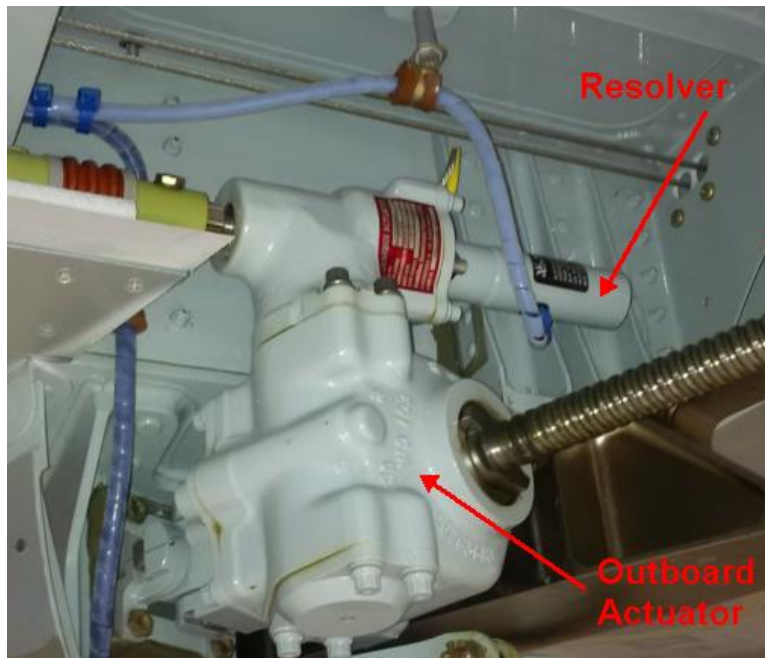
Figure 1
Right Flap Actuator and Resolver

Bombardier has identified a common failure mode in the slat and flap resolvers. The resolver part number GT415-5300-3 rotor winding can break causing the wiring resistance to vary intermittently or become open with the temperature variation. This change in the resistance affects the surfaces position values reported to the SFCUs. When the difference between the left and right resolver value becomes too high, the SFCU connected to this channel will stop operating until the surfaces position values returns within acceptable limits. Since only one of the two channels of the resolver rotor is usually affected, the system continues its operation in degraded mode.

A new Slat Flap Resolver part number 5917991 / GT415-5300-5 is now available and introduces improvements in the rotor core design, reducing the number of wires in the winding and increases the wire gauge.

Both Resolver part numbers (-3 and -5) are interchangeable and intermixable, but a -3 cannot be modified to the latest configuration. Therefore, the -5 version of the Slat and Flap Resolver is available to Operators via the Aircraft Illustrated Parts Catalog (AIPC) on attrition basis, upon failure of a -3 resolver.
