# Advisory Wire

REFERENCE NO:	AW700-28-0496, Rev 1	INFORMATION TYPE:	Maintenance Operational
ATA:	28-41	EFFECTIVITY:	Global Express Global XRS Global 5000 Global 5000 feat. Vision Flight Deck Global 6000 Global 5500 Global 6500
SUBJECT:	<b>Fuel Quantity Indication Fluctuation</b>

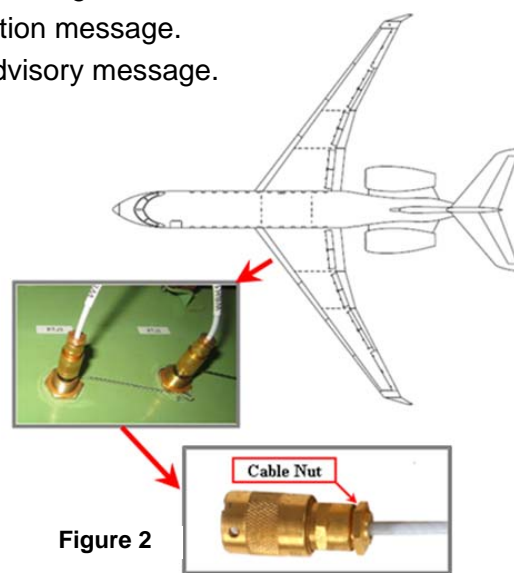
Figure 2

When accessing the CAIMS/OMS fault messages, multiple probe failures powered by the same excitation power were also reported. Further troubleshooting revealed that a large number of events were caused by loose cable nut on the co-axial excitation connectors (Refer to figure 2, picture below shows as an example).

The cable nut is designed to provide an electrical contact between the wire shielding and the coax connector external shell to ensure shield continuity between the FMQGC and the various fuel probes. Proper shielding of the excitation circuitry prevents Electromagnetic Interference (EMI) and ensures a clean signal for the different fuel probes connected on the same excitation line.

- During troubleshooting for a fuel quantity fluctuation issue where multiples probe failures are reported on the same excitation circuit, Operators are recommended to perform a wiring check between the FMQGC and the fuel probes to ensure excitation circuit integrity (ref 1.1). Particular attention needs to be taken to ensure cable nut on the back of the co-axial connector is secured and the connector is not damaged (ref 1.2).
- The SmartFix Plus™ troubleshooting tool includes this condition in the *Observed faults* section, in order to prevent unnecessary removals of the FMQGC (ref 1.3). Troubleshooting recommendations can also be found for specific fuel probe failures under the *Troubleshooting by CAIMS/OMS* section of SmartFix Plus, accessed from the [Bombardier Customer Portal](#).
