AW700-32-0280

SUBJECT: Nose Wheel Steering – Troubleshooting of
SCU GW415-8100-3

EFFECTIVITY:
Global Express aircraft (9002 to 9999)
Global Express XRS aircraft (9127 to 9999)
Global 5000 aircraft (9127 to 9999)

ATA: 32-51

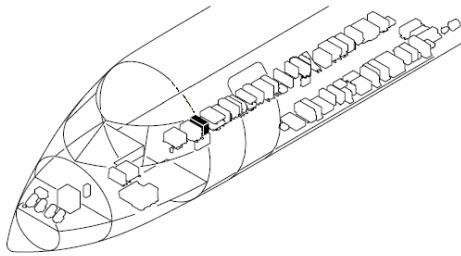
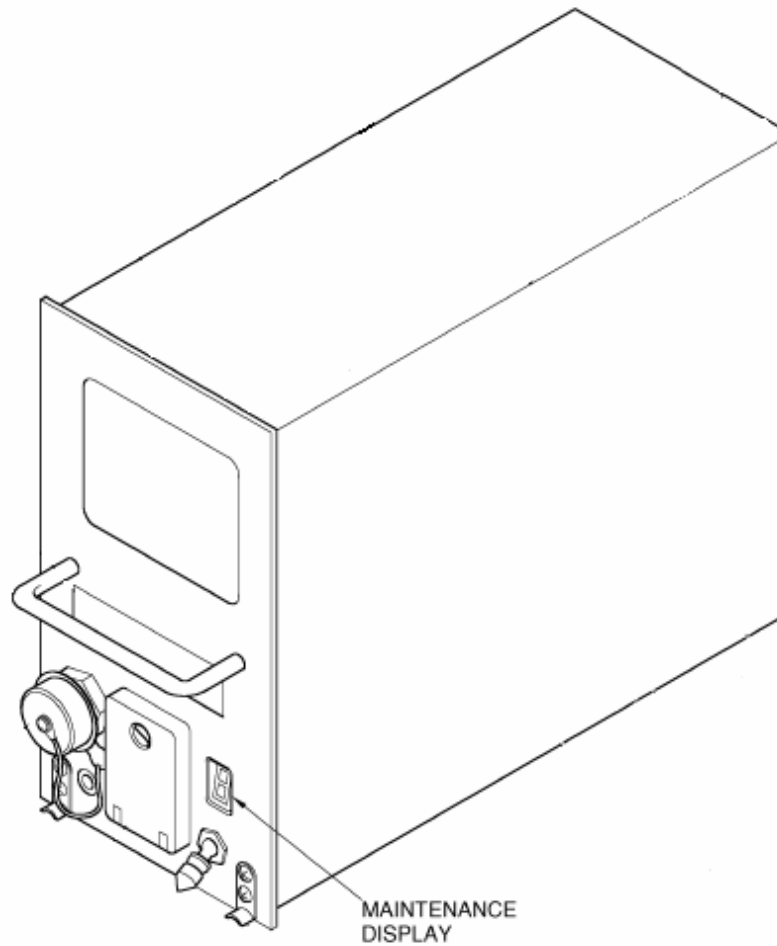
Figure 1

Operators with SCU -3 are encouraged to use the SCU fault codes on the maintenance display window (Figure 1) to troubleshoot the NWS system until the revised LDI (Osprey .033) becomes available.

If the above information is insufficient, customers may perform a SCU fault download as per the AMM task 32-51-01-970-801 and forward it to the Bombardier Customer Response Center at ac.yul@aero.bombardier.com for assistance.
