Advisory Wire

REFERENCE NO:	AW700-34-0501, Rev 01	INFORMATION TYPE:	Operational
ATA:	34-61	EFFECTIVITY:	Global Express / XRS (9002 - 9312, 9314 - 9380, 9384 - 9429) Global 5000 (9127 to 9383, 9389 to 9400, 9404 to 9431 and 9998)
SUBJECT:	Flight Management System (FMS) – Descent Angle changes upon Place-Distance (PD) HOLD Insertion

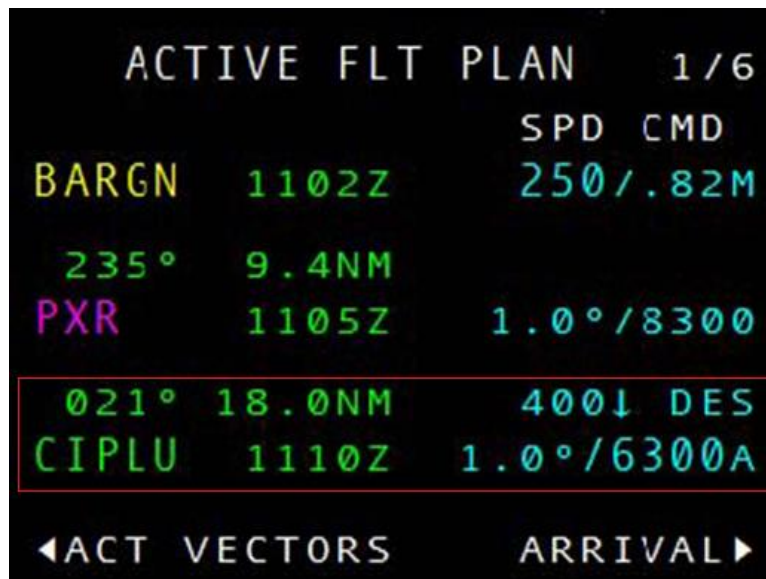
Figure 1

A situation is described in the Honeywell SIL (Ref 1.1), where the descent angle change after the insertion of a HOLD on a Place Distance (PD) waypoint in a flight plan. In the example described in the Honeywell SIL (Ref. 1.1), after crossing 'PXR' Very High Frequency Omnidirectional Range (VOR) waypoint, the pre-

selector altitude is dialed down and a vertical DIRECT-TO to 'CIPLU' is performed (Figure 1). At this point in time, the descent angle changed to less than 3.0 degrees, in this case to 1.0 degree.

Operators should be familiar with the condition detailed in the Honeywell SIL (Ref. 1.1) and flight crew are encouraged to monitor FMS behavior during all flight plan changes.

Correction to this condition will be considered as a part a future software change to the IAC/FMS.

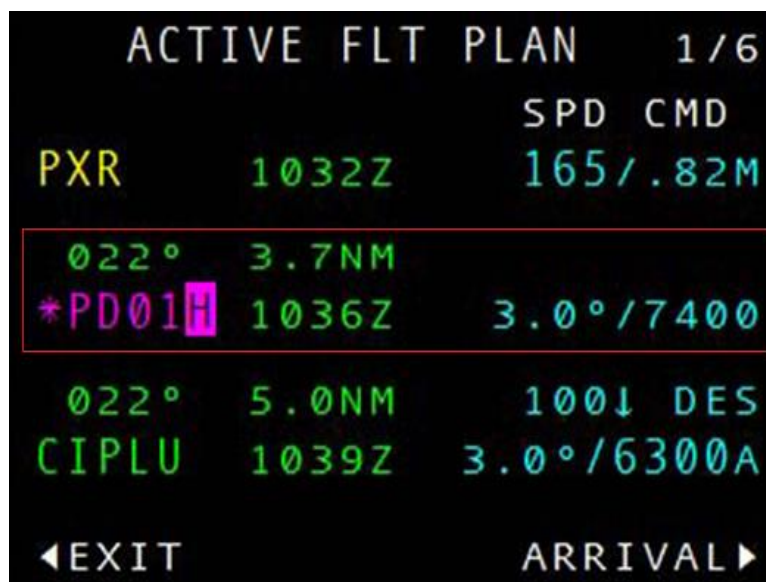
Figure 2

A PD waypoint is inserted between the next waypoint 'CIPLU' and the 'PXR' VOR waypoint. Then a HOLD is inserted on the PD waypoint. When activated, the descent angle changed back to the 3.0 degrees (Figure 2). The aircraft would also level off at this point. The active descent angle should not change while making flight plan changes in VPATH mode.
