# ADVISORY WIRE

REFERENCE NO:	AW700-34-0516, Rev 01	INFORMATION TYPE:	Maintenance Operational
ATA:	34-55	EFFECTIVITY:	Global Express / XRS (9002 - 9312, 9314 - 9380, 9384 - 9429)
SUBJECT:	<b>Space Based Augmentation System (SBAS) Global Navigation Satellite Sensor Unit (GNSSU) failure in flight</b>		Global 5000 (9127 to 9383, 9389 to 9400, 9404 to 9431 and 9998)

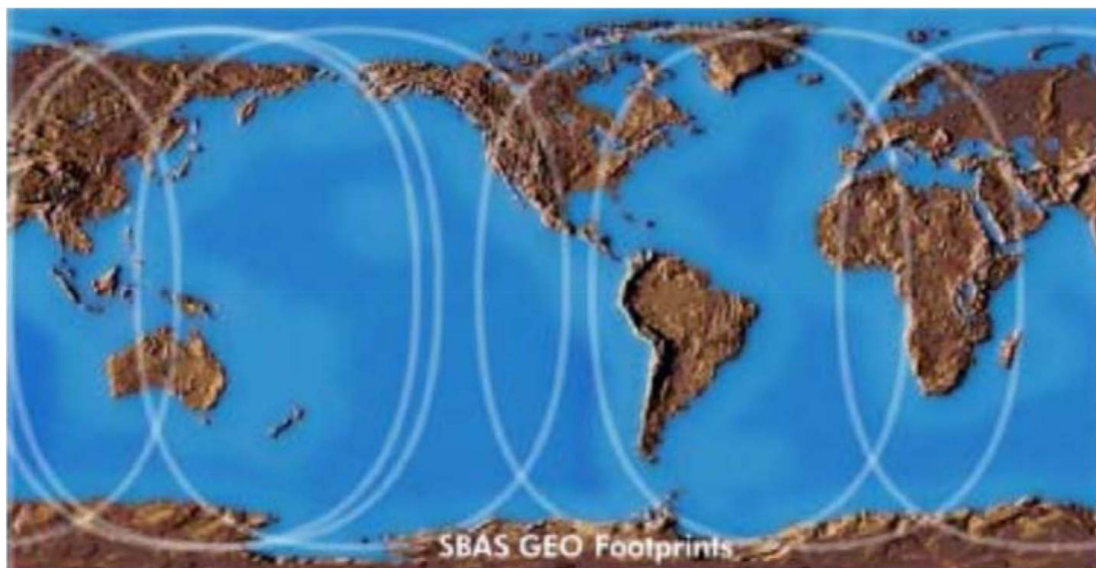
Figure 1- SBAS Satellite Coverage Map

The probability of encountering this software anomaly is small and it is not possible for the operator to predict when the SBAS GNSSU is under these exact conditions. In general, these events occur more frequently when the aircraft is close to the edge (see white lines) of the SBAB coverage regions (Ref. Figure 1).
