Advisory Wire

REFERENCE NO:	AW700-34-0607, Rev 01	INFORMATION TYPE:	Operational
ATA:	34-61	EFFECTIVITY:	Global Express / XRS (9002 - 9312, 9314 - 9380, 9384 - 9429) Global 5000 (9127 to 9383, 9389 to 9400, 9404 to 9431 and 9998)
SUBJECT:	Flight Management System (FMS) – Navigation database altitude constraint missing from the active flight plan

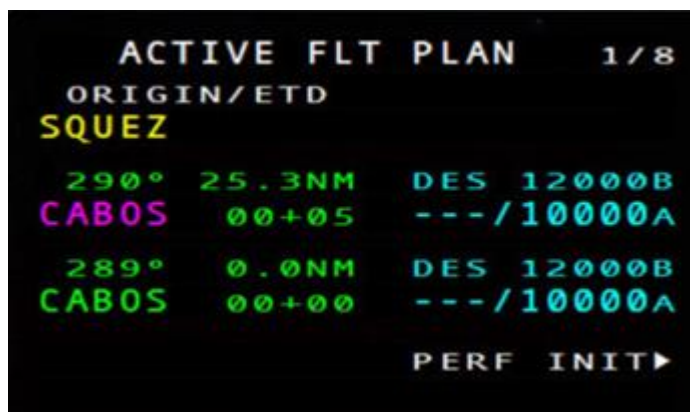
Figure 1

As shown in example Figure 1, the system displays the common waypoint in the active flight plan twice. When the aircraft sequences the first double CABOS waypoints, lateral guidance LNAV would disconnect and the lateral mode reverts to ROL.

This issue is due to an FMS software anomaly where melding of a common waypoint in these type of procedures are not properly handled when both procedures contain the same altitude constraint.

This FMS anomaly of LNAV reverting to ROL mode was resolved by implementing a Database Management (DM) solution that removes the altitude constraint from the last leg of the STAR common route.

Operators should be familiar with the condition detailed in the Honeywell SIL (Ref. 1.1). Flight crews are advised to fly the published procedures available in the NavDB and monitor all phases of flight.

This condition was mitigated by implementing DM solution and will be corrected in a future NZ FMS software loads.

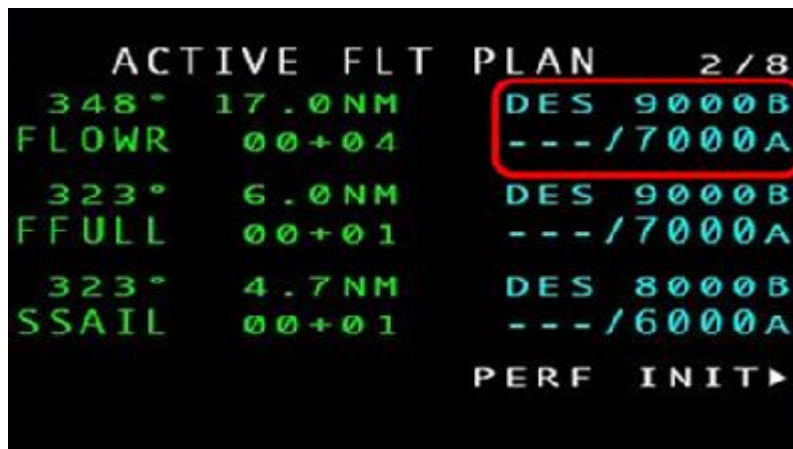
Example in Figure 2 and Figure 3 show a portion of the TMBRS2 STAR going into Portland International airport (KPDX). The altitude constraint on waypoint FLOWR in Figure 2 is per charted procedure with no DM solution applied.

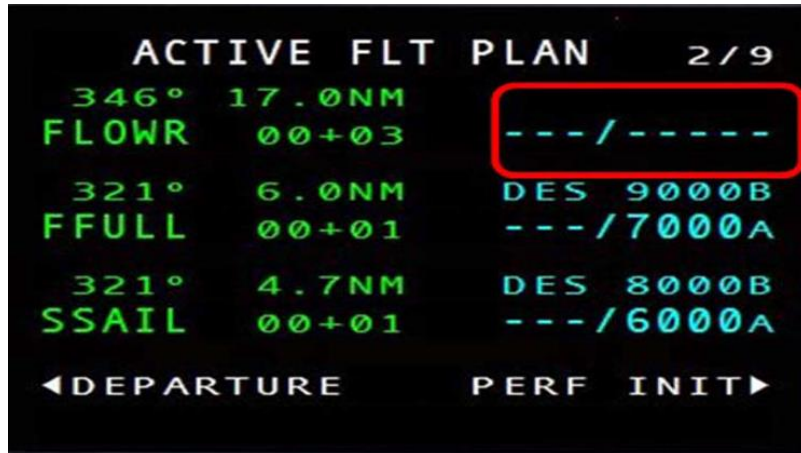
In Figure 3 the same partial STAR procedure but with the DM solution applied. The altitude constraint on waypoint FLOWR is removed from the active flight plan.
