Advisory Wire

REFERENCE NO: AW700-36-0826, Rev. 06

EFFECTIVITY: Global Express
Global XRS
Global 5000
Global 5000 feat. Vision Flight Deck
Global 6000
Global 5500
Global 6500

**SUBJECT: Kidde Bleed Leak Detection
Loops Notice of Escape**

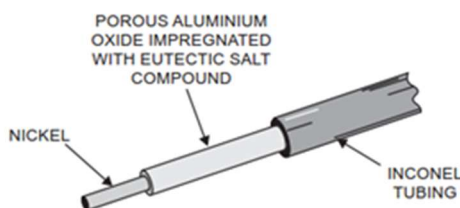
LDL elements contain thermo-resistive eutectic salt compounds embedded between an inner conductor and an outer casing. A local temperature increase causes the salt compound to become conductive resulting in a resistance drop between the inner conductor and outer casing which subsequently sets off the appropriate cockpit warnings.

Due to a manufacturing process error, some LDL elements may not be fully filled with eutectic salt, and this could result in the LDL elements being unable to detect a bleed air leakage in the affected area.

Bombardier has released SBs (Ref. 1.9) to test and replace any defective LDL elements on the affected aircrafts. The SBs are mandated by the ADs (Ref. 1.10 to 1.12) within 2000 Flight-hours or 120 months, whichever comes first, from the ADs effective date. It is recommended (when possible) that the incorporation of the SB be planned during a scheduled maintenance event as described in the SBs.
