Advisory Wire

REFERENCE NO:	AW700-38-0625 REV 1	INFORMATION TYPE:	Maintenance Operational
ATA:	38-11	EFFECTIVITY:	Global Express / XRS (9002 - 9312, 9314 - 9380, 9384 - 9429)
SUBJECT:	Waste Tank Level DP Sensor – Fail message		Global 5000 (9127 to 9383, 9389 to 9400, 9404 to 9431 and 9998) Global 5000 feat. Vision Flight Deck (9386, 9401, 9445 - 9997) Global 6000 (9313, 9381, 9432 -9997)

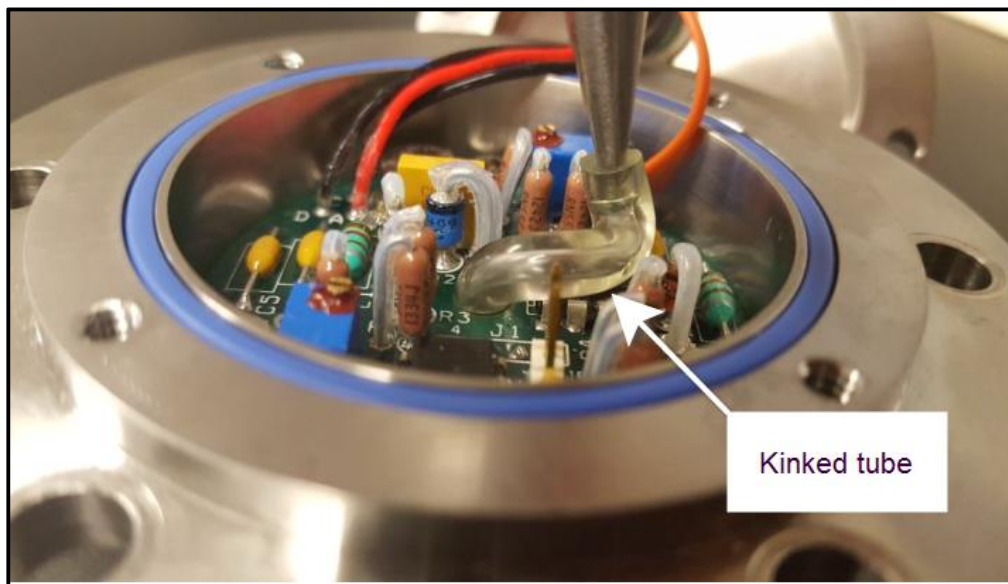
Fig. 1

Some operators have reported experiencing fail or erratic indication from the DP sensor. After analysis, it was found that the PVC level transmitter tubing was potentially kinked (Fig. 1). When the tank is pressurize, this kink could either, provide variation in waste level indication or indicate a SENSOR FAIL message on the GTSE. Serial number 435 through 1203 are potentially affected with this condition. Some units in the range have been modified with a smaller tube. The letter "R" follows the existing serial number to indicate it was repaired. All new units (above SN: 1204) were manufactured with the improvement.

- Verify the incorporation of the listed SB (ref. 1.1 to 1.4), that introduce the installation of a heater on the DP sensor in addition of an insulation blanket. If the SB has been incorporated, please ensure the insulation blanket is not damaged and still properly installed.
- Per SMM instruction (ref. 1.5), drain and rinse the waste tank before the pre-charge.
- Per vendor SIL instruction (ref. 1.6), perform a pre-charge by adding 2.5 gallons (9.5 liters) of water in the waste tank via the rinse water line. This practice will use water acting as a barrier and help stop particles from hitting the DP sensor diaphragm and slowing down the rapid decompression of a flush cycle.

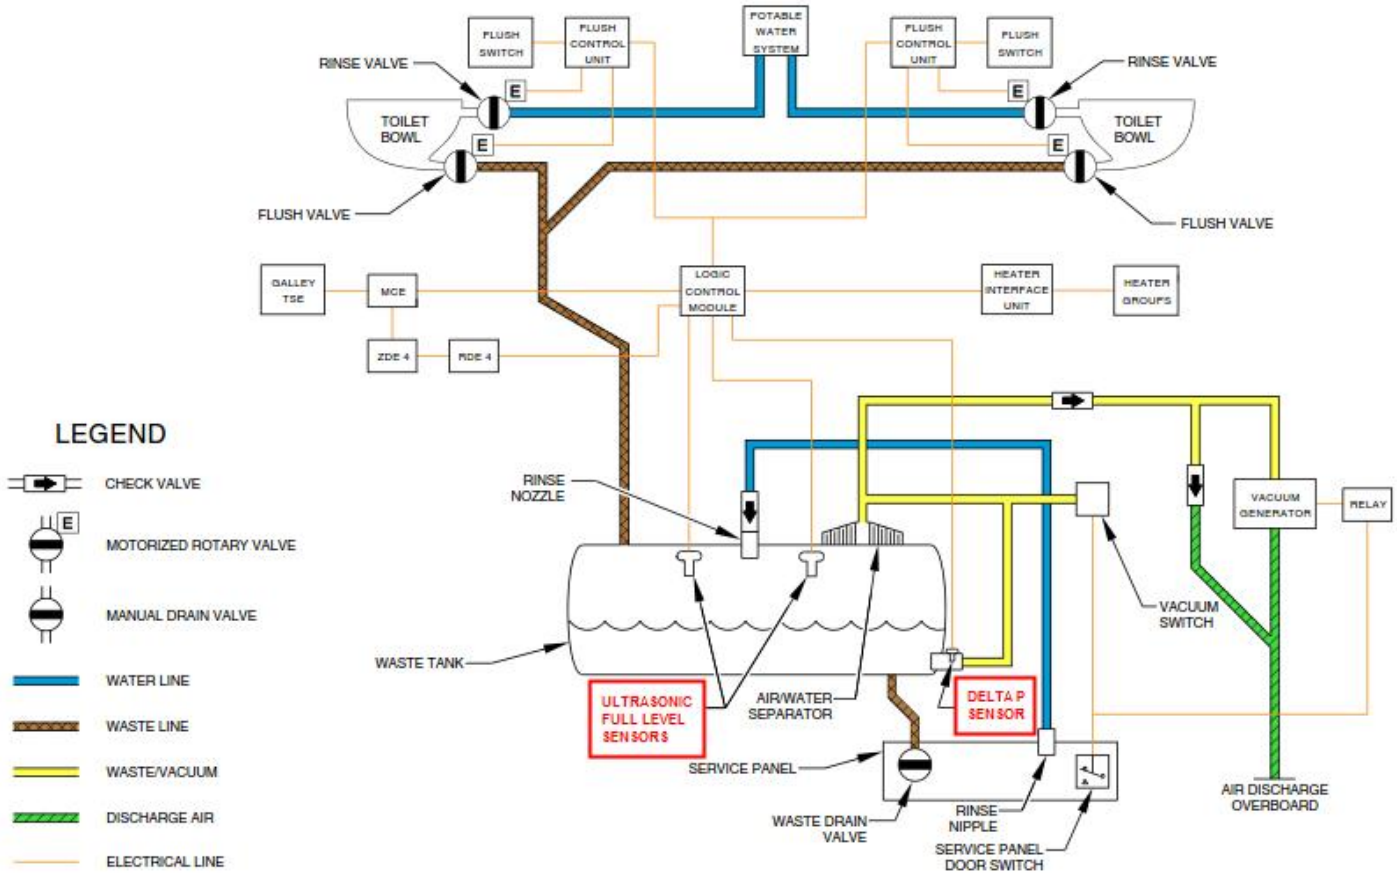
Fig. 2

The waste system is designed with two ultra-sonic sensors (Fig.2) that are working independently. Both ultra-sonic sensors need to be triggered (wet), before shutting down the waste system (full). The DP sensor continuously monitors waste tank fluid level.

Erratic readings, internal failure or failed DP sensor will not inhibit the waste system operation.
