# ADVISORY WIRE

## AW700-49-0334, Rev. 1

**SUBJECT:** APU STARTER - Brush Inspection

**EFFECTIVITY:** Global Express Aircraft (9002 to 9153)  
Global 5000 aircraft (9127 to 9413, 9415 to 9442, 9998)  
Global XRS aircraft (9159 to 9431)  
Global 5000 featuring Vision Flight Deck (9386, 9401, 9445 to 9997)  
Global 6000 aircraft (9313, 9381, 9432 to 9997)

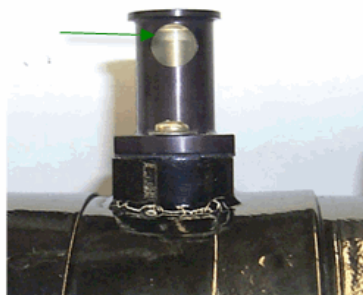
**Indicator in UP position,  
 indicating brushes are good**

On Starter Motor P/N 2704554-2, the bronze pin color can be hard to read and a dropped indicator pin can be missed during inspection as shown on the pictures attached.

- When performing the 500 APU hours TLMC task (Ref. 1.2), Bombardier encourages technicians to pay particular attention when inspecting the brush wear indicator:

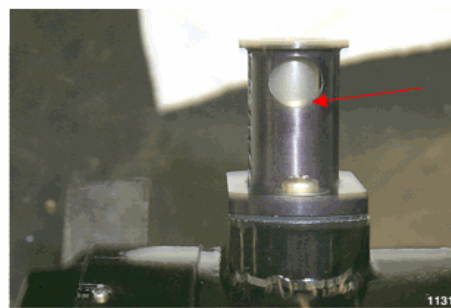
**Indicator in DOWN position,  
 indicating brushes are worn**

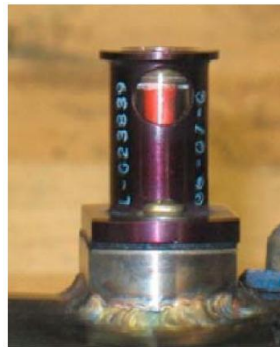
On Starter Motor P/N 2704554-3 (Ref 1.6), take note that to improve visibility, the new Brush Wear Indicator (BWI) is now equipped with an indicator pin coloured bright red.

- Operators may want to adapt the frequency of the brush cleaning procedure (Ref. 1.4) to a schedule which best supports their individual needs.
- Operators should always adhere to the APU Starter duty cycle as per the AMM (Ref. 1.3) in order to minimize degradation of the Starter brushes.
- Bombardier recommends concerned Operators comply with the previous Honeywell Service Bulletin dated 2007 (Ref. 1.5.)
- Honeywell has recently developed and made available through Vendor Service Bulletin Ref. 1.6 an improved BWI design that directly acts on the motor brush, thus minimizing tolerance stack-up and providing a more accurate indication of brush wear. This Vendor Service Bulletin (VSB) was incorporated in production as of aircraft 9486.
