# Advisory Wire

REFERENCE NO:	AW700-49-0546, Rev 01	INFORMATION TYPE:	Maintenance Operational
ATA:	49-00	EFFECTIVITY:	Global Express / XRS (9002 - 9312, 9314 - 9380, 9384 - 9429) Global 5000 (9127 to 9383, 9389 to 9400, 9404 to 9431 and 9998)
SUBJECT:	<b>Dashing indication with the use of MOBIL 254 oil</b>

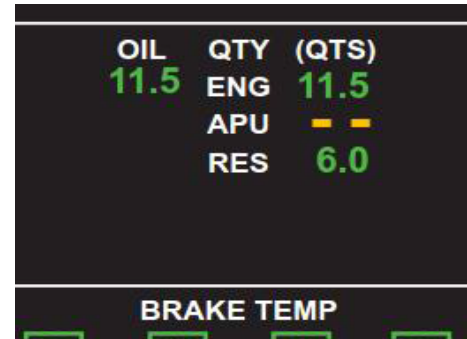
Figure 1

The use of Mobil 254 oil and Mobil Jet II (MJ II) is more susceptible than any other oil to cause dashing indication in the cockpit because of the BITE limit (validity of the SSM) set in the FADEC software and the capacitance of the oil level sensor that is affected by the oil dielectric constant. When the capacitance is below 60pF, the FADEC will send a No Computed Data (NCD) to the avionics suite. This NCD condition results in an invalid SSM on Label 177 (Oil level indication) of the FADEC and causes an amber dashing indication in the cockpit (see Figure 1).

Currently, the oil quantity can be read through CAIMS at all times as CAIMS does not consider the validity of the label sent by the FADEC. However, for more precise reading and as mentioned in Vendor's SIL (reference 1.1), FCOM (reference 1.2) and AMM (reference 1.3), delay of 15 minutes should be allowed for the oil to settle and resume to a normal oil level indication. Oil quantity can also be read physically through the APU gravity oil servicing cap.

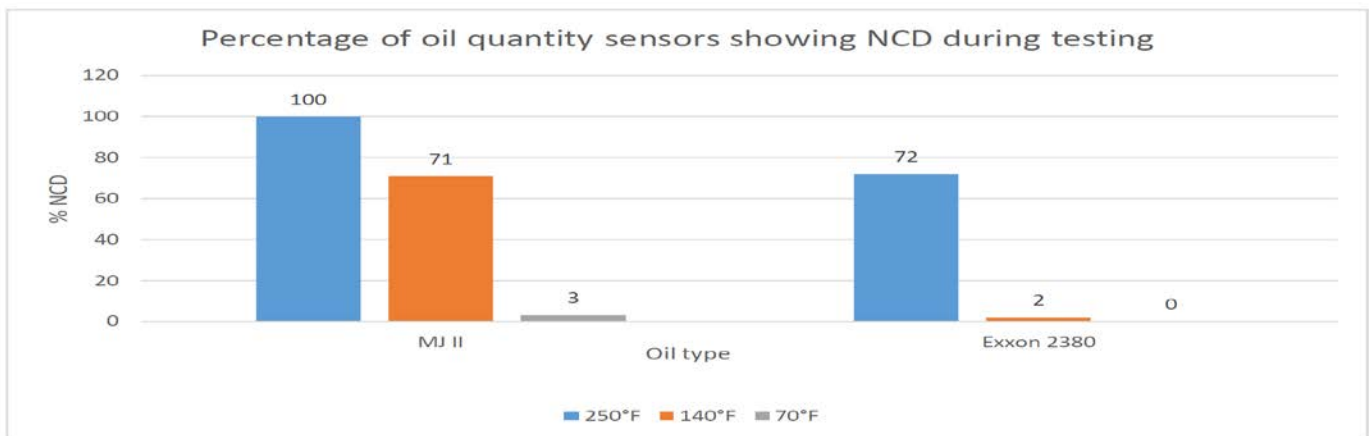
Despite the fact that MOBIL 254 and MJ II oils are more susceptible to cause dashing indication, Operators using more common oil such as EXXON 2380 could also experience the issue, albeit less frequently. Figure 2 shows the fleet exposure to this condition in correlation with the different oil temperatures.
