Advisory Wire

REFERENCE NO: AW700-52-0651

ATA:52-36

SUBJECT:
Passenger door
vent flap
mechanism

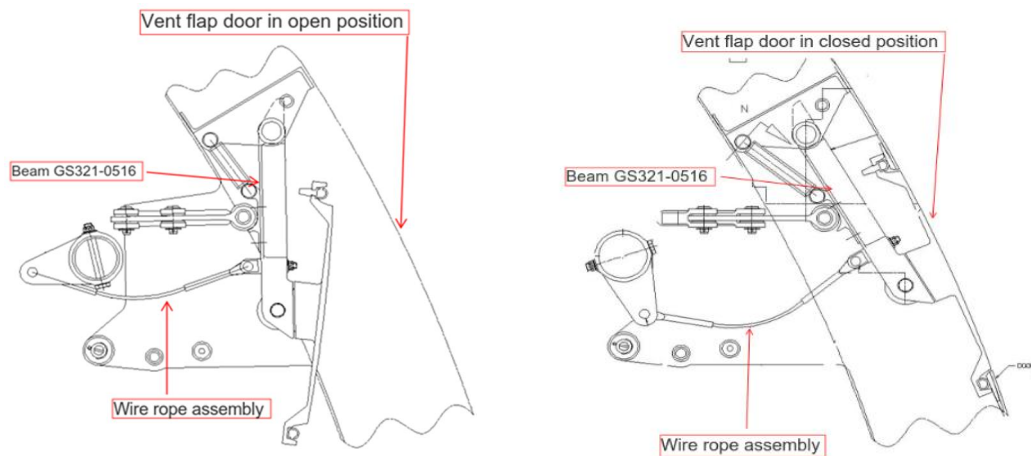
The vent flap is designed to relieve potential residual cabin pressure during the opening of the passenger door. Investigation determined that the passenger door vent flap beam is cracking due to repetitive elevated loads being applied through the door mechanism.

In the event that the vent flap beam cracks, the vent door may not properly seat on the door structure resulting in an unscheduled maintenance event.

When this condition occurs, a gap around the vent flap door can be noticed visually when the passenger door is in the closed position. This item is an active top issue at the advisory (Ref 1.2) for which Bombardier is currently working on a redesign of the passenger door vent flap mechanism.

At this time, there is no action required. Should this condition occur, the beam will require replacement prior to next flight. BA technical services will keep you informed as the redesign progresses.
