# Advisory Wire

REFERENCE NO:	AW700-56-0663 Rev 01	INFORMATION TYPE:	Maintenance
ATA:	56-10	EFFECTIVITY:	Global Express / XRS (9002 - 9312, 9314 - 9380, 9384 - 9429)
SUBJECT:	<b>Windshield Delamination Criteria for a Pro-Active Replacement</b>		Global 5000 (9127 to 9383, 9389 to 9400, 9404 to 9431 and 9998) Global 5000 feat. Vision Flight Deck (9386, 9401, 9445 - 9997) Global 6000 (9381, 9432 -9997)

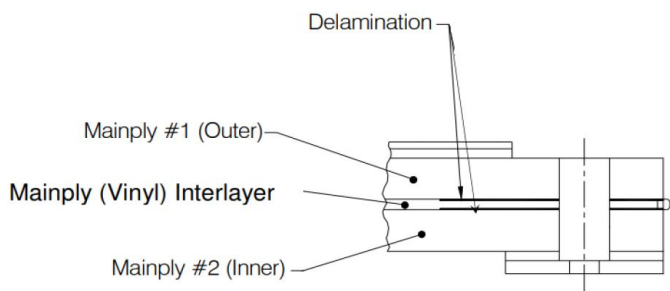
Main ply delamination occurs between a main ply and the vinyl interlayer, as shown in Figure 1. This type of delamination is located at the center of the windshield as opposed to face ply delamination, which is very close to the exterior surface. Delamination between main plies is typically located on 3 sides (Figure 2): the upper and lower edges, and along the center post and denoted by jagged edges as opposed to face ply delamination which typically shows in smooth beach mark pattern (Figure 3).

Figure 1: Main ply delamination location

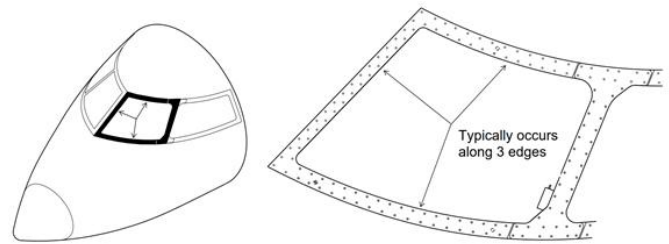
Figure 2: Edges of occurrence

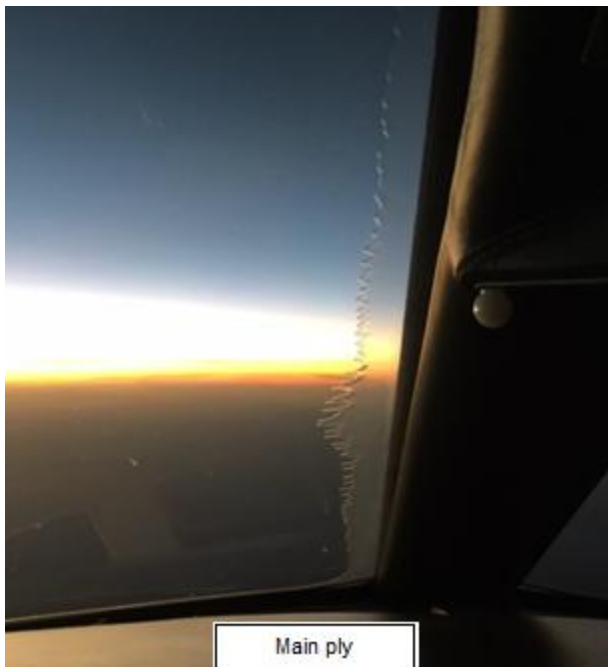
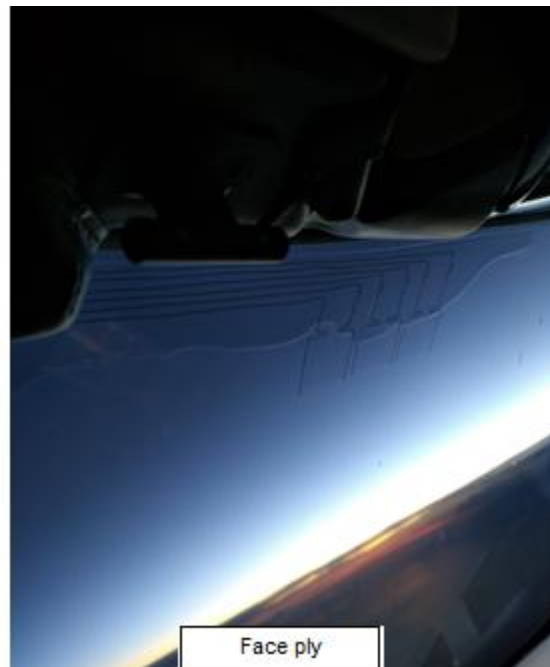
Figure 3: Main ply VS face ply delamination
